**SECTION 1**  
**DEPARTMENT OF PUBLIC**  
**WORKS FACILITIES – 24 NEW BOSTON ROAD**

**INTRODUCTION**

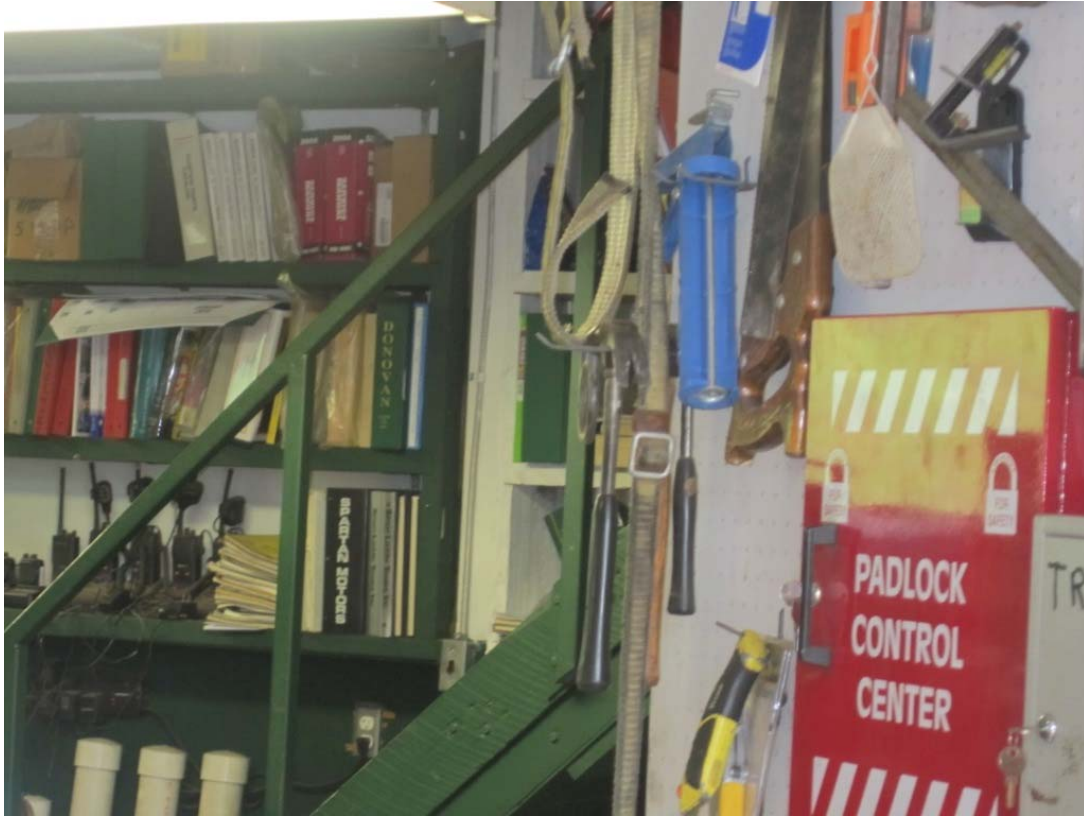
- 5.1. VT Fire Prevention and Building Code.
  - 5.1.1. The Division of Fire Safety found 3 minor violations.
    - 5.1.1.1.Storage shall be in accordance with NFPA 1 chapter 60 (oil, POL products)
    - 5.1.1.2.Guard non-compliant on stairs NFPA 101 Chapter 7
    - 5.1.1.3.Move rag bucket away from combustible material NFPA 1.
  - 5.1.2. The building is in compliance with the VTFPBC. The VTFBC includes NFPA 101 Life Safety Code and the 2006 International Building Code.
- 5.2. Vermont Occupational Health and Safety Administration (VOSHA)
  - 5.2.1.1. The project WorkSafe inspection identified several VOSHA violations. All of these have been corrected.

Photograph No. 1: Stairway going to 2<sup>nd</sup> level of DPW that needs mid-rail at the least.

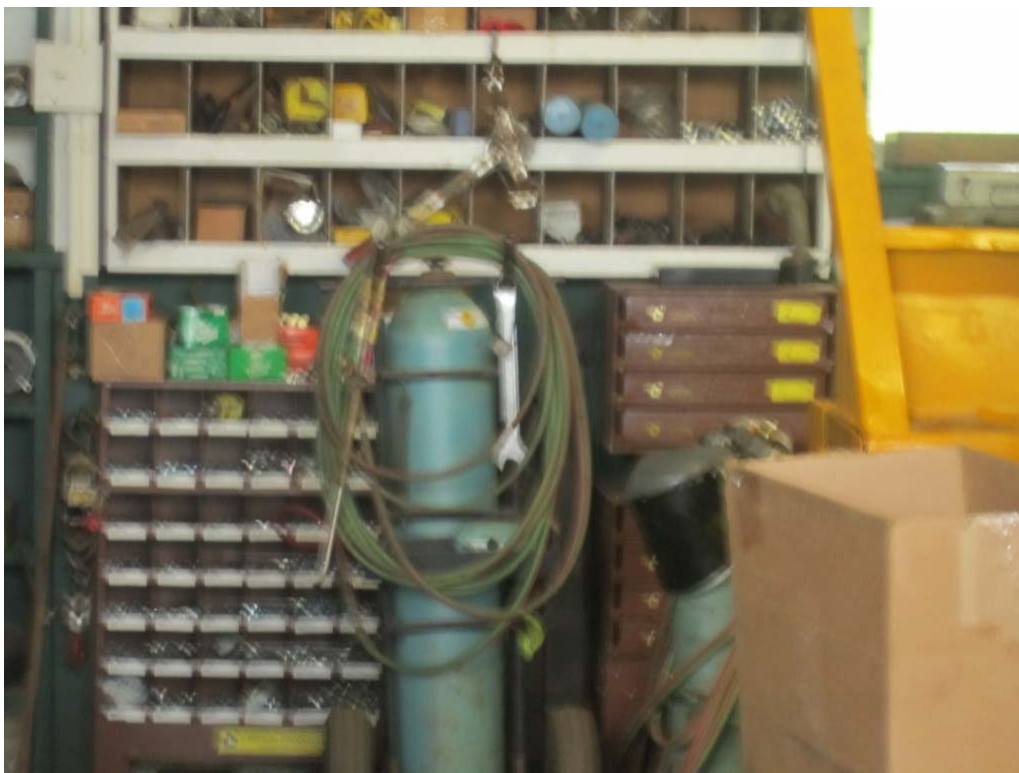
Photograph No. 2: Highly flammable acetylene tank storage.

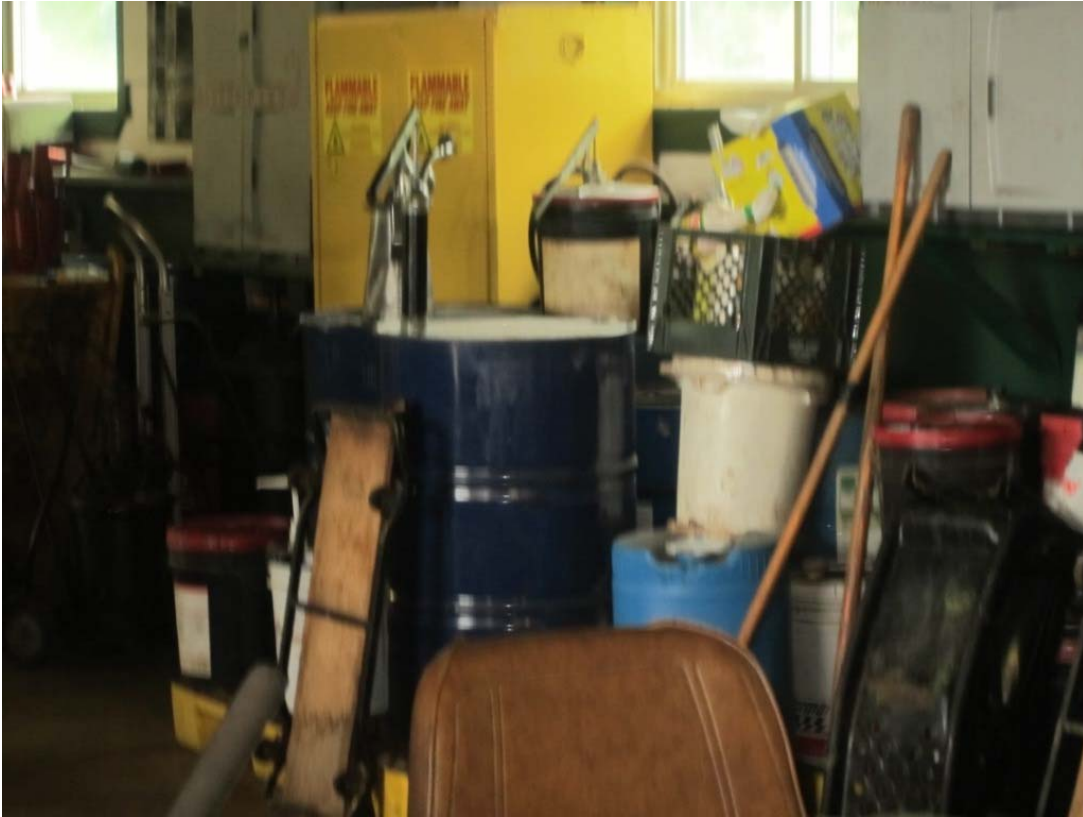
Photograph No. 3: More flammable fuel oil storage in bulk in the main DPW maintenance shop.

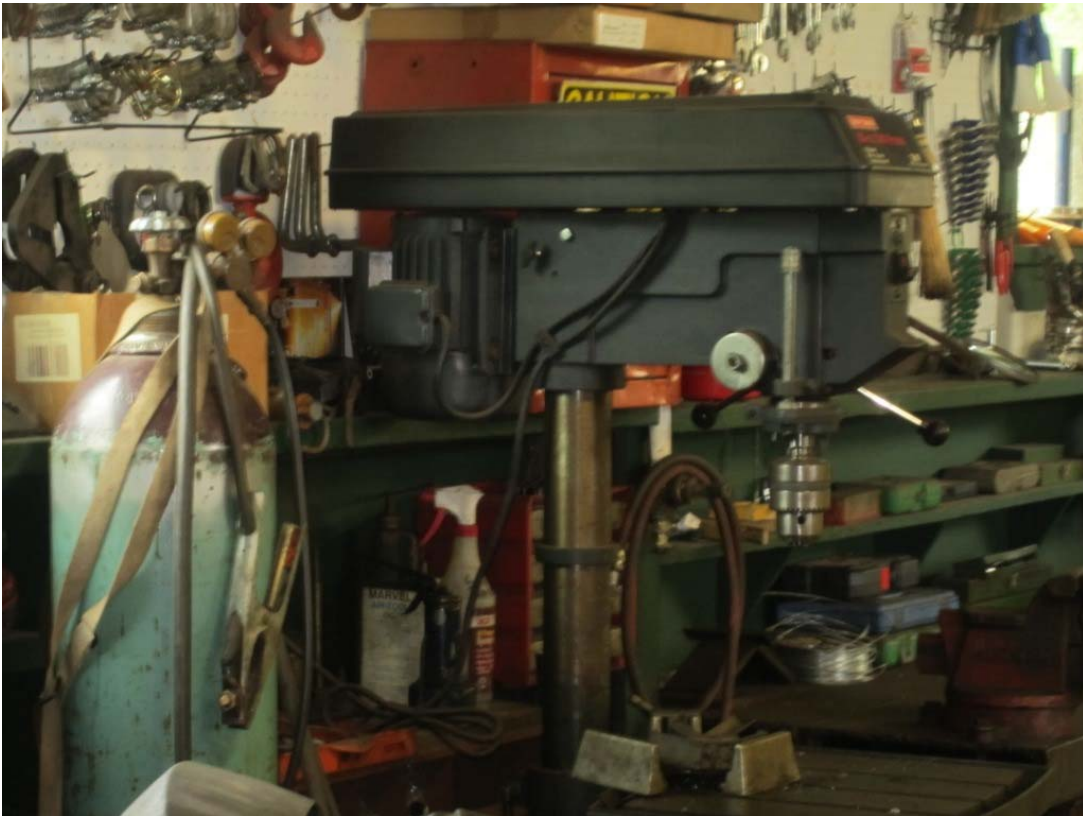
Photograph No. 4: Flammable storage with equipment.

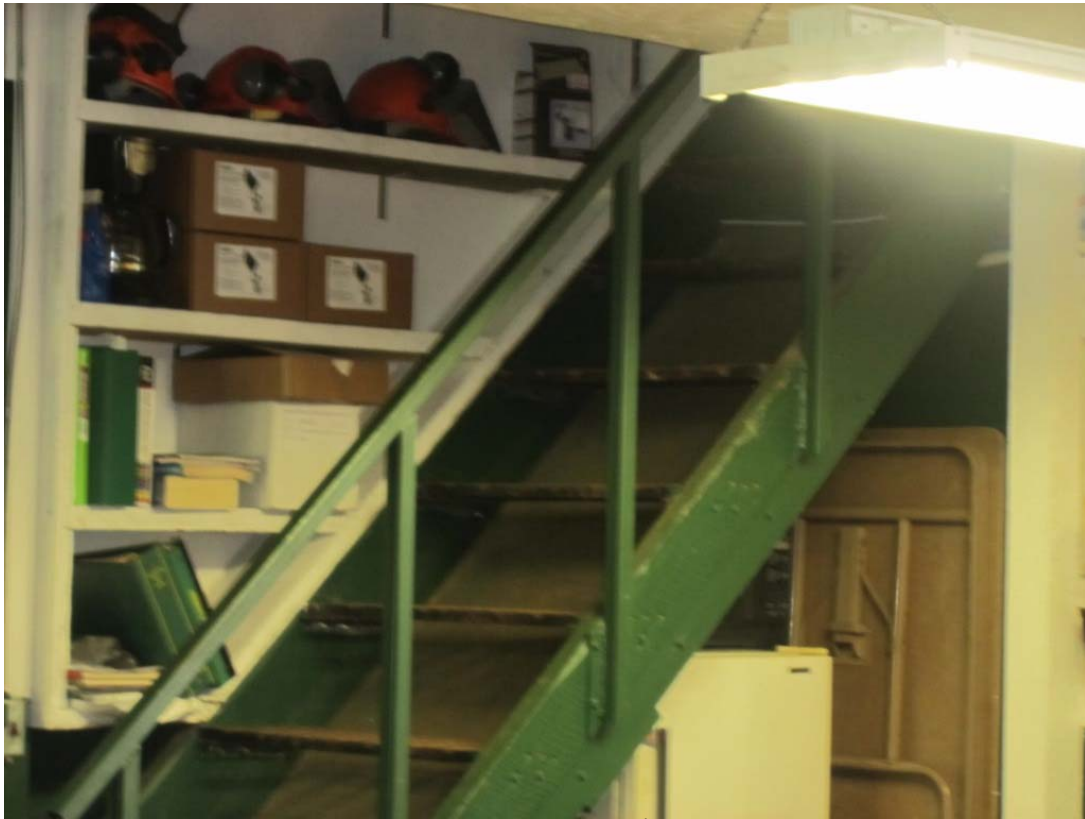
Photograph No. 5: More of the stairway to the 2<sup>nd</sup> level that needs mid-rail.

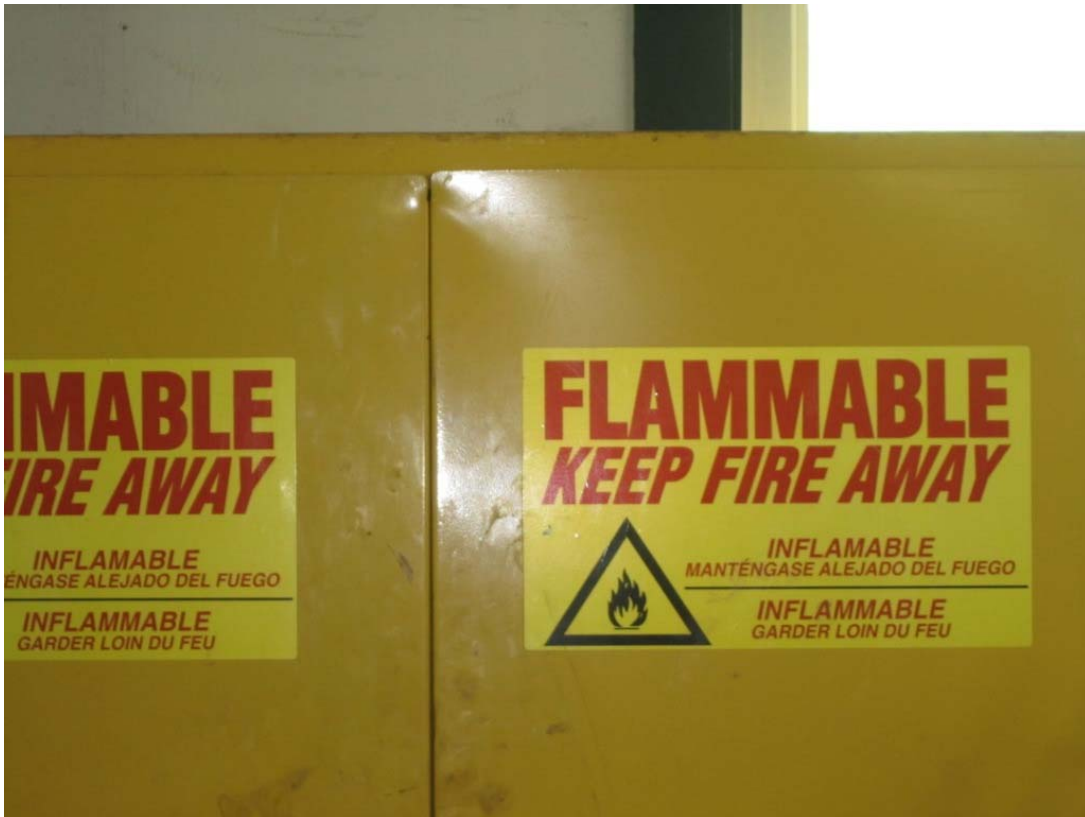
Photograph No. 6: Flammable cabinets, several throughout the shop.

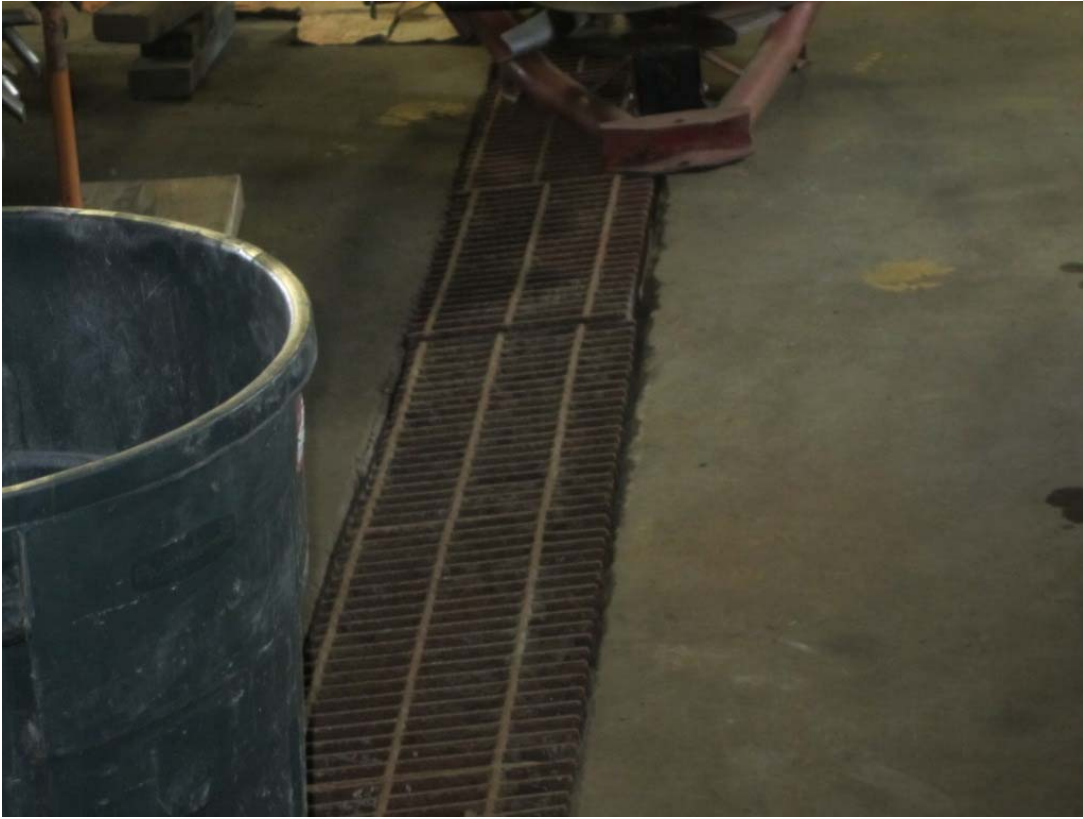
Photograph No. 7: Continuous floor grate for floor drain.

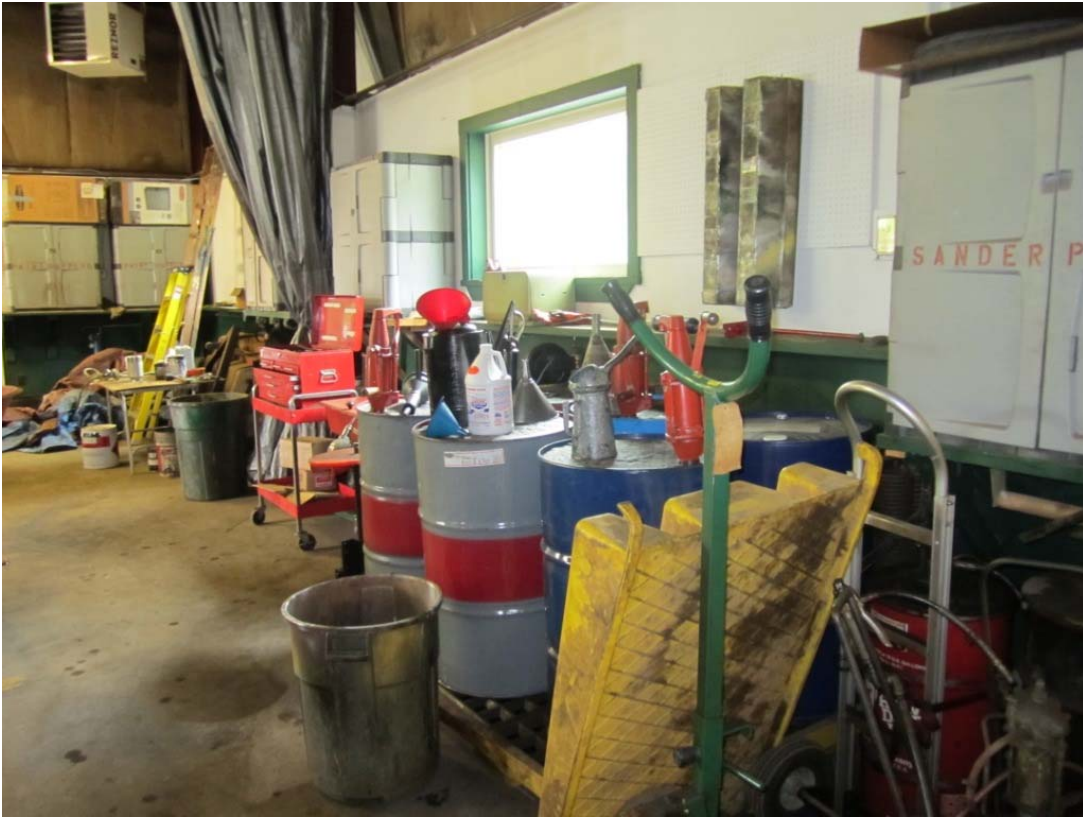
Photograph No. 8: Flammable liquid containers stored in maintenance garage.

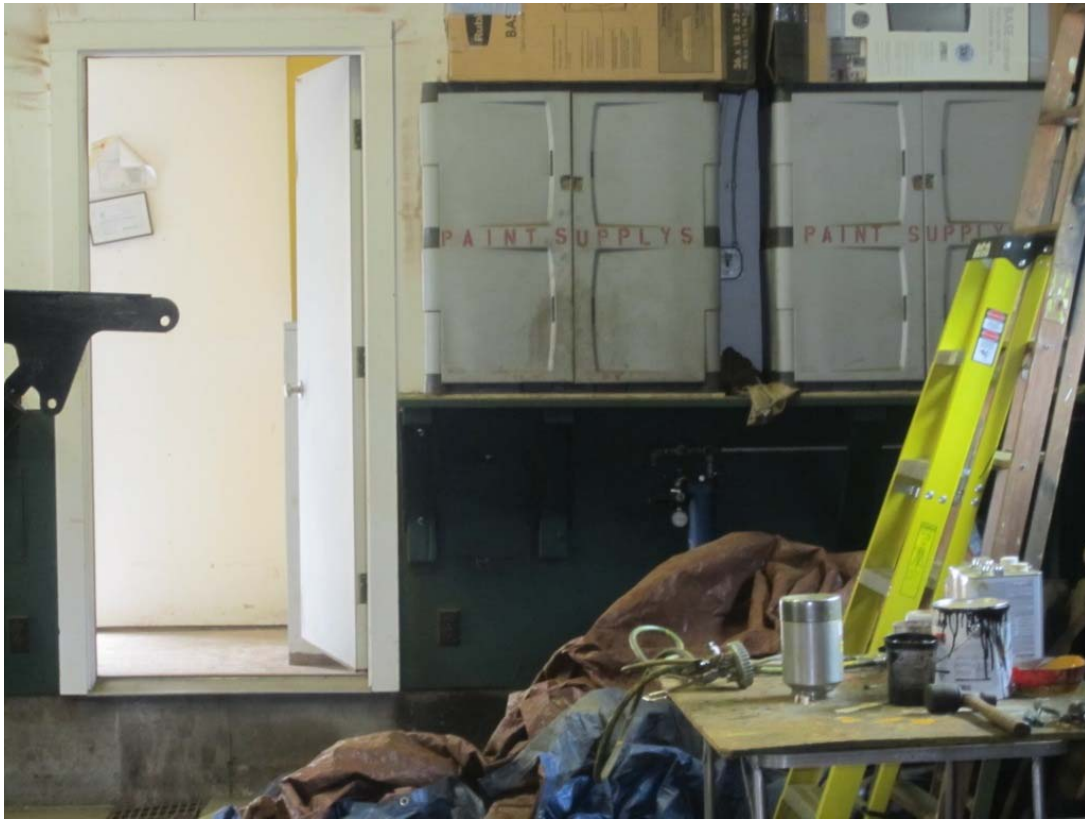
Photograph No. 9: More Flammable cabinets and oversized step up into generator room.

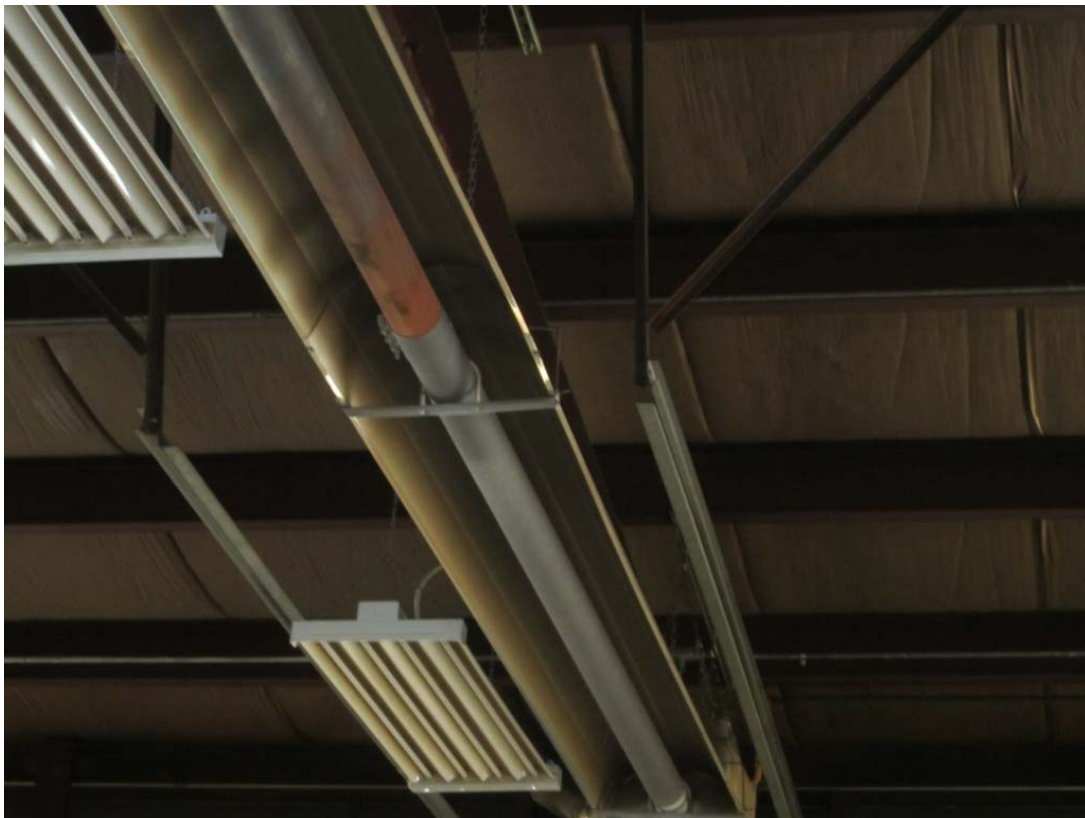
Photograph No. 10: Heat piping for convection style heat system.

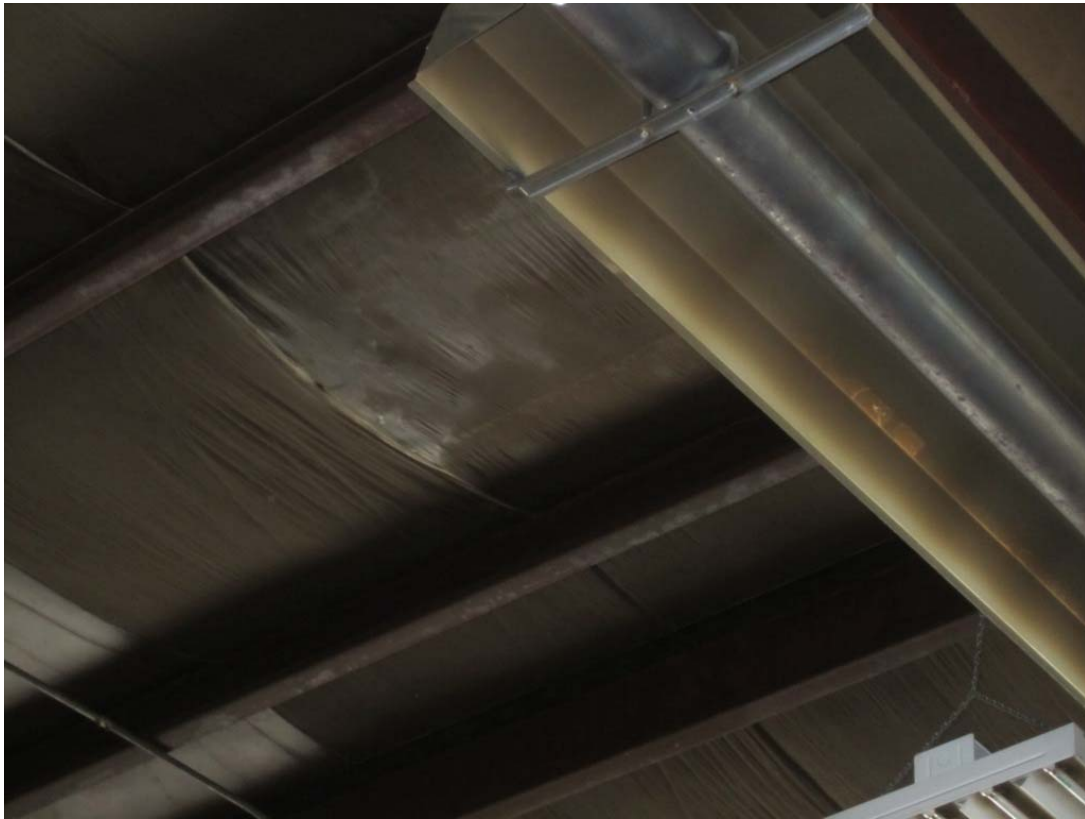
3.1.2. Roof. The roof system consists of a steel roof deck (approximately 3 feet wide ribbed steel decking) attached to steel purlins. The underside is insulated to the R-3 level. This creates significant ice damming and causes leaks. The decking is fastened using screws with rubber washers. The washers have deteriorated and the decking is split near some of them. As a result the roof leaks year round. A new roof system consisted of rigid insulation and membrane will eliminate the ice problem, reduce the structural load on the roof and stop the leaking. The roof support system will have to be evaluated by a structural engineer to determine the roof’s load carrying capability.

Photograph No. 11: Standard metal building insulation soaked by leaking roof.

New membrane roof with flute filler and 2 inch Iso over entire area \$38,000.00-\$42,000.00.

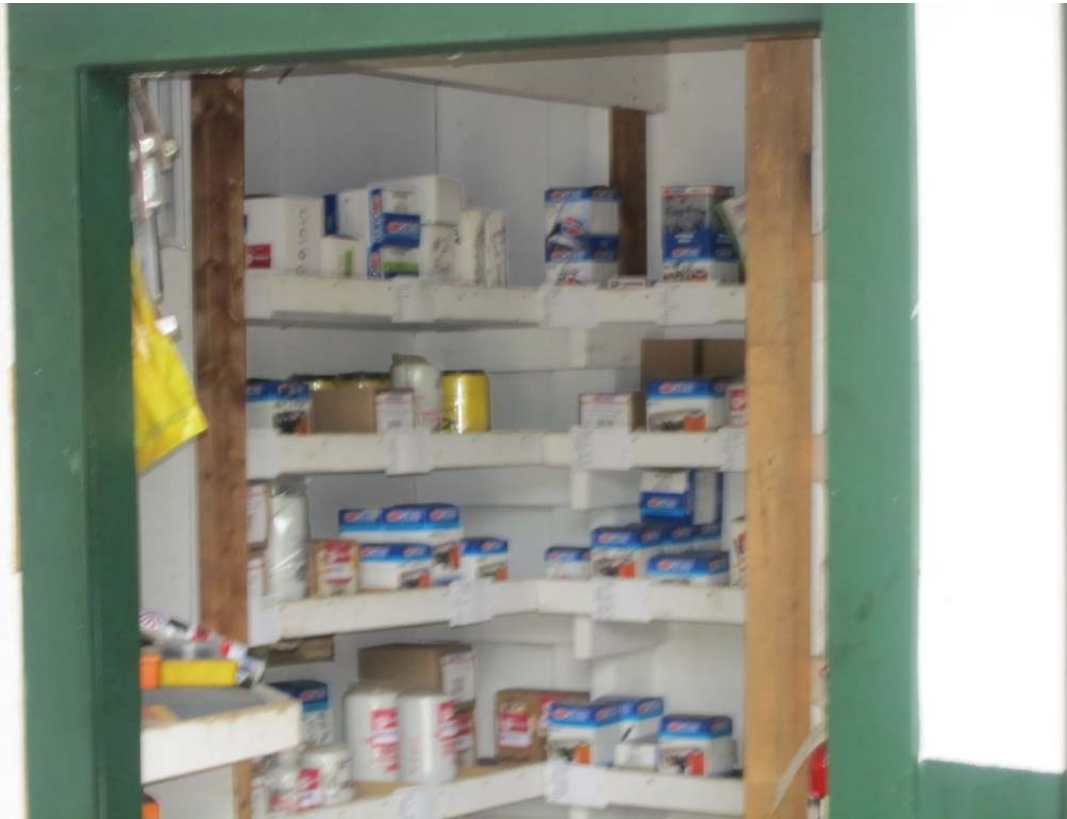
Photograph No. 13: Small open storage room.

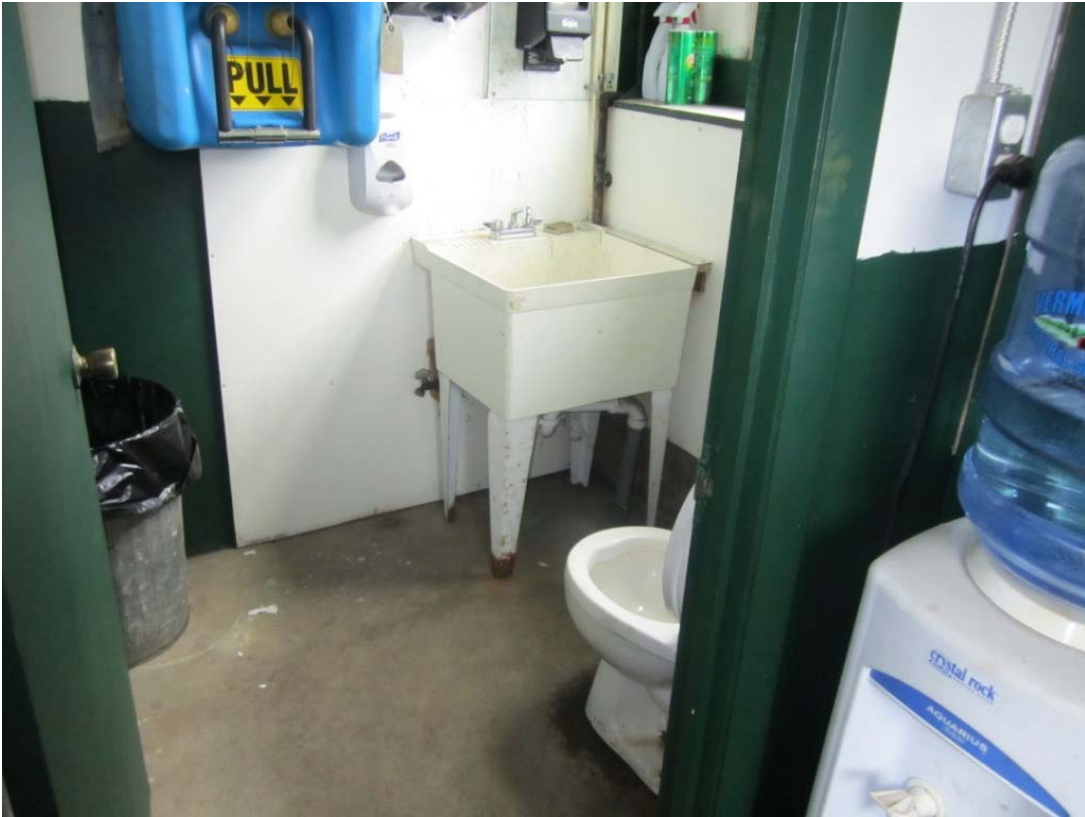
Photograph No. 14: Existing bathroom and eyewash station.

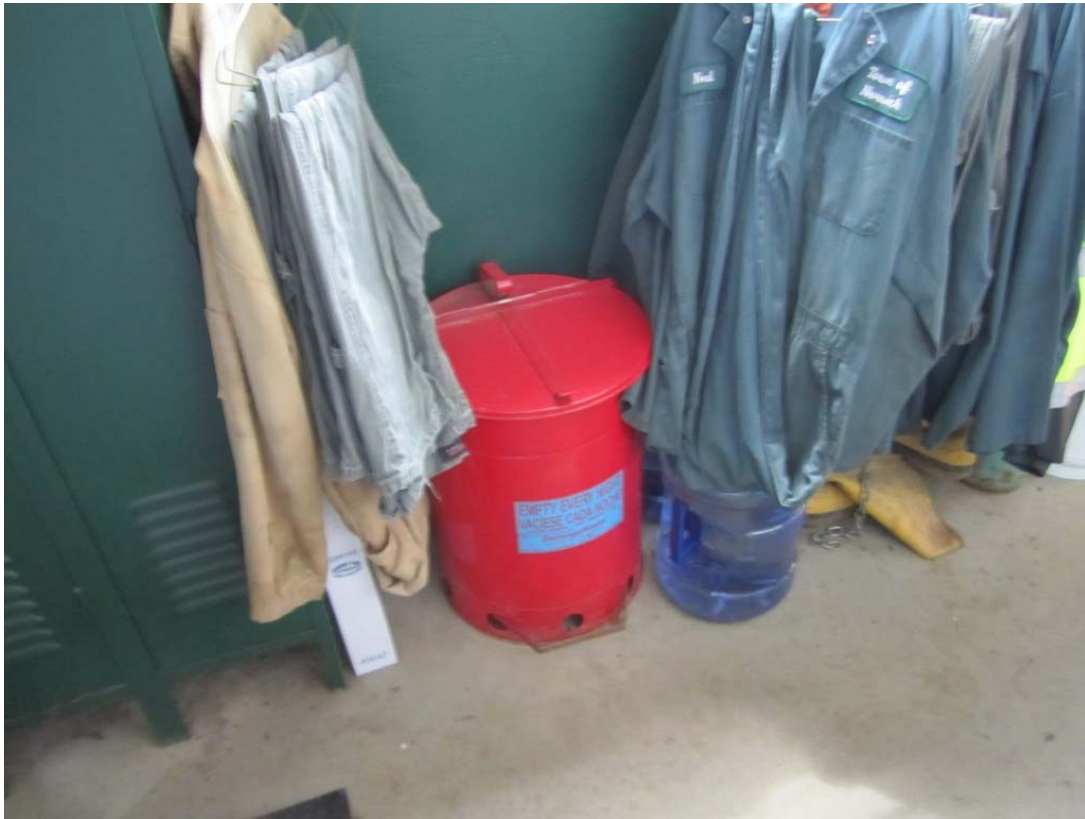
Photograph No. 15: Oily rag container.

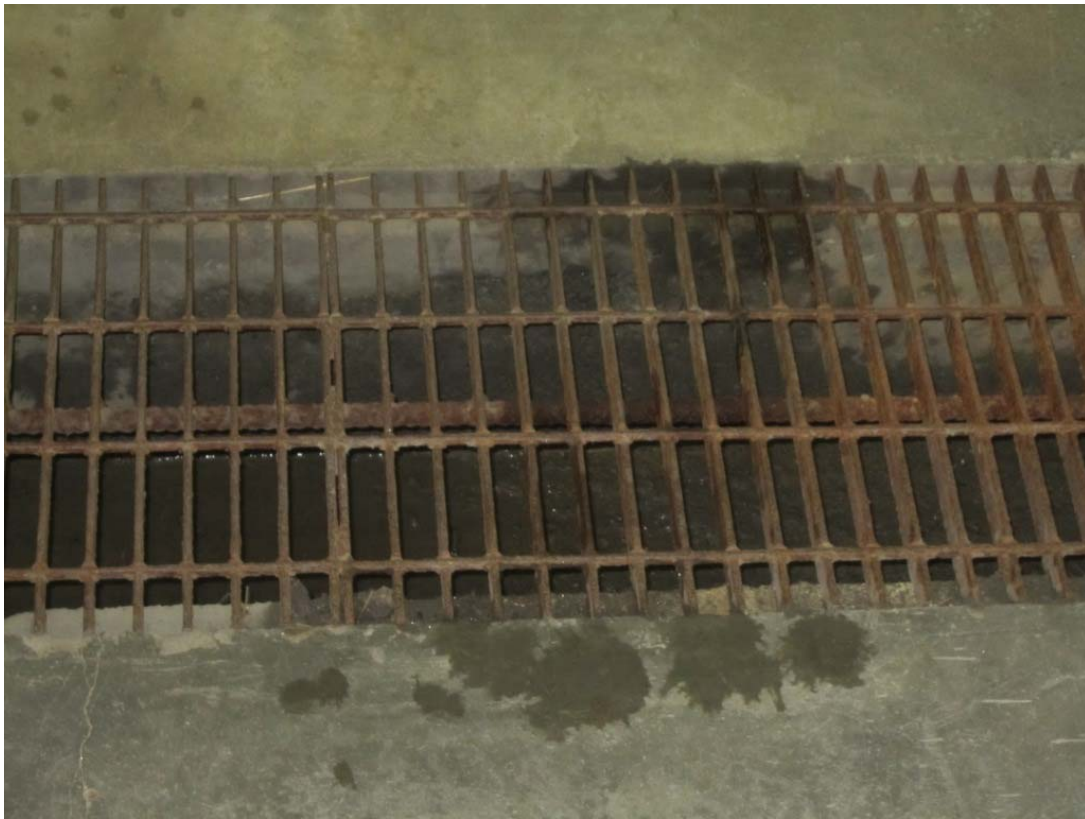
Photograph No. 20: Continuous floor drain grate to nowhere.

1. Eliminate the floor drain. Some facilities report to the UIC Program that despite the existence of the floor drain/injection well system, there is no appreciable discharge. When this is the case, the DEC recommends that floor drains be closed and sealed. All closures should be reported to the UIC Program.
