## **SECTION 1**

### **FIRE STATION – 11 FIREHOUSE LANE**

The following report was prepared for the Town of Norwich Vermont by a team of professionals assembled by Mink Brook Management, LLC with the intent to identify the code and functional deficiencies within the three Town buildings housing the Department of Public Works, the Town Police Department, and the Town Fire Department. We have included in this report budget figures showing estimated costs to bring these buildings up to code and meet the functional standards typical for each department if these buildings were new today. The standards were identified by the team of professionals who have designed and constructed complexes in each of the categories discussed. We understand that each of these buildings is in need of maintenance work at this time and there are line items in the budget showing some of the maintenance repairs identified during our inspections. It is not the intent of this report to try to sway the Town of Norwich to perform the remedial work as described as it may not be in the best interest of the Town to do so. It is the intent of the report to inform the Town of Norwich of the costs associated with the

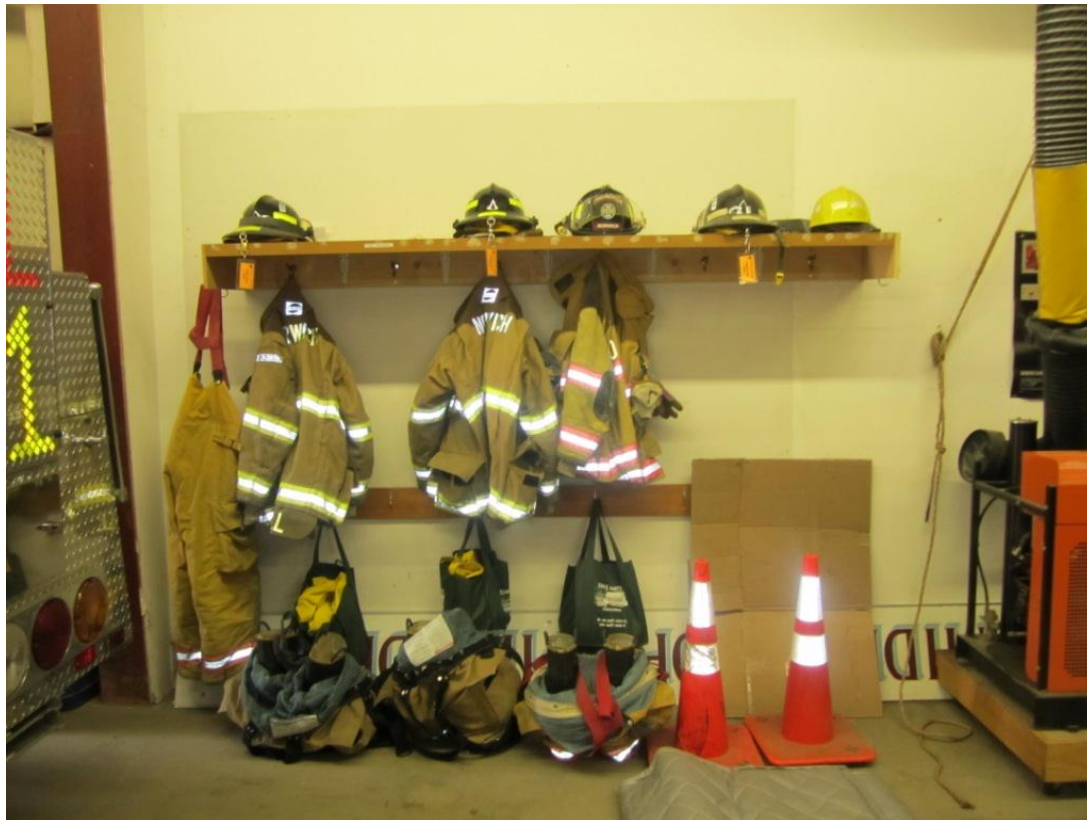
Photograph No. 2: Open storage for Personal Protective Equipment.

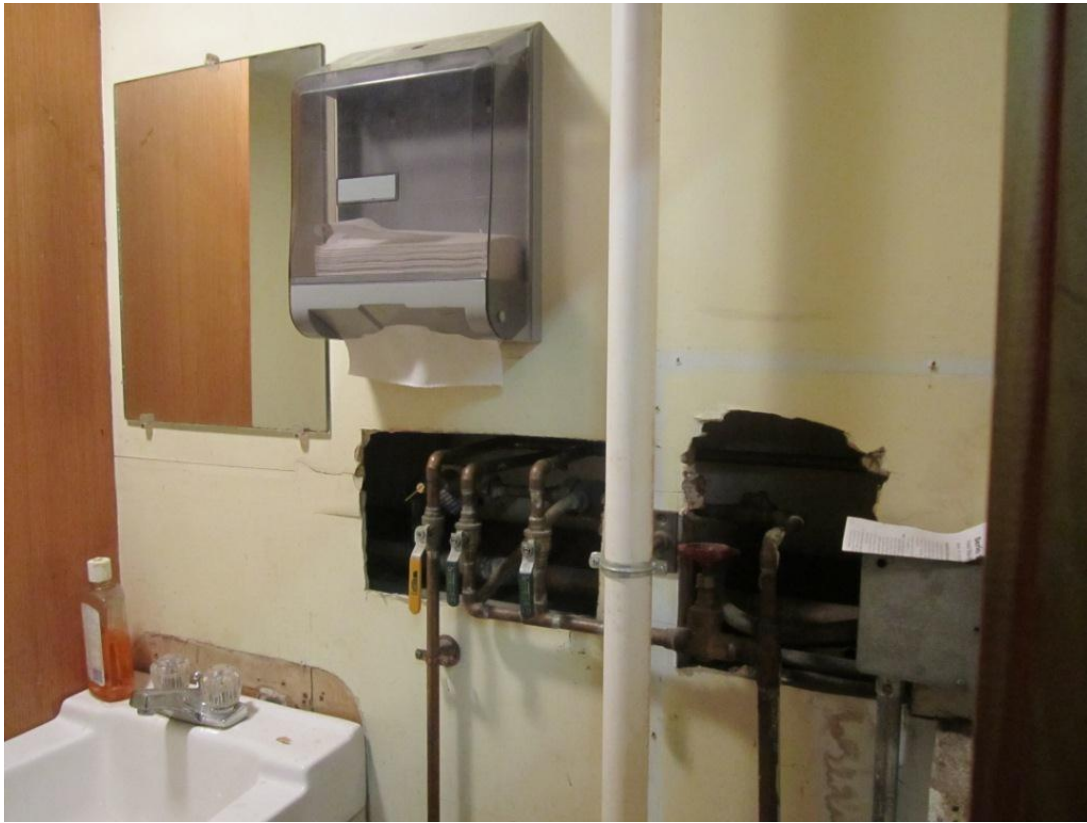
- 4.1.4. Toilet facilities are required for men and women and shall be accessible. There are numerous code violations (IBC, ADA) with the existing toilet room and the room is not large enough to do anything that will comply with the code requirements. It appears to be virtually impossible to correct these deficiencies without providing additional space through renovation (and/or building addition). The existing facility does not have adequate space to accommodate such a renovation without losing other necessary functional space. Looking at the existing facility and adding an addition 15' x 22' to house two bathrooms, one for men and one for women. These two bathrooms would have all handicap accessible dimensioning, handicap grab bars, doors, and hardware. Estimated cost ... \$50,000

Photograph No. 4: Bathroom with holes through the wall into furnace room.

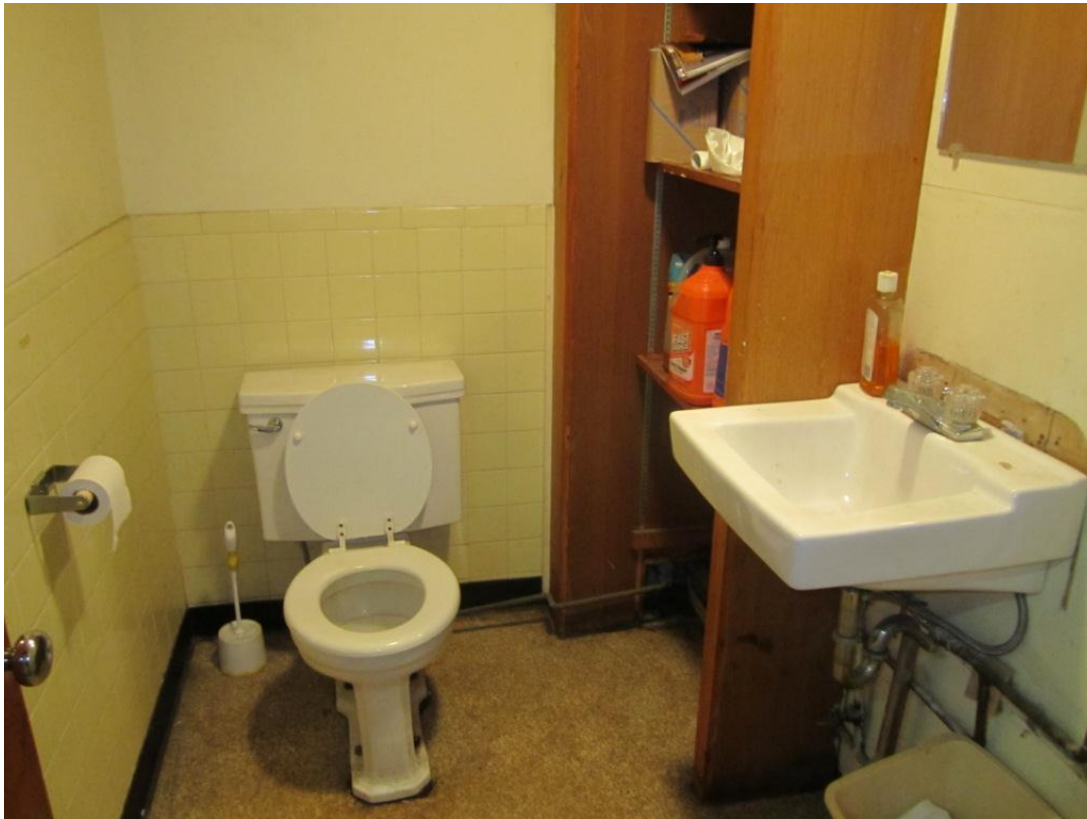
Photograph No. 5: More bathroom.

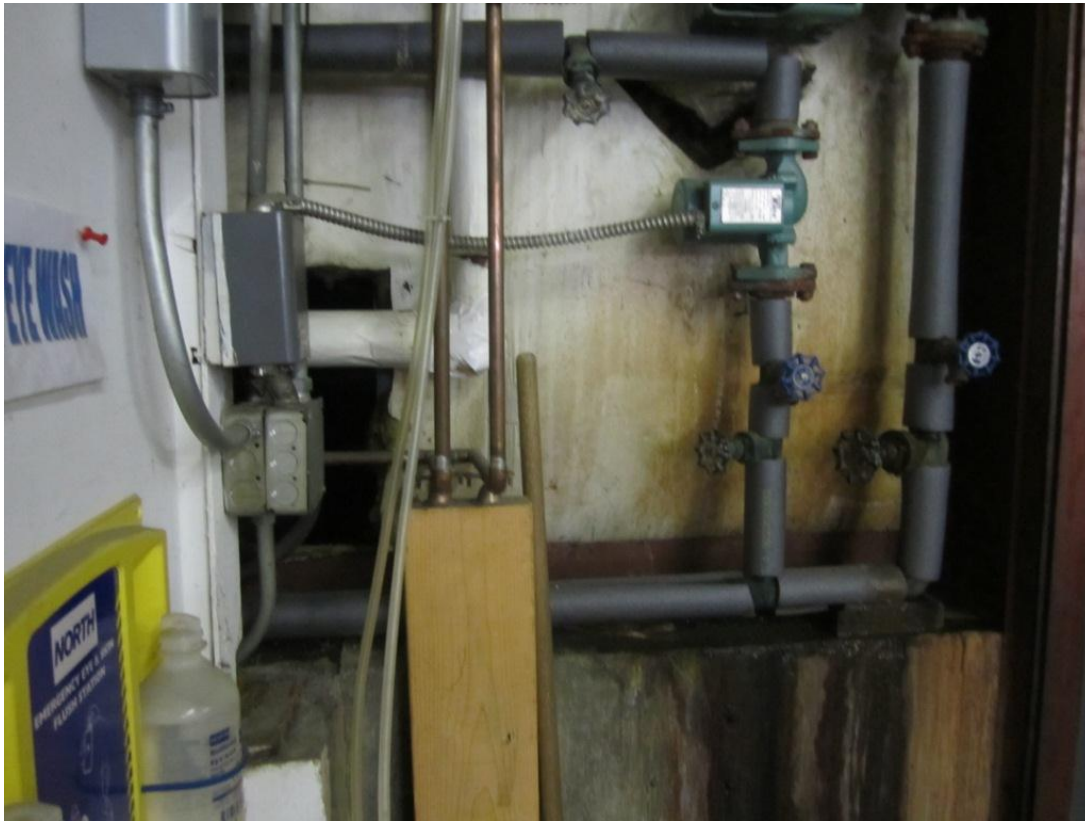
- 3.4.1. Heating System. The furnace room that is attached to the metal building in the back has no provisions for fresh air intake for the furnace and there is no fire separation between the furnace room and the Fire Station. The heating plant is an oil fired boiler that circulates hot water. It is old, problematic, and undersized for the area it's trying to heat.

Photograph No. 6: Holes in the wall through to the furnace room from outside the bathroom and from the main Fire Station building.

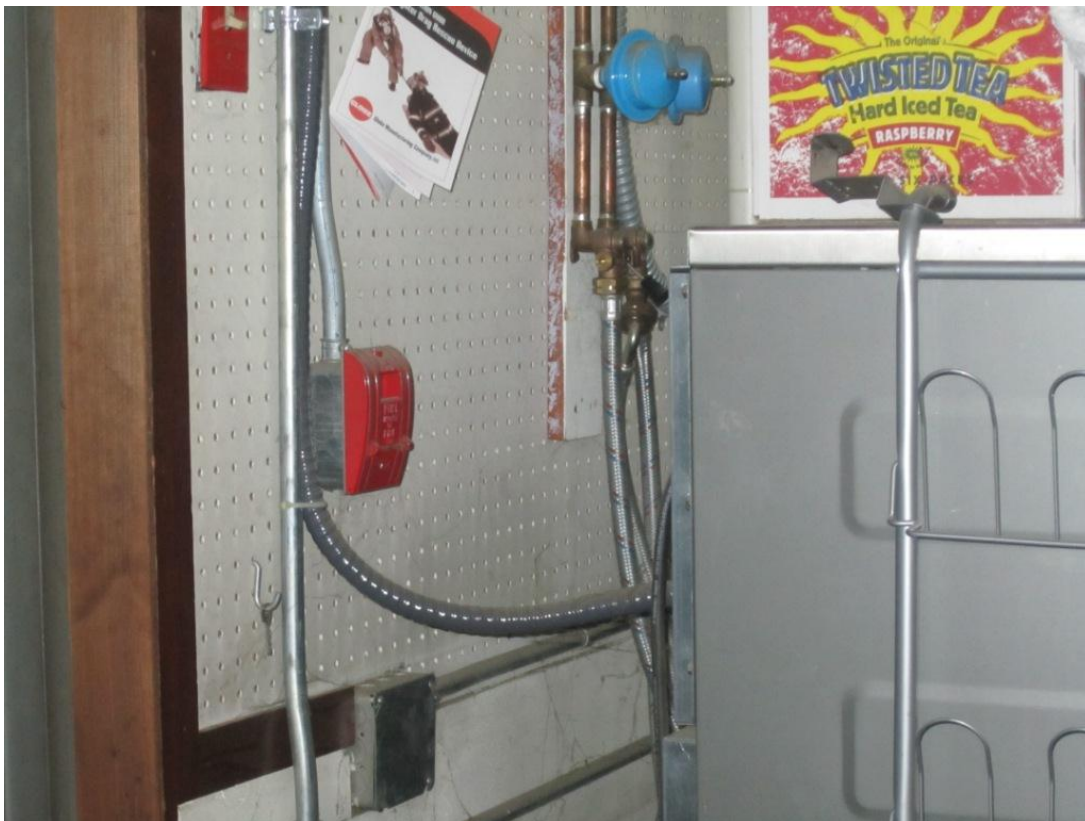
- 2.3.2. Inadequate space/location for laundry. The washer/extractor for cleaning protective clothing is on the apparatus floor. There is no space for a dryer so garments must be dried on “make shift” racks.

Photograph No. 7: Washing machine with partially hidden pull station.

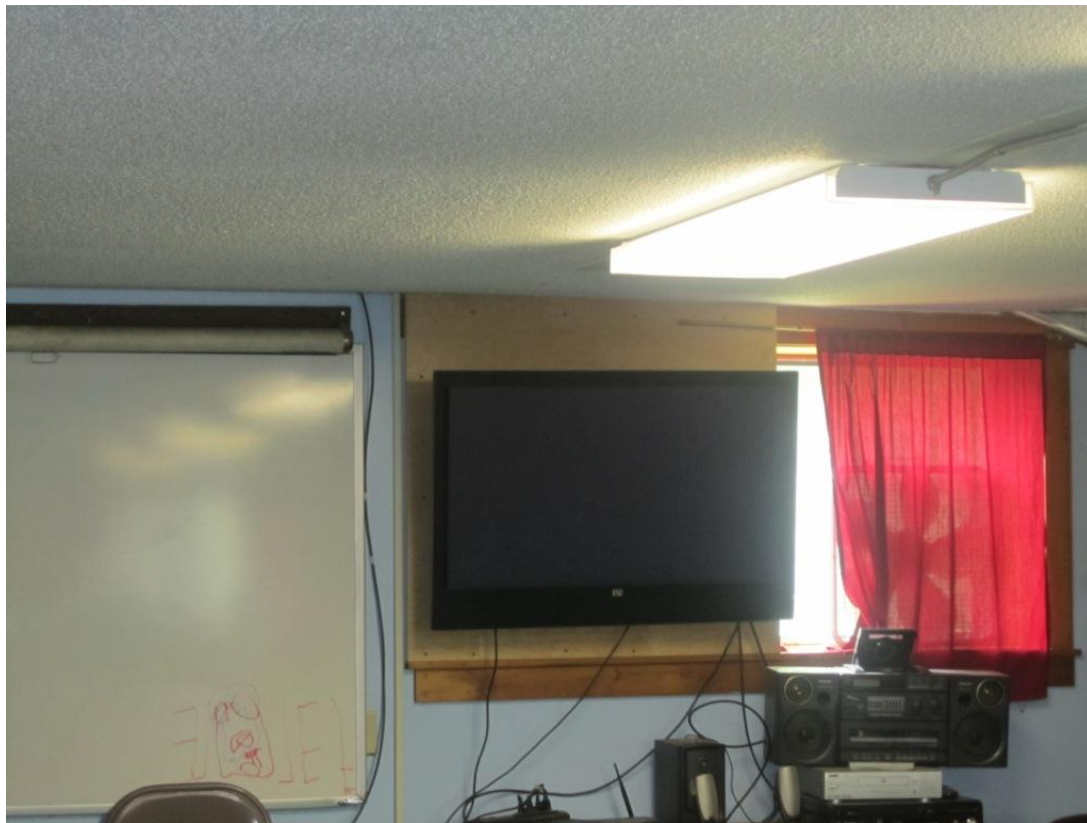
- 3.2.2. The existing Fire Station exterior walls are poorly insulated and remain at an R factor of 3. The standard R factor for a 2' x 6' wooden frame in anyone's home would be R-19. It would be a very good idea to improve the insulation characteristics of the Fire Station by implementing the foam procedure proposed by Dayco, Inc. (See Attached Proposal) Estimated cost ... \$5,000
- 3.2.3. The three overhead doors are not insulated. ) Estimated cost ... \$5,000
- 3.2.4. The windows are single pane glass and need replacing. ) Estimated cost ... \$4,000
- 3.2.5. The fluorescent light fixtures on the apparatus floor are not energy efficient. Efficiency Vermont offers rebates for the purchase of qualifying lights; it does not include installation cost. Estimated cost \$1,200

Photograph No. 8: Training room exterior wall with window.

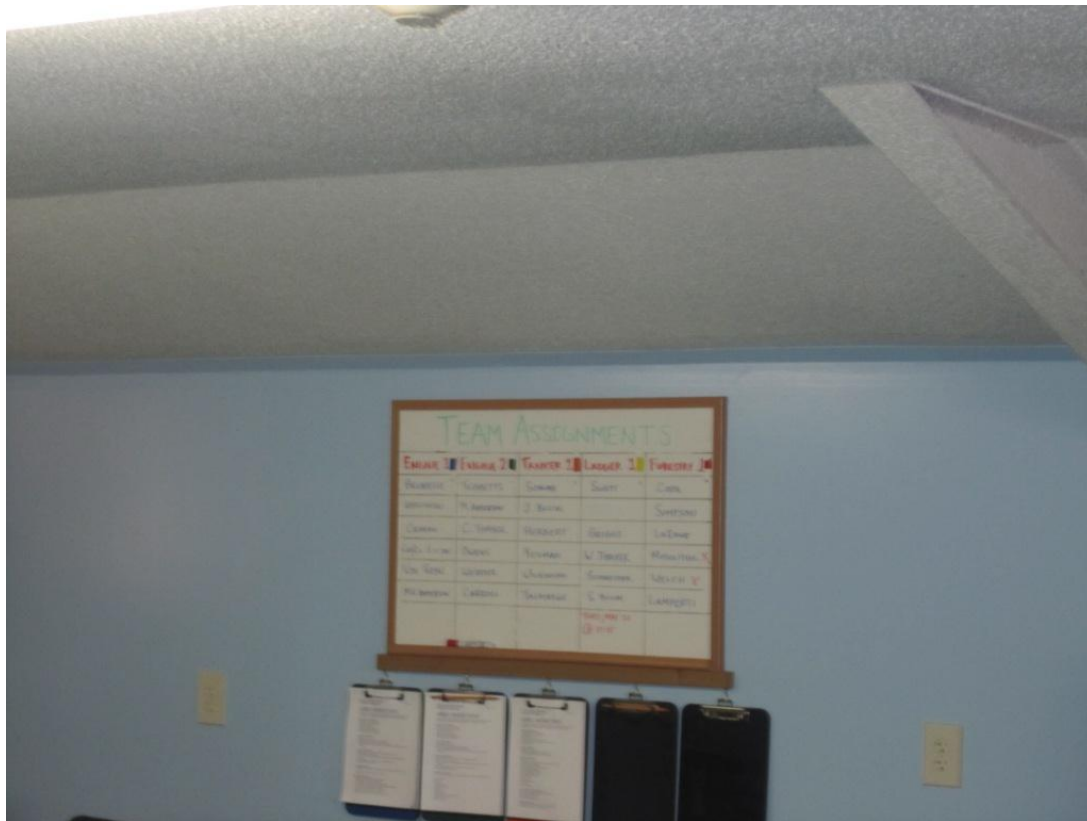
- 4.1.5. Ceiling in the Day Room/Training Room does not meet the required clearance height for such spaces, which is 7'-6" minimum. (2006 IBC – Section 1208.2) Raising the ceiling is impractical due to the extensive modifications and the limited benefit. There is no requirement to change the ceiling height even if the existing building was retained and used as part of a public safety building.

Photograph No. 9: Training room continued.

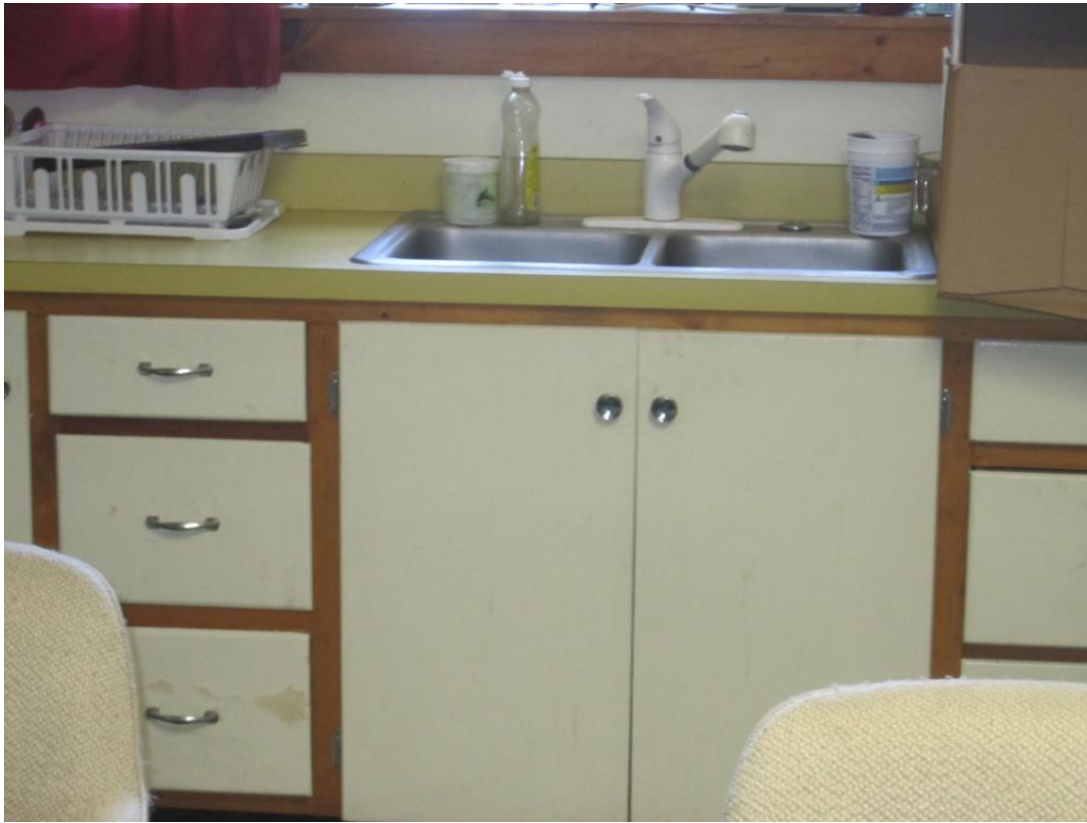
- 4.1.3.1. The existing counter, sink, and base cabinets are at a height of 36" above the finish floor. The lower base cabinets would have to be cut down in order for the heights to work for the ADA requirement. The sink would have to be lowered to fit the condition as well. Renovating the kitchen is impractical due to the extensive modifications and the limited benefit. There is no requirement to modify the kitchen even if the existing building was retained and used as part of a public safety building. If this building is retained for use with an addition this space would not be used as kitchen. Estimated cost ... \$4,000

Photograph No. 10: Kitchen.

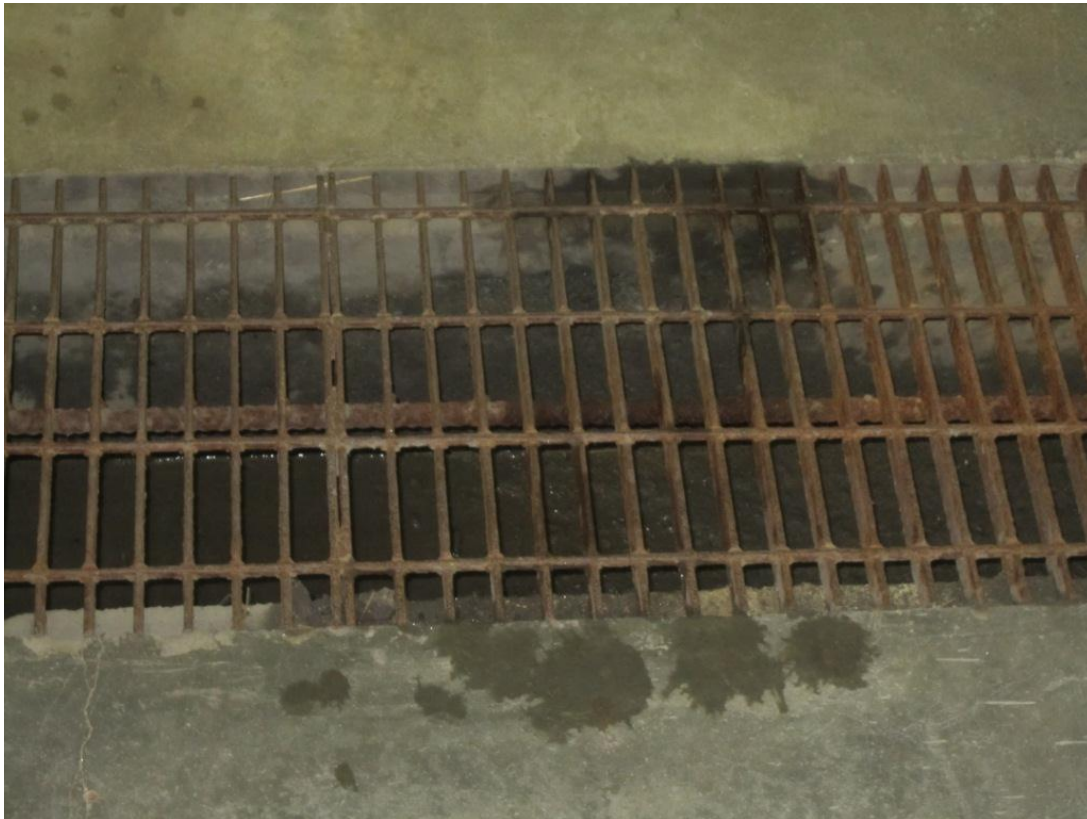
The apparatus floor drains do not drain to an approved oil separator. There is an existing grate and drain in the floor of the apparatus bay that does not meet underground injection control regulations. The Vermont Department of Environmental Conservation would govern what would need to be done to this existing drainage system so it was approved. This may require the installation of oil and grease interceptor and then a storage tank that could be pumped when needed. Floor drains require UIC (underground injection control) registration at a minimum. UIC registration does not guarantee acceptance by the VDEC (Vermont Department of Environmental Conservation). Oil and grease interceptor may be a necessity to obtaining approval from the VDEC. Please review the options under Appendix B in the upcoming pages. We would recommend using the option of a holding tank that could be pumped periodically. Based on discussion with Fire Station Personnel our belief is that holding tank may have to be pumped two times a year. This appears to be the most economical way to meet the code. Estimated cost ... \$4,500

Photograph No. 11: Open floor grate that runs full length of the building.

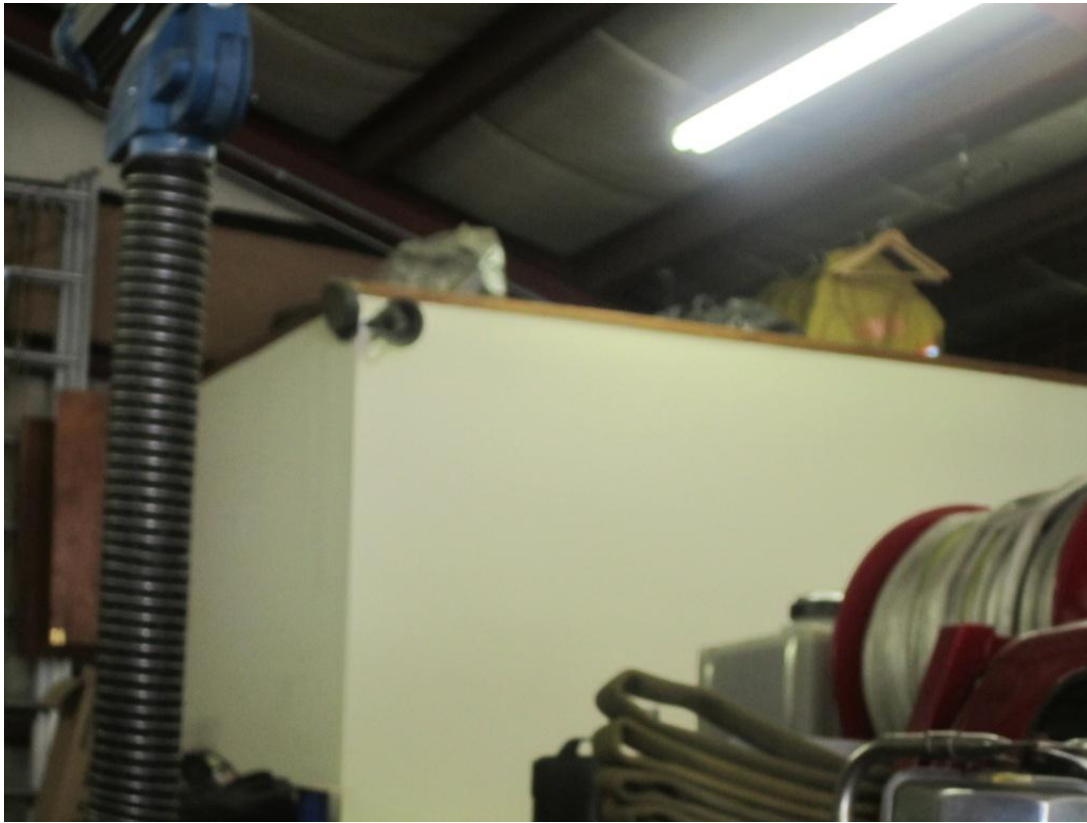
- 3.4.2. Exhaust Extraction System. A source capture vehicle exhaust system was installed in 2009. This had dramatically improved the indoor air quality and prevents the build up of exhaust residue on equipment and the building. This system meets the requirements of NFPA 1500 Fire Department Occupational Safety and Health Program.

Photograph No. 12: Exhaust extraction hose system and open storage beyond.

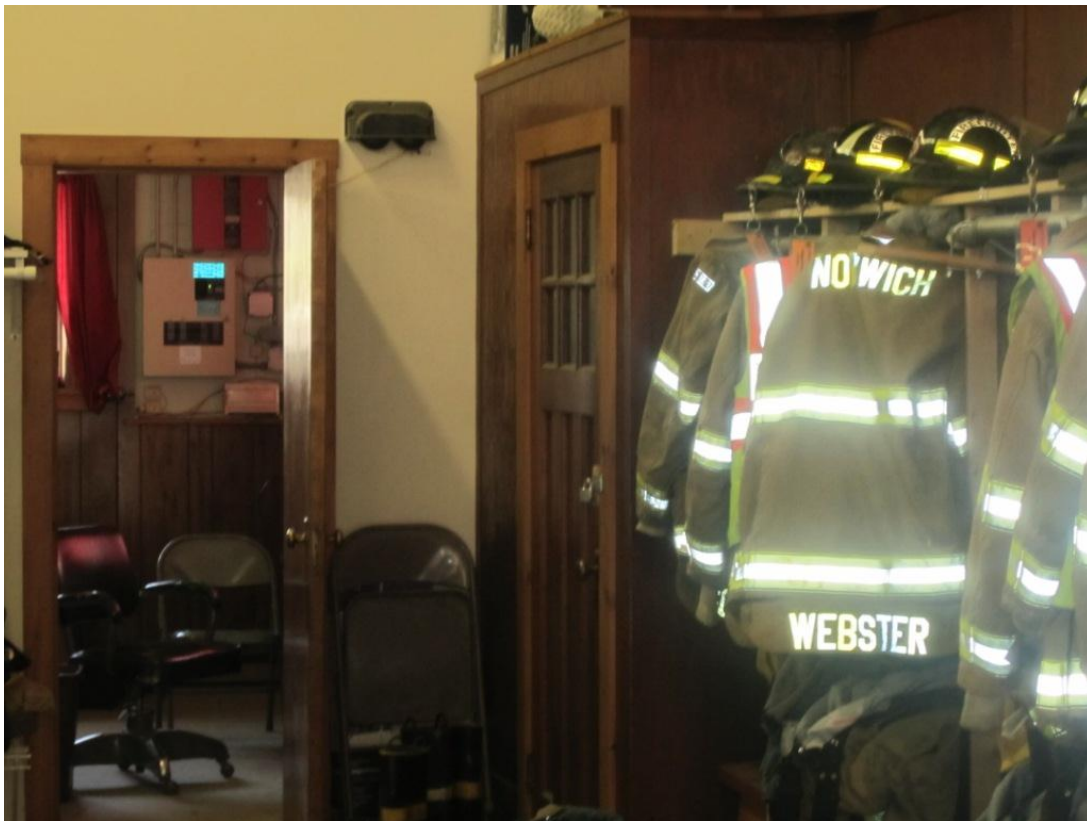
- 2.4. Office
  - 2.4.1. The fire station office is about 120 gross square feet and contains several file cabinets, a copier, and desk. The electric panel is in the office and the National Electric Code requires 3 feet of clear space in front of the panel. There is a lack of adequate space for records storage and use of the space by more than two people is impractical.

Photograph No. 13: Open storage and electrical, telephone office.

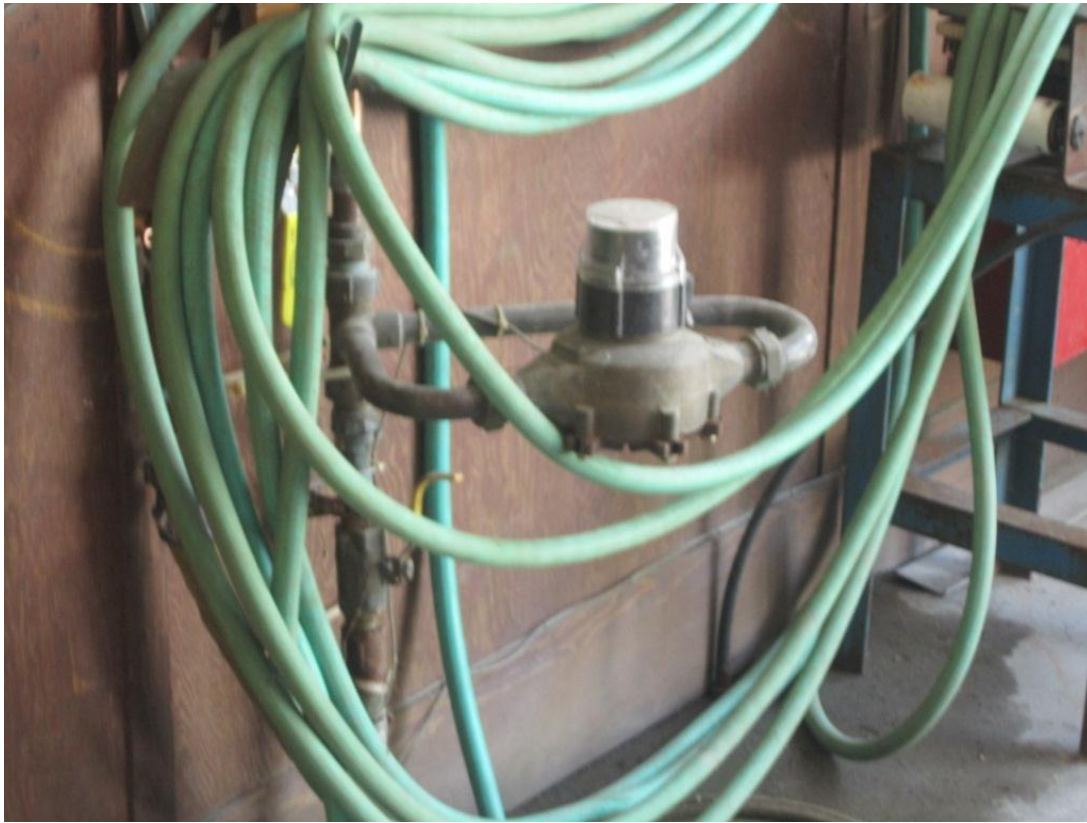
Photograph No. 14: Town water meter without backflow prevention.

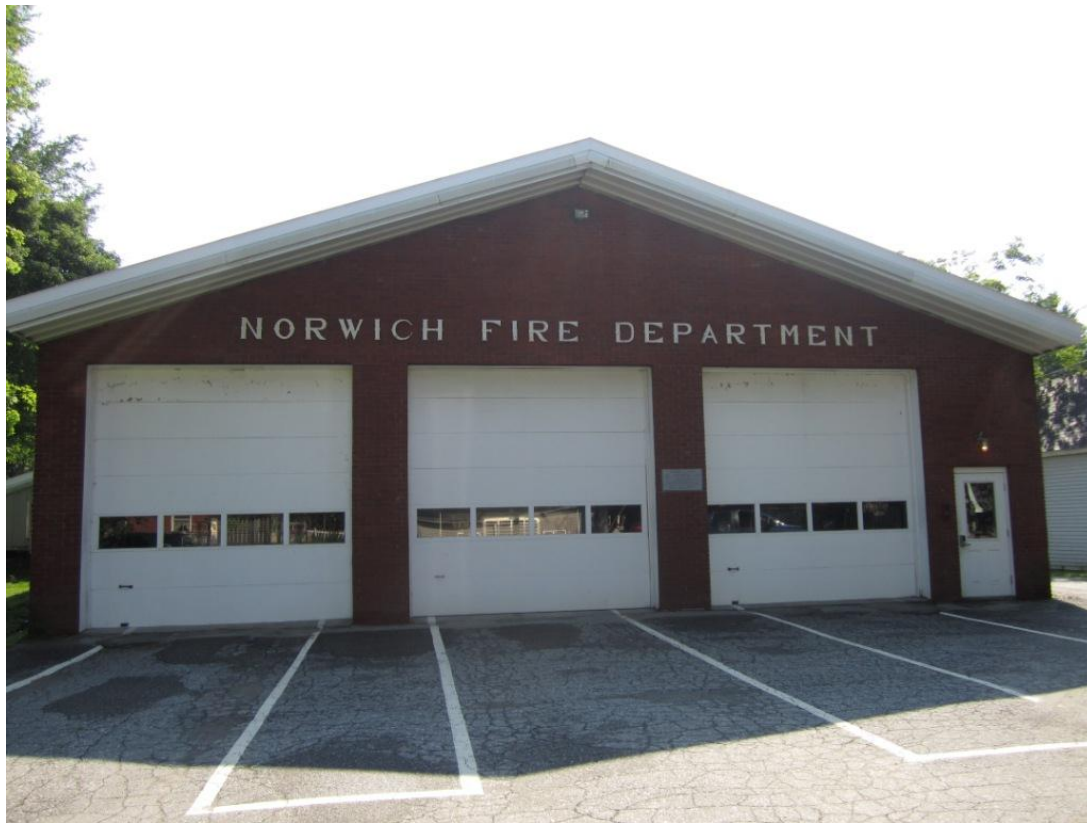
- 4.1.2. The existing doors do not meet ADA standards for new construction. There are at least five doors that would need to be replaced in order to meet the criteria set forth in the code. The replacement of these doors would entail removing the existing doors, frames, and hardware, adjusting the location of the door opening to fit within the confines of the room entered and allow the 18" clear to obstruction on the handle side of the door, patch and repair the finishes and install a new pre hung door unit, including hardware in its place. Replacing these doors is impractical due to the extensive modifications and the limited benefit. There is no requirement to change these doors even if the existing building was retained and used as part of a public safety building. Estimated cost ... \$20,000

Photograph No. 16: Front of the building showing OH Doors for equipment and front entrance door.
