POLICE STATION – 10 HAZEN STREET

INTRODUCTION

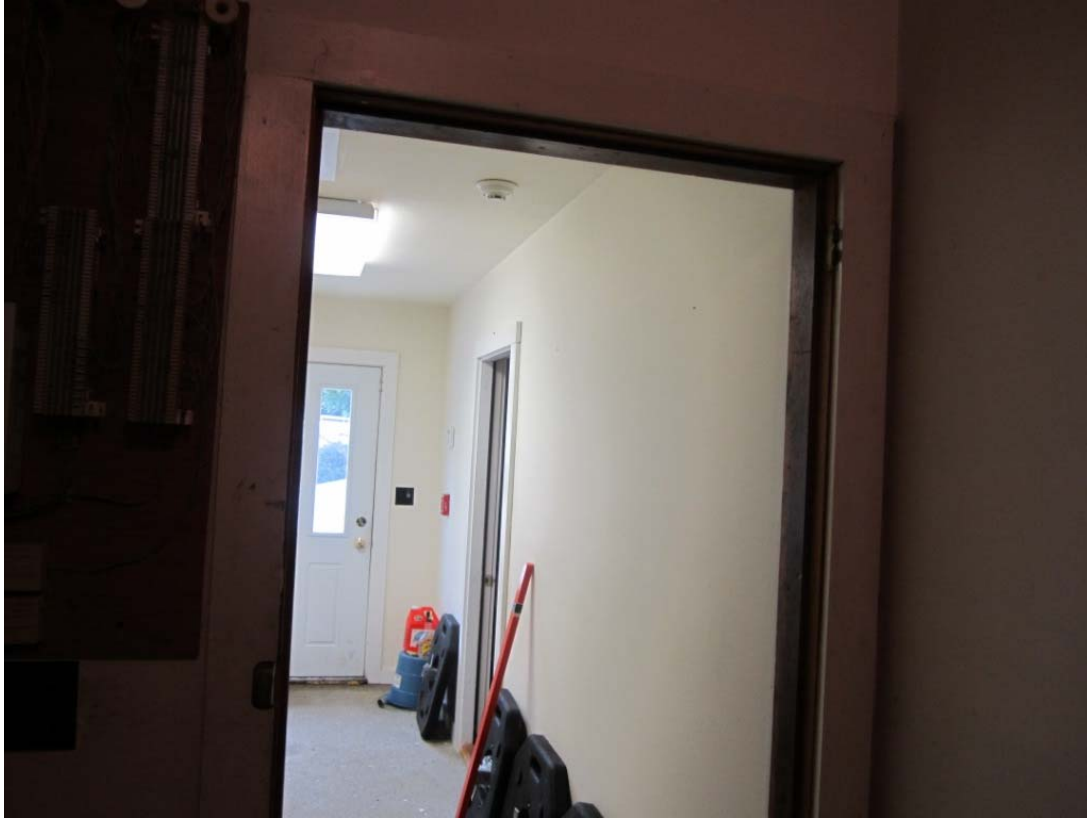
Photograph No. 1: Exit hallway to garage entrance.

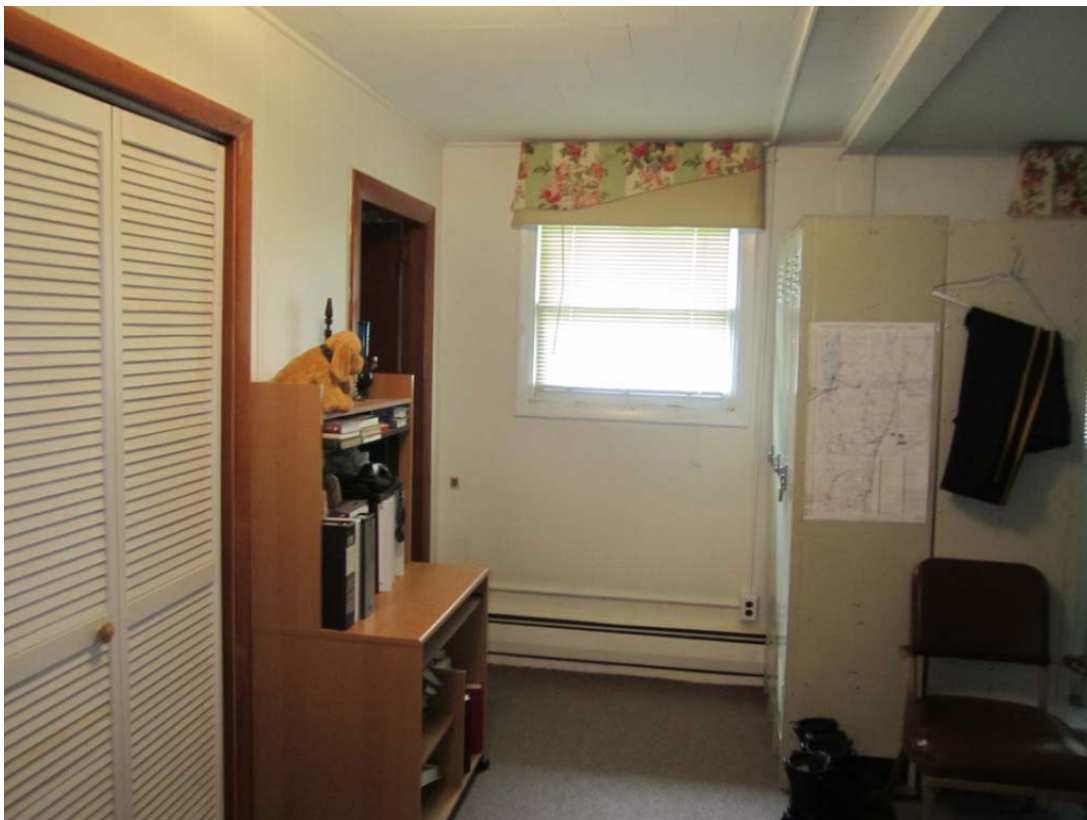
Photograph No. 2: Partial locker room.

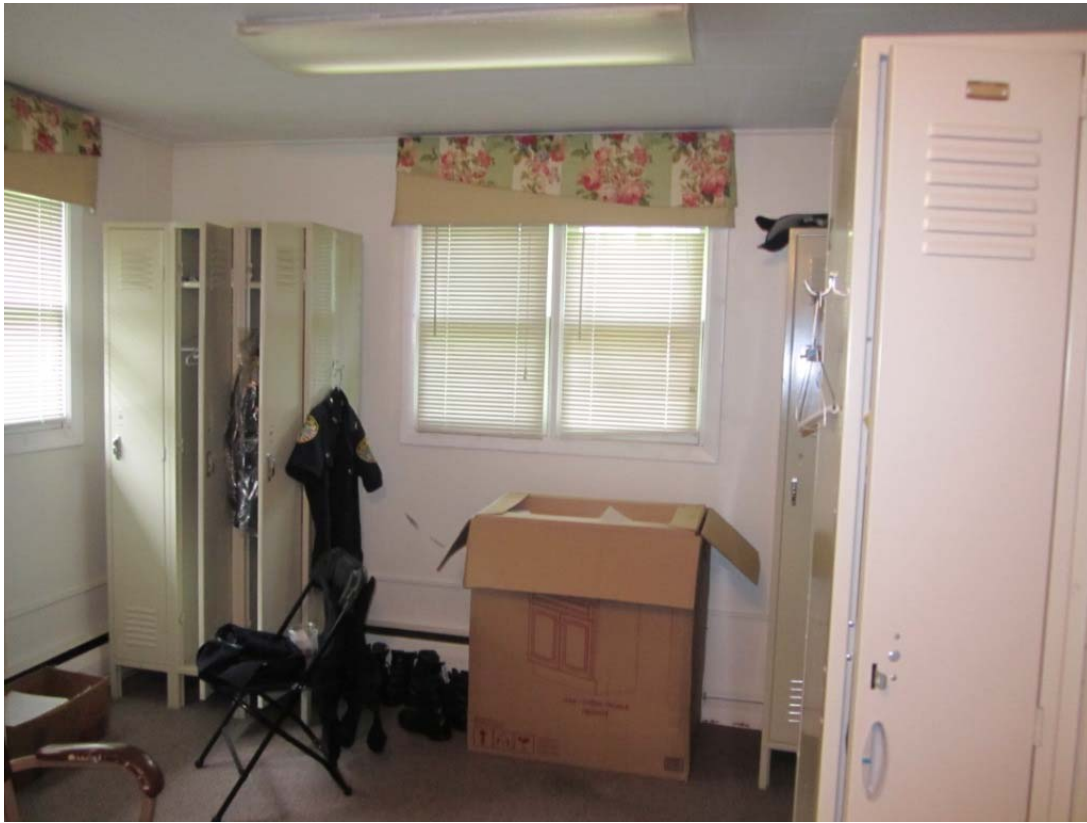
Photograph No. 3: Partial locker room.

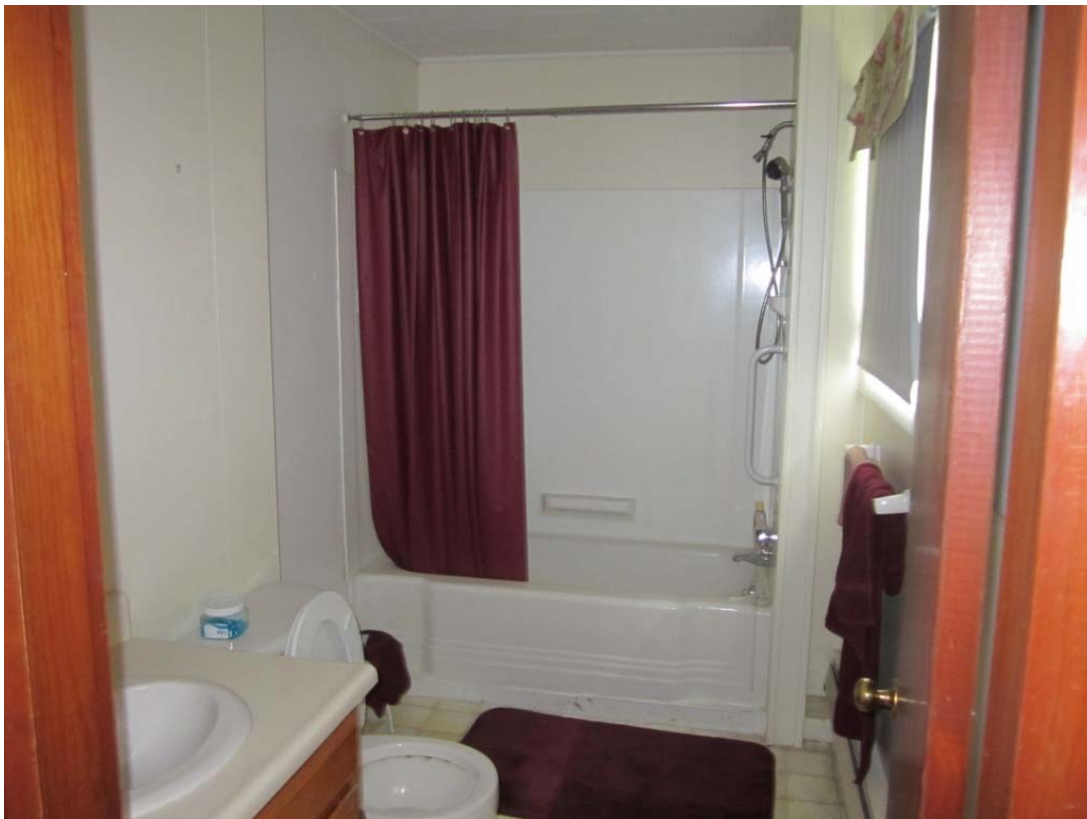
Photograph No. 4: Bathroom and shower off locker room.

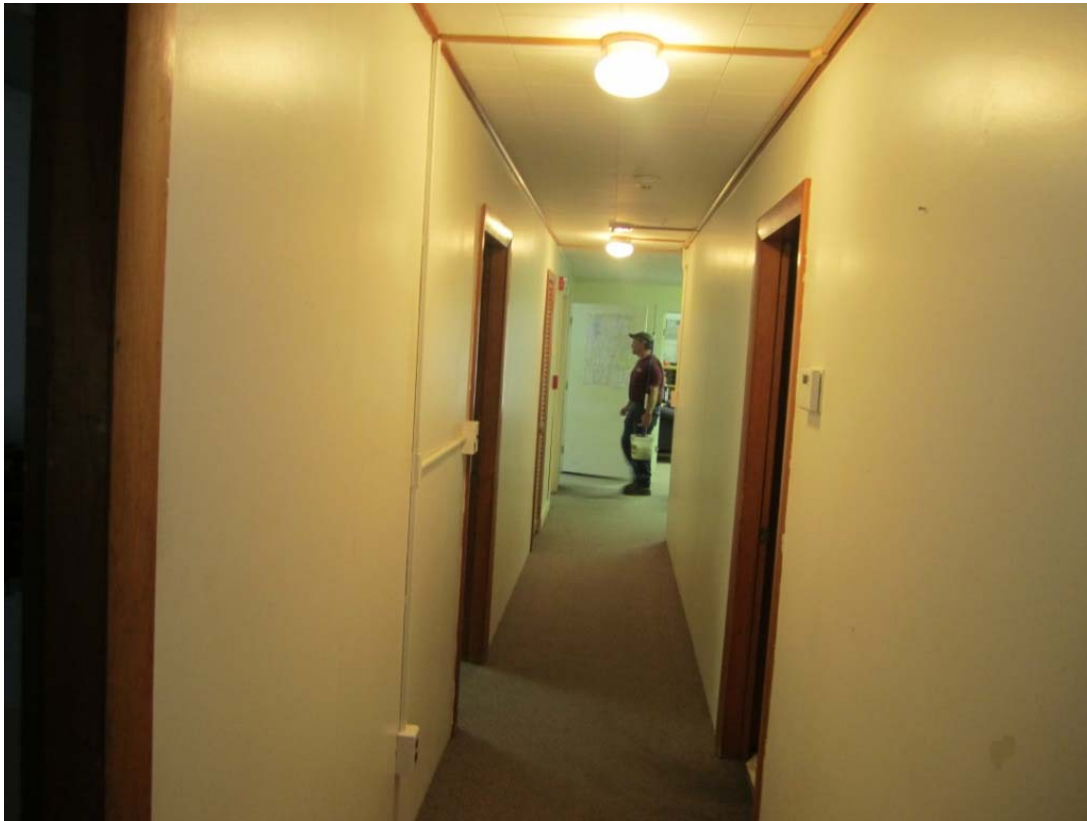
Photograph No. 5: Narrow corridor from Fire Chief office looking toward conference room and front entrance.

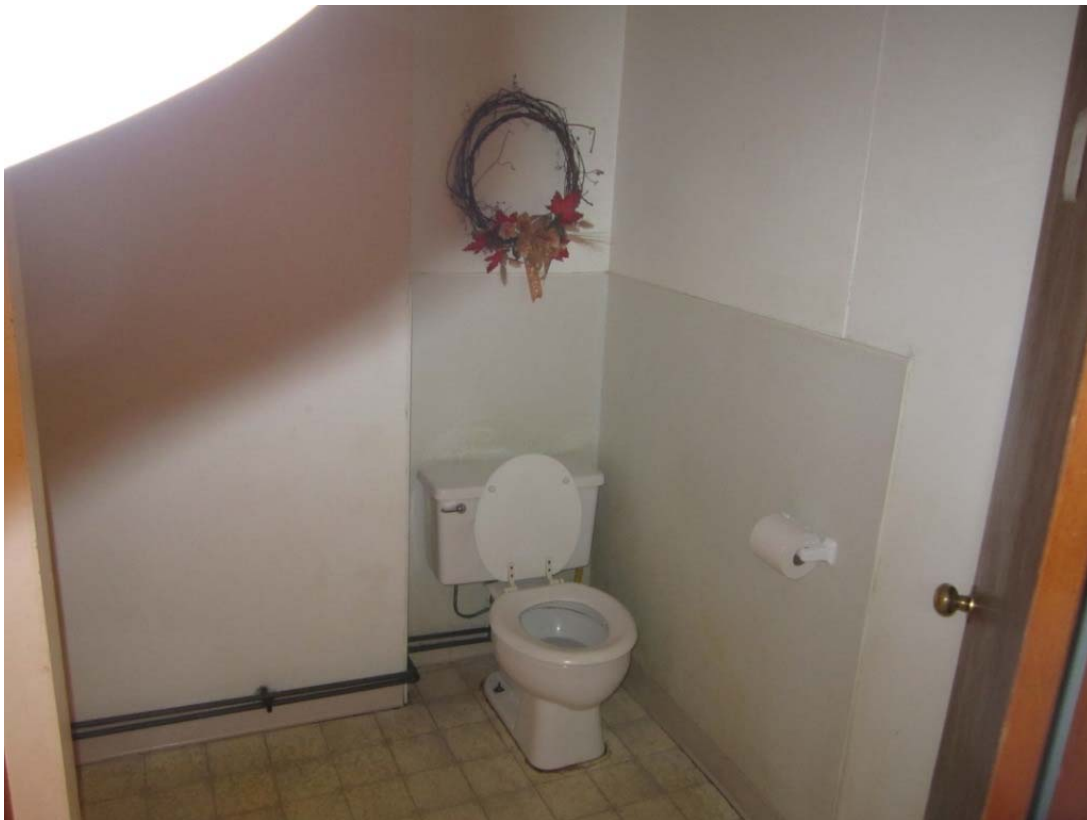
- 3.11. Toilet facilities are required for men and women and shall be accessible. There are numerous code violations (IBC, ADA) with the toilet rooms. It appears to be virtually impossible to correct these deficiencies without providing additional space through renovation (and/or building addition). The existing facility does not seem to have adequate space to accommodate such a renovation without losing other necessary functional space.

Photograph No. 6: Toilet room off corridor.

- 3.11.1. Men's and Ladies rooms will be constructed as an addition to the building in order to meet the ADA and IBC requirements. Bathroom facilities were figured to be 15'-0" x 22'-0" with ADA lavatories and toilets, toilet partitions, and handicapped grab bars. Estimated Cost ... \$50,000

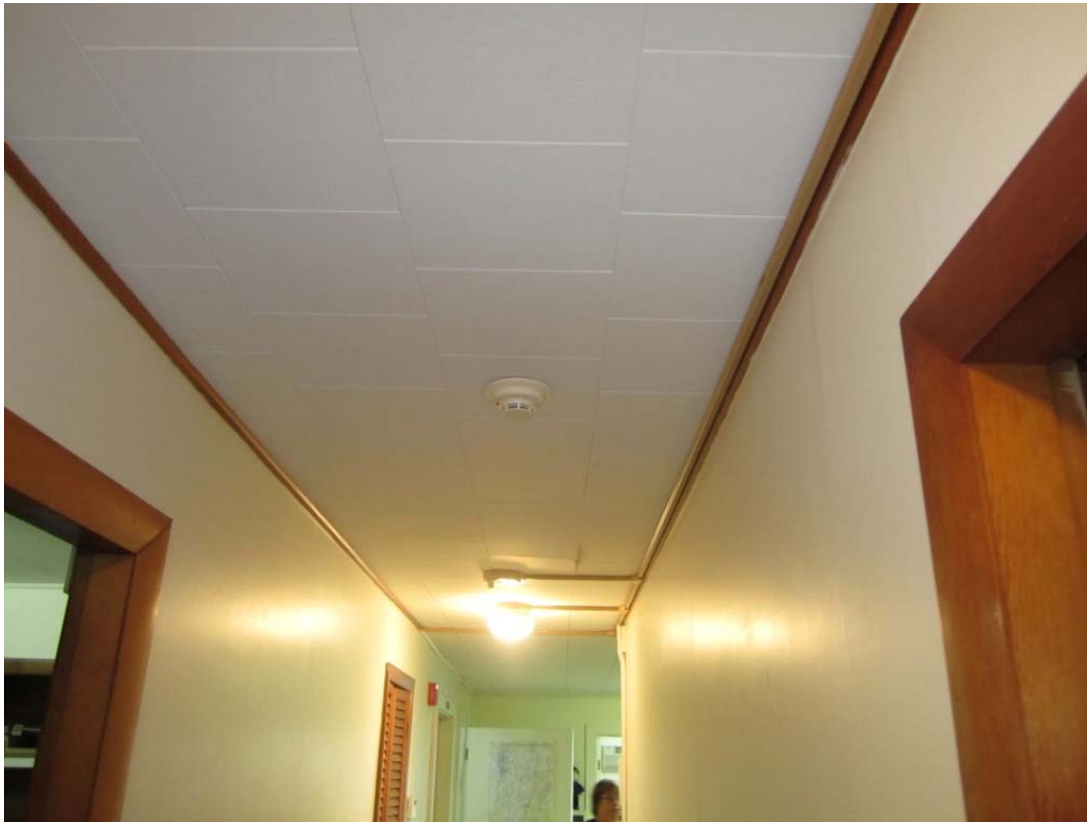
- 3.7. Interior ceiling finish tiles are required to have a flame spread rating not greater than 200 and a smoke developed rating not greater than 450. (IBC 2006, section 803)

- 3.7.1. The existing ceiling tiles do not meet the characteristics discussed in the above code and are within violation for this IBC requirement. The ceiling grid should be torn out and replaced by a ceiling product that does meet the flame and smoke spread rating. For proposes of this report we carried the cost of the demolition of the existing tile, and the installation of a standard 2 x 4 grid of suspended, insulated ceiling tile. Estimated Cost ... \$6,200

Photograph No. 7: Flammable ceiling tile typical throughout the building.

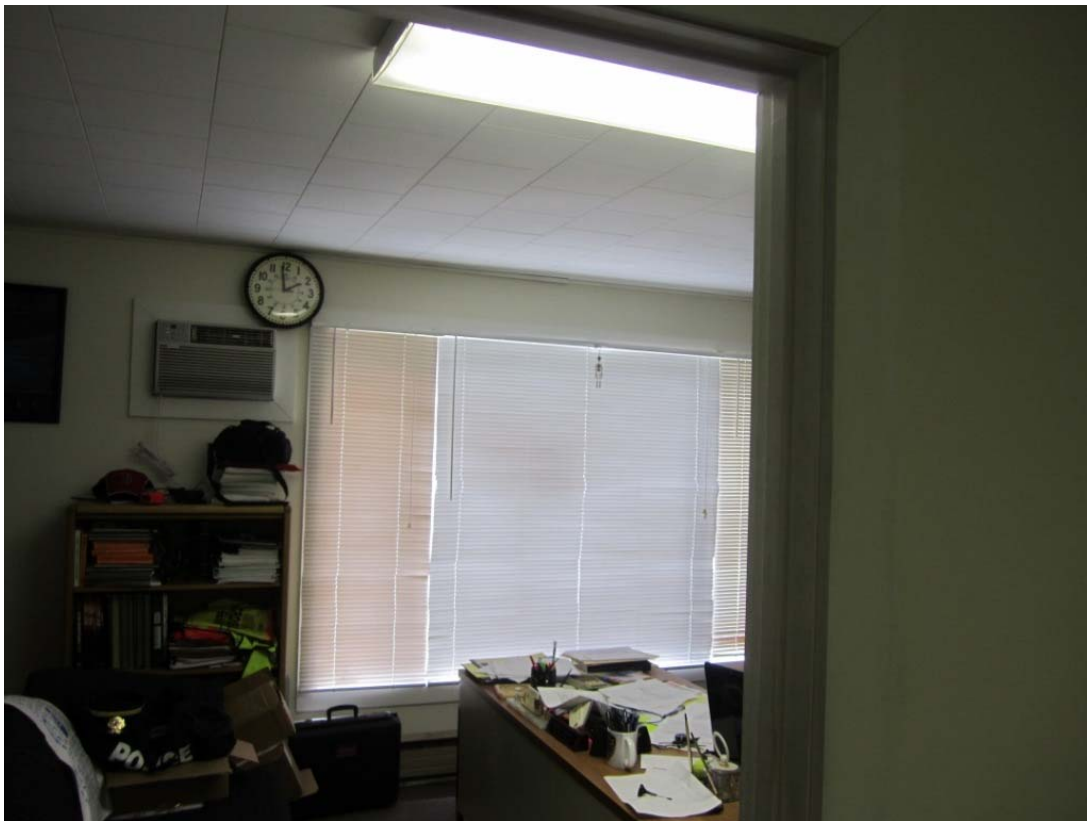
Photograph No. 8: Police Chief office.

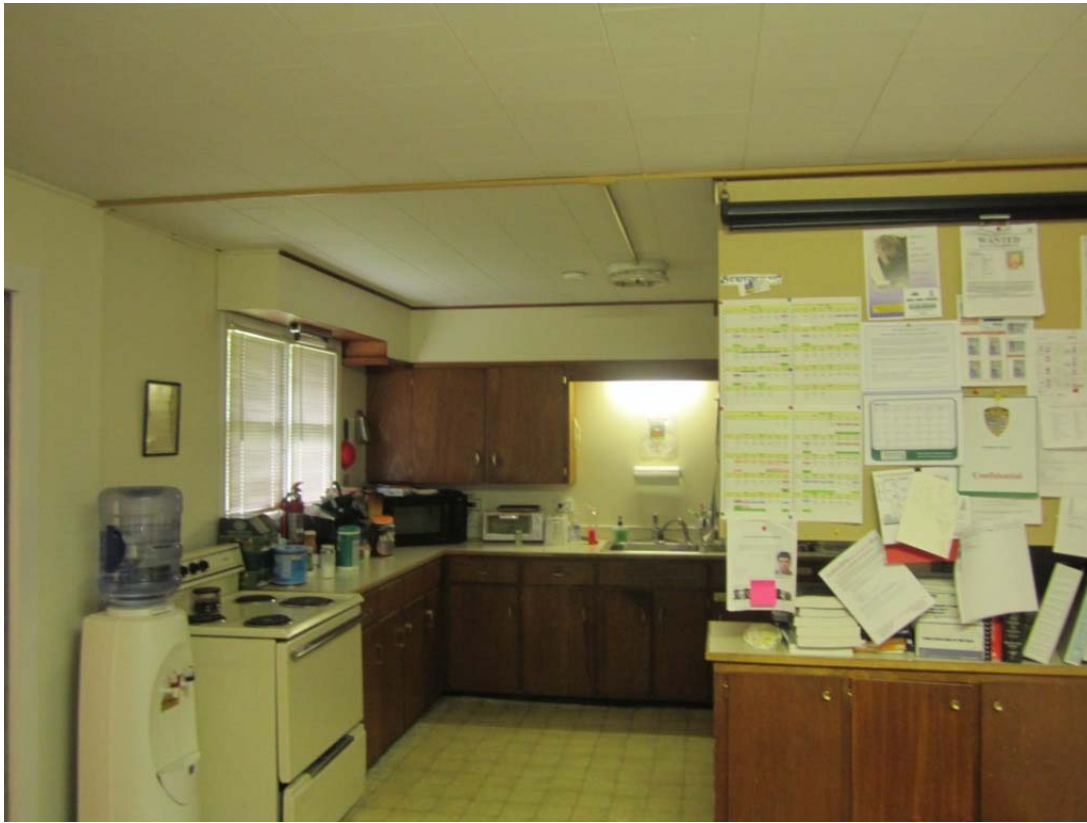
- 3.4. Accessible kitchens are required to have a sink with a maximum height of 34" and an accessible counter with a maximum height of 34". (ADA 28CFR Ch. 1, 7/1/94 edition, section 4.24 and 4.32.4)

Photograph No. 9: Existing kitchen.

- 3.4.1. The kitchen base cabinets would have to be removed and the sink plumbing lowered to accommodate the code requirement height of 34" off finish floor to meet the ADA code requirements. Estimated Cost ... \$4,000

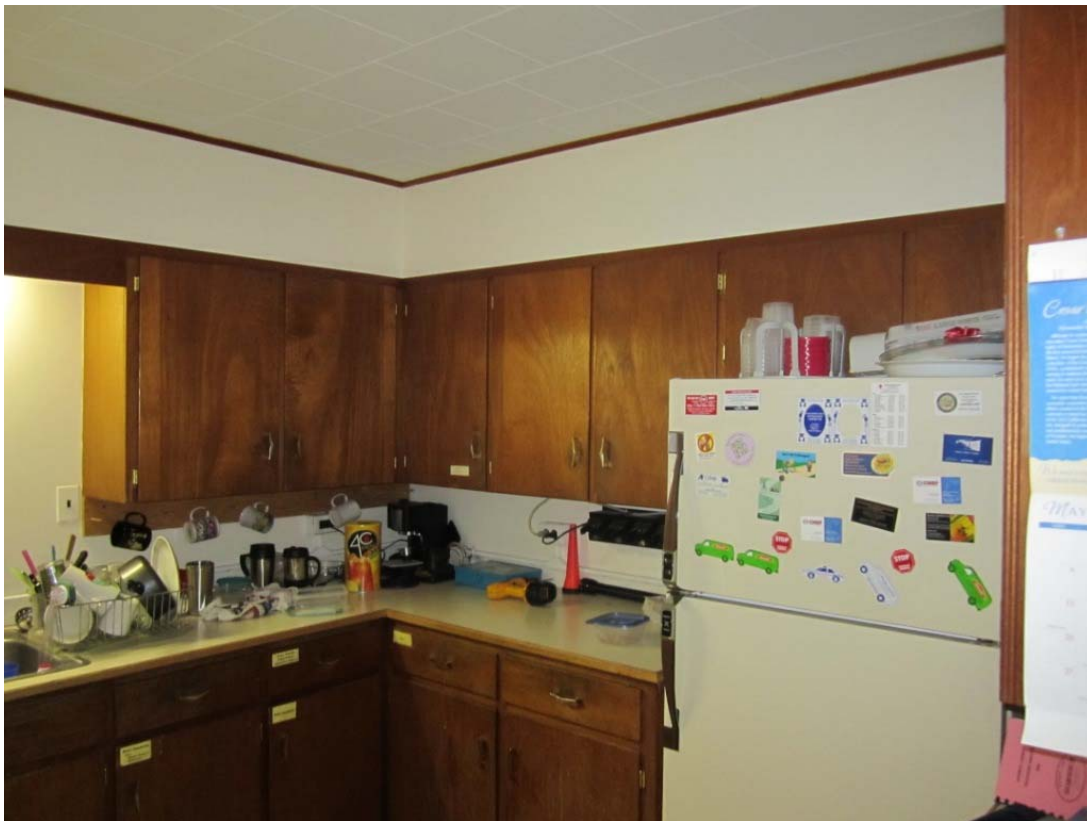
Photograph No. 10: Existing kitchen.

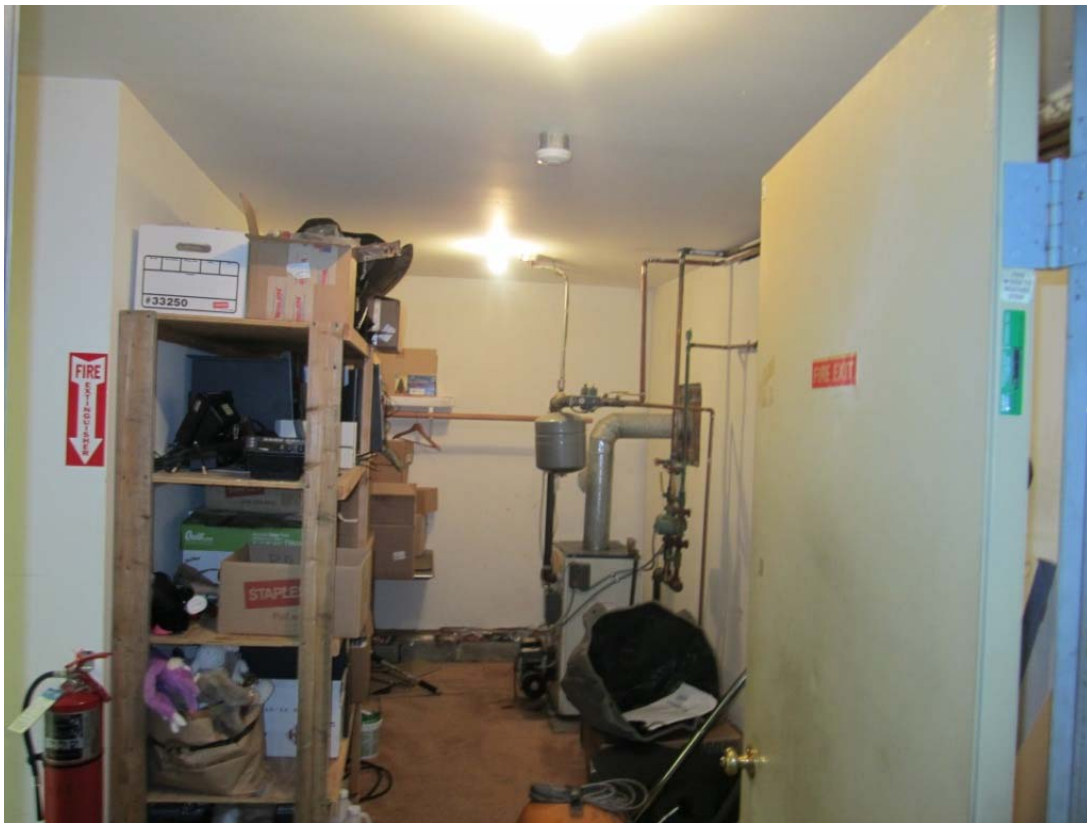
- 3.12. Certain specific storage rooms, electrical rooms, mechanical rooms and any other accessory use, incidental use, or required separation of uses must be properly classified in terms of fire-resistant construction. (2006 IBC – Chapters 3, 4, 5, 6 and 7; 2006 NFPA 101 – Chapters 6, 8, 9, 40, 42 and 43)

Photograph No. 11: Furnace room with open storage.

- 3.12.1. There is a certain amount of work that will need to be done in the room where the furnace is located. Storage shelves will need to be protected from the furnace and all combustible fluids, etc. Box in the existing furnace with louvered doors for air circulation. Estimated Cost ... \$2,000

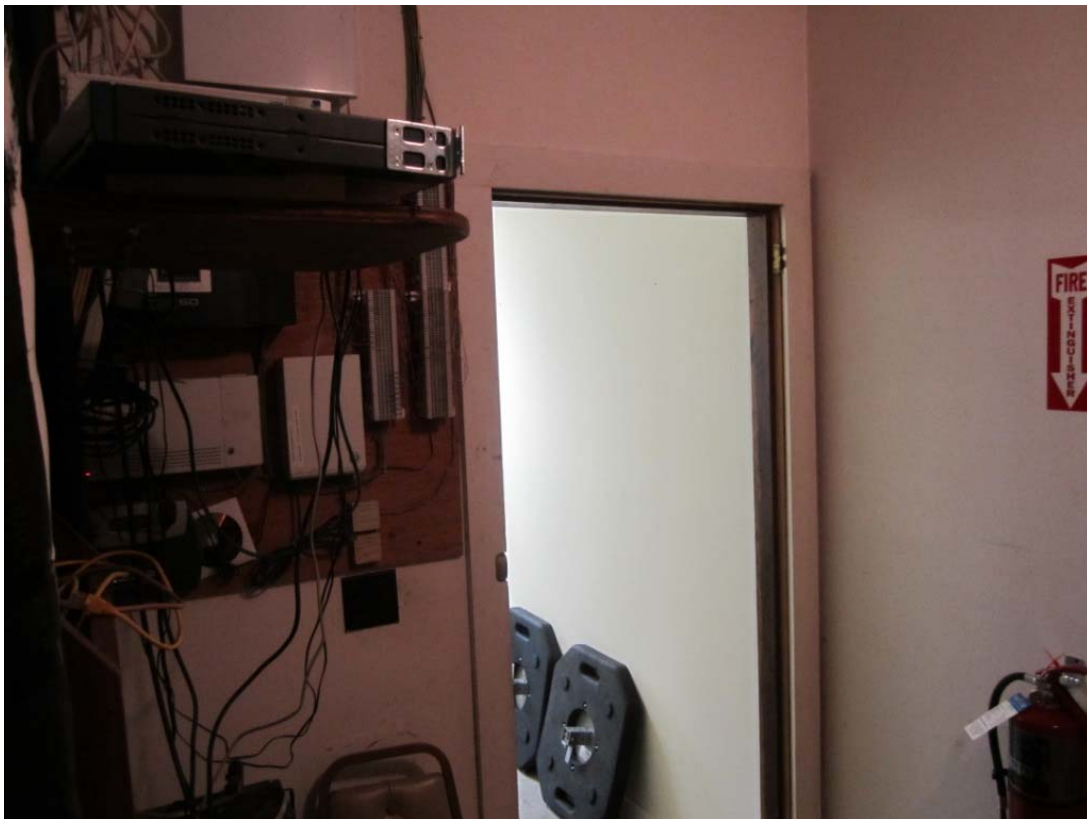
Photograph No. 12: Open telephone punch board.
