TOWN OF NORWICH

Norwich Pool Dam and Recreation Area

PRESENTATION by
Shawn Patenaude, P.E.

August 20, 2012

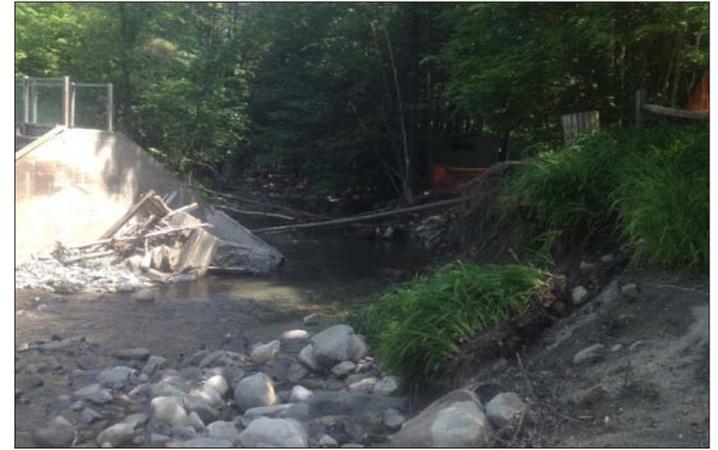
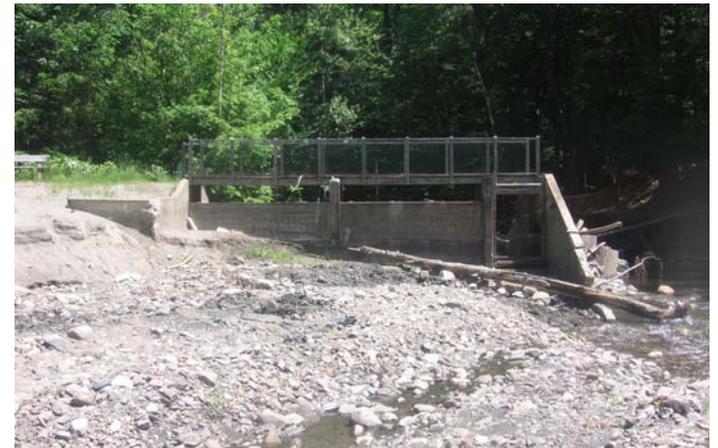
Existing Conditions

Impact from Tropical Storm Irene

- Amount of rainfall
- Overtopping
- Erosion of right embankment

Conclusions from Visual Inspection and Desktop Analysis

- Vintage concrete (1949)
 - Minimal reinforcement and cracks
- Antiquated flashboard design
 - Nonfunctional
