Town of Norwich Board of Civil Authority
Tax Assessment Appeals

Appellant Evidence Packet

RESIDENTIAL REPORT

153 Delta Dr
WHITE RIVER JUNCTION, VT 05001

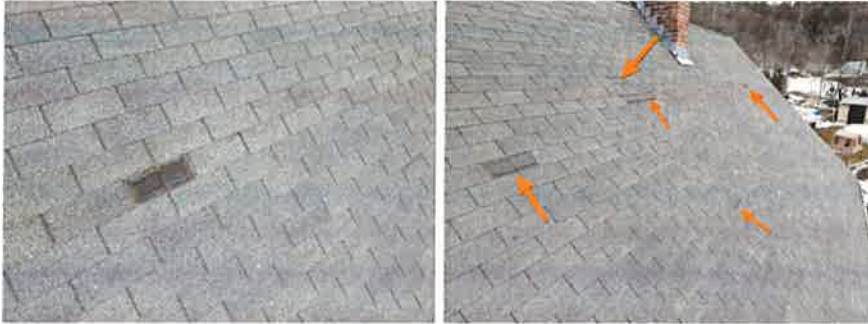
DAMAGED/MISSING

Shingles are missing/damaged in several areas on the front of the home.

Shingles should be repaired/replaced by a qualified contractor to prevent leaks.

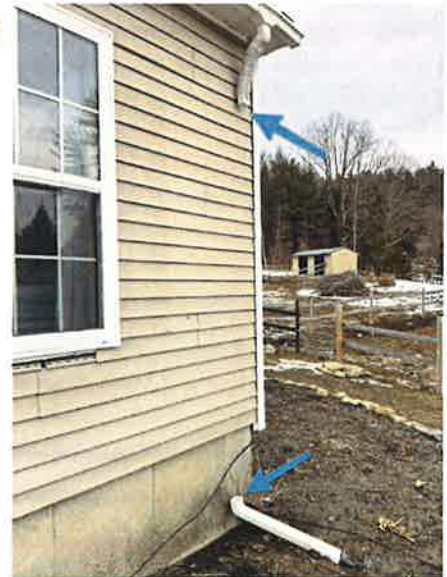
2.2.1 Roof Drainage Systems

DOWNSPOUTS MISSING

Home was missing downspouts in one or more areas. .

I recommend installing downspout extensions that drain at least 6 feet from the foundation.

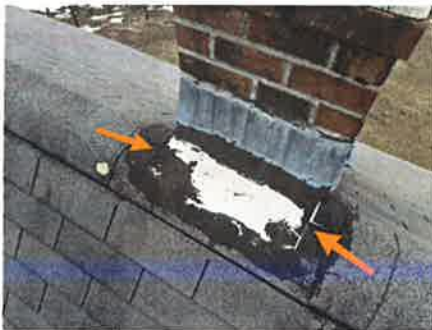
Chimney flashing is in need of repair/replacement:

- Flashing behind the chimney has been "repaired" with tar.
- counter-flashing is not well sealed

Signs of leaks were noted around the chimney.

Poor repair

I recommend having this re-flashed by a qualified contractor

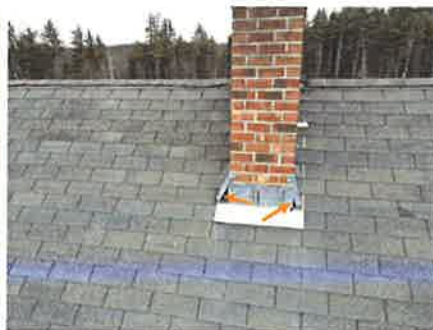
Loose counter-flashing

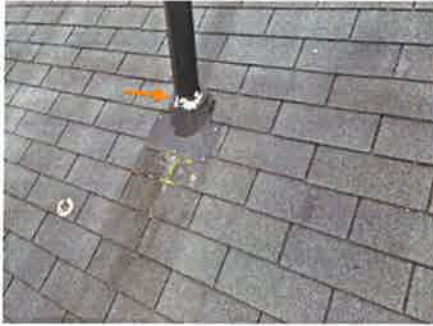
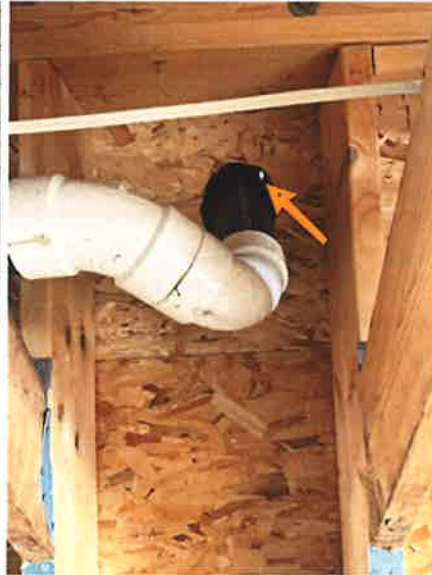
The flashing boot at the drain vent is in need of replacement:

- The rubber boot is worn out, and no longer fits tight on the vent stack. The rubber has been caulked, but does not form a good seal.

This boot should be replaced by a qualified contractor

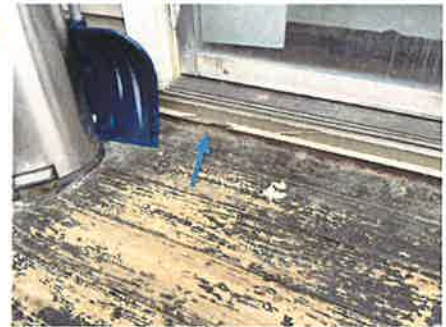
CRACKING/DAMAGE - MINOR

Minor damage to siding and trim was noted.

This is common for vinyl siding.

Sealing cracks/holes and/or patching/replacing damaged siding will be normal maintenance.

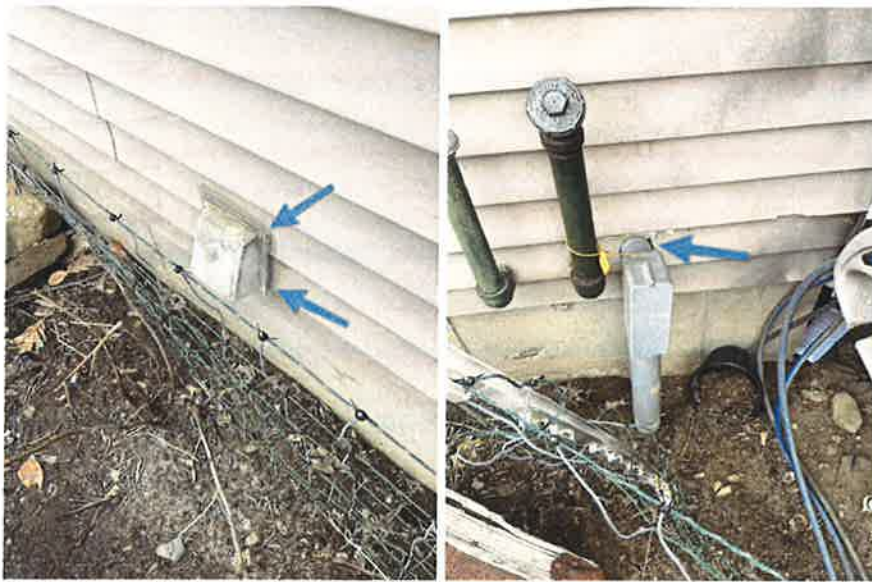
3.1.2 Siding, Flashing & Trim

UNSEALED PENETRATIONS

These openings can allow access for moisture/pests.

Contact a qualified professional.

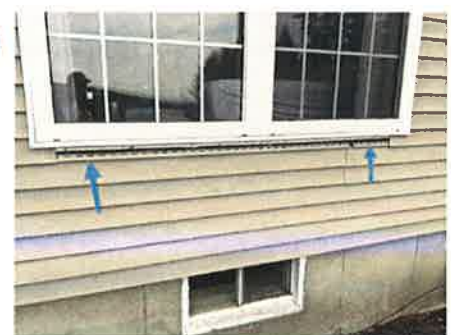
3.1.3 Siding, Flashing & Trim

UNFINISHED SECTIONS OF SIDING AND TRIM

Siding/trim was missing from:

This can allow moisture intrusion.

Siding and trim should be properly installed by a qualified contractor.

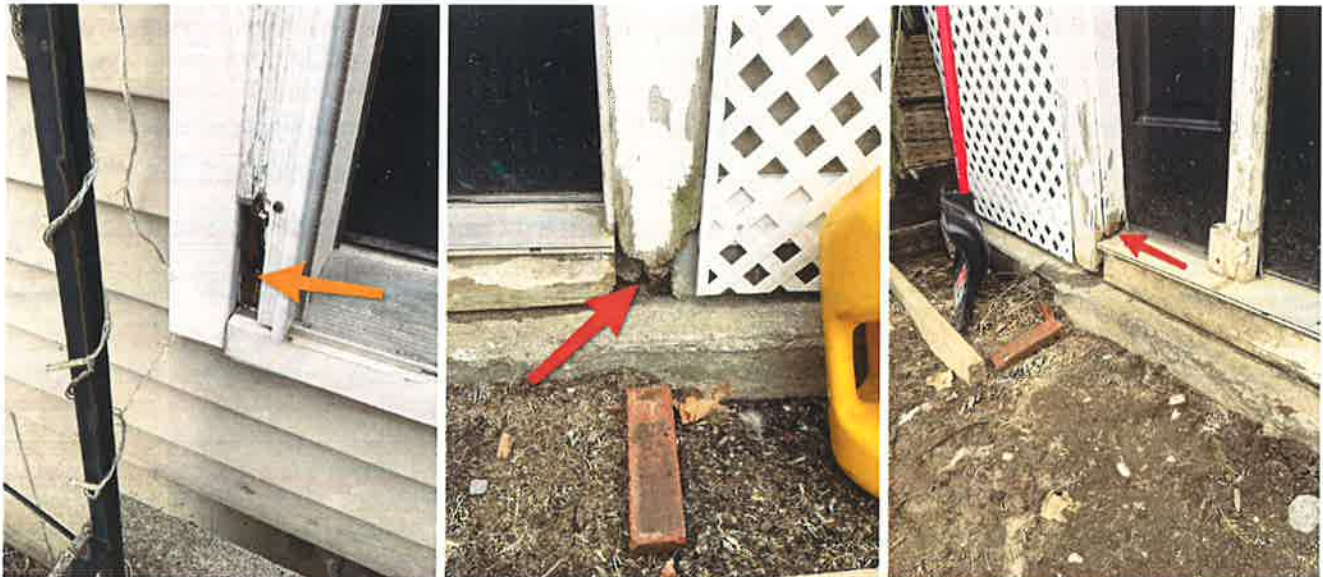
3.1.4 Siding, Flashing & Trim

DECAY

Trim is showing minor to moderate decay in the following areas:

There appears to be decay to sheathing at the front door, and sheathing and framing at the basement entry.

Extending to framing at basement entry

Keeping material coated in a high-quality paint/stain will help, as would installing gutters.

It is important that siding and trim repairs be made in keeping with best practices: back-priming of all materials, and proper caulking/sealing joints, etc.

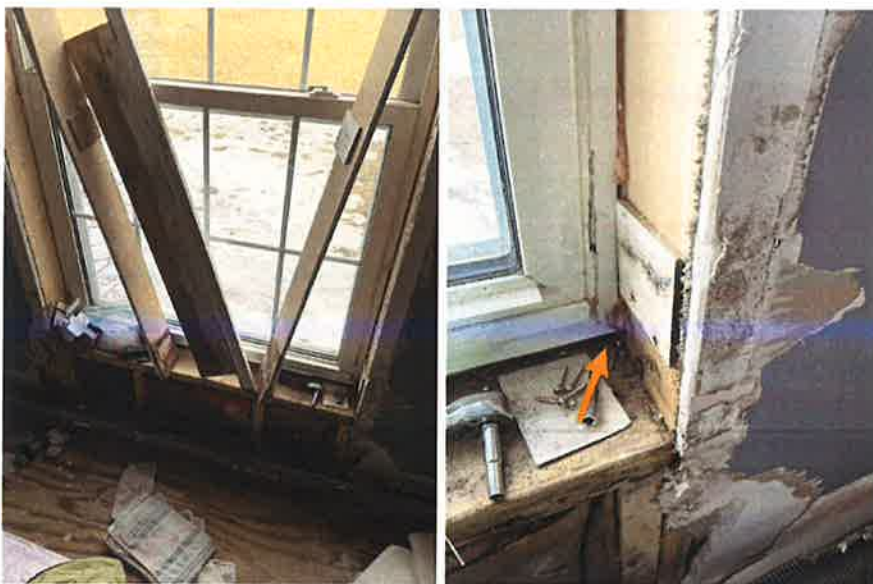
3.1.6 Siding, Flashing & Trim

WINDOW INSTALL/LEAKS

There have reportedly been leaks at several window units around the home.

Minor deterioration to framing was noted at the bedroom window that has had trim and drywall removed.

Based on reported leaks and condition found, having windows removed and reinstalled after openings are properly prepped/flashed would be beneficial

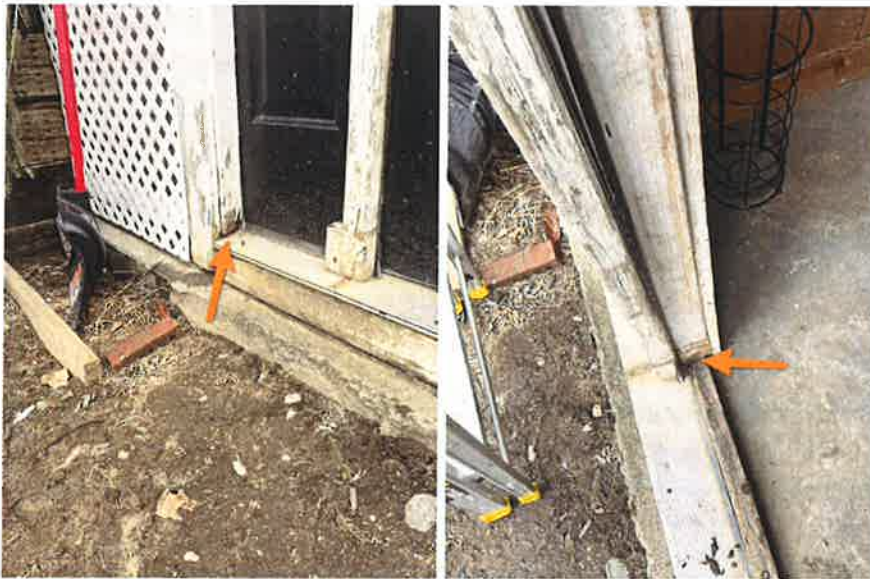
3.2.1 Exterior Doors

BASEMENT DOOR

As noted earlier, there is significant decay to jamb and frame around the basement door. Additionally:

- weatherstripping is deteriorated/damaged
- Threshold shows deterioration/decay

This unit will need to be removed for wall repairs to be properly completed, and the unit would likely benefit from replacement.

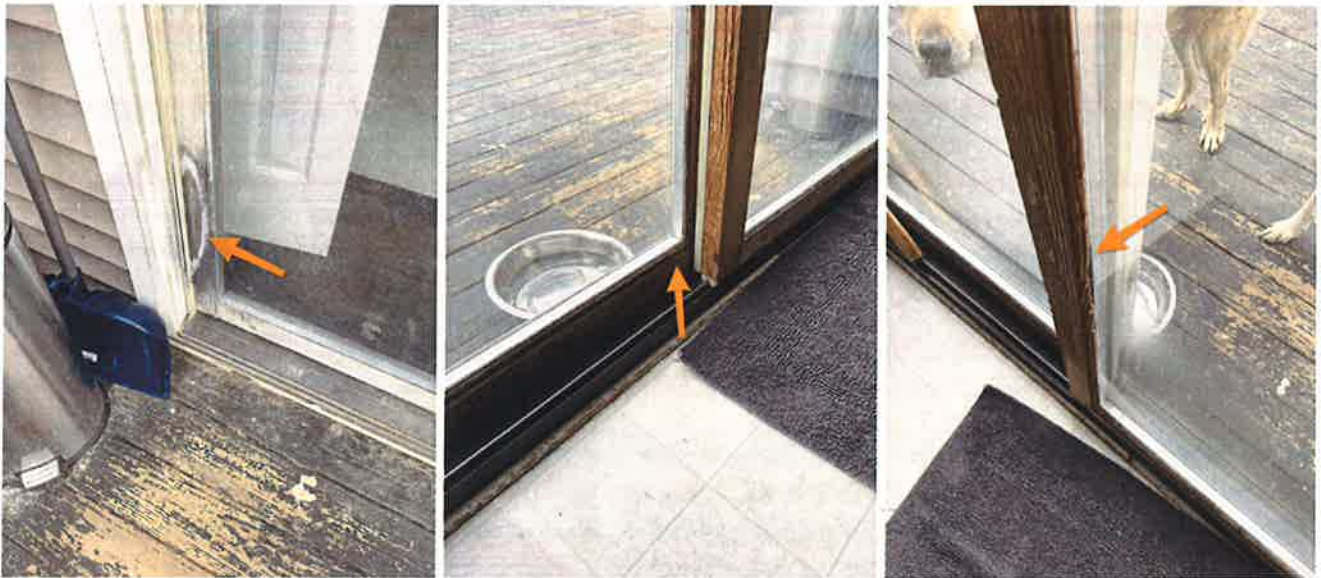
3.2.2 Exterior Doors

SLIDING DOOR

- The door to the back deck showing some damage to the exterior cladding on bottom and side rails.

- damage was noted to the interior of side and bottom rails.

Repairs to door rails and latch can be made to extend the life of this unit, but replacement will likely be warranted in the near future.

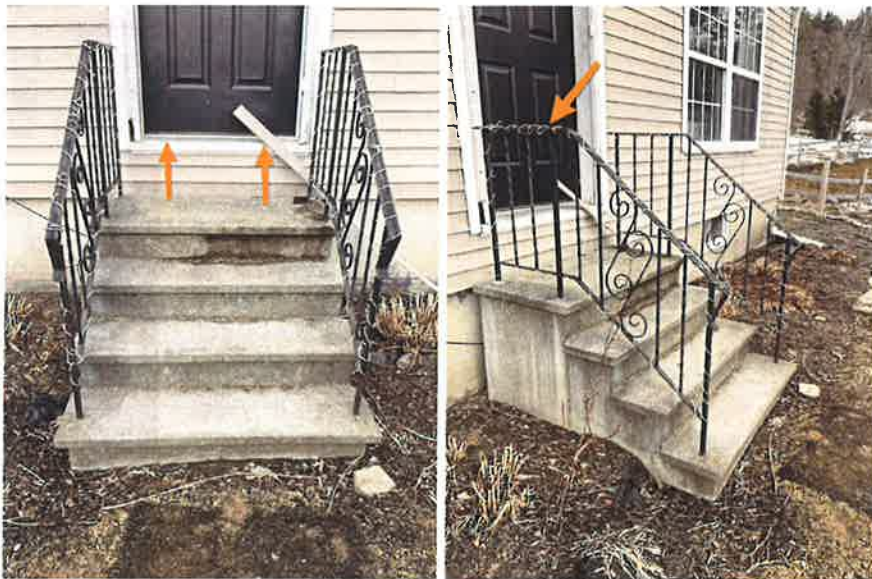
3.3.2 Walkways, Patios & Driveways

EXTERIOR STEPS

Corrections to the front steps are recommended:

I recommend having these steps re-set on a proper base, at the proper height, and having the rails extended or replaced.

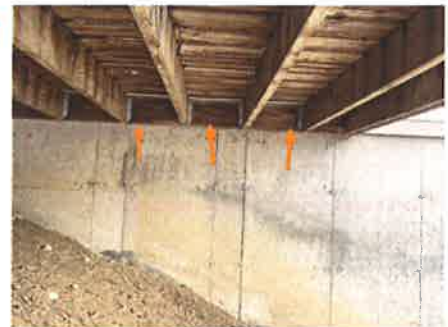
Lack of anchoring to the home is the most common cause of deck failure in the US.

Contact a qualified professional.

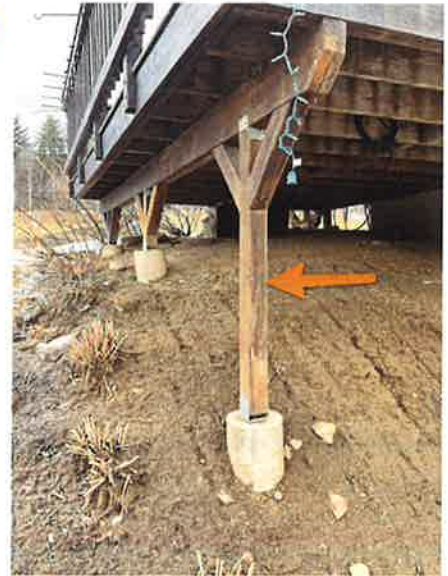
3.4.3 Decks, Balconies, Porches & Steps

SUPPORT POSTS

The support posts under the back deck are inadequately sized by current standards (on high side)

Contact a qualified professional.

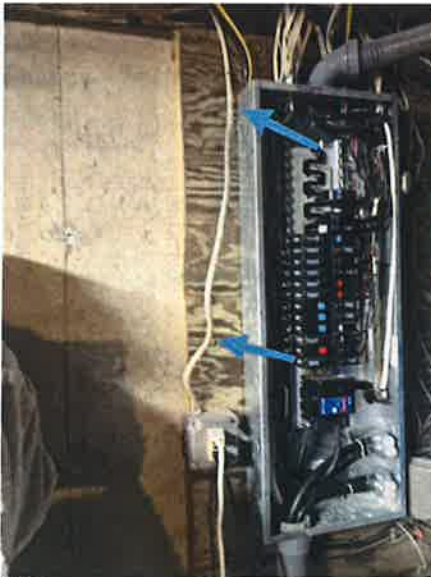
5.3.1 Branch Wiring Circuits, Breakers & Fuses

IMPROPER FASTENING OF WIRES

Loose wires can be unintentionally snagged/pulled which can damage electrical connections.

This is especially important in traffic areas, and in the area of main and sub panels where wiring should always be fastened within 12 inches of entering or exiting.

Basement

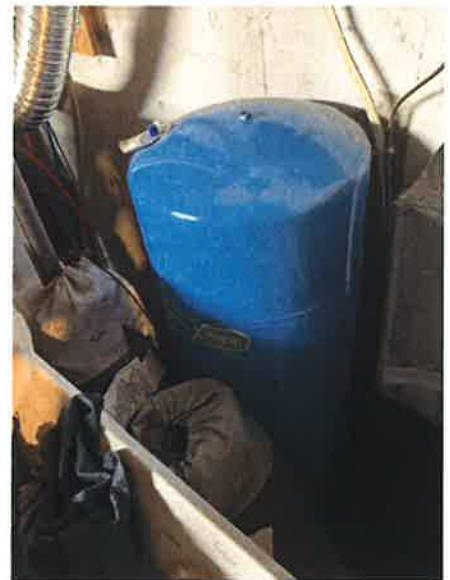
ACCESS

The pressure tank, and main shut-off were obstructed by laundry appliances and personal belongings.

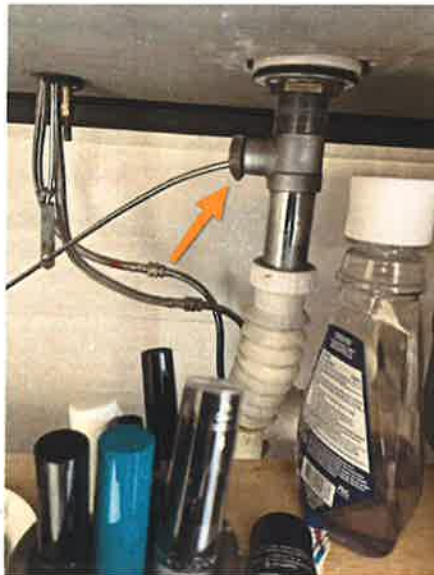
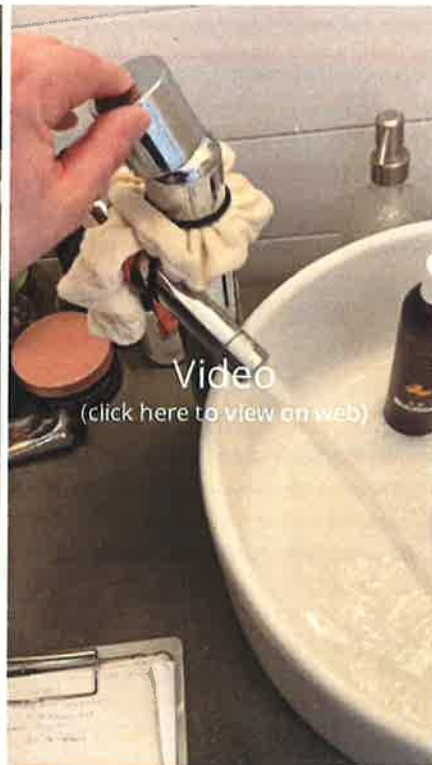
6.3.1 Water Supply, Distribution Systems & Fixtures

LEAKING FIXTURE

Contact a qualified professional.

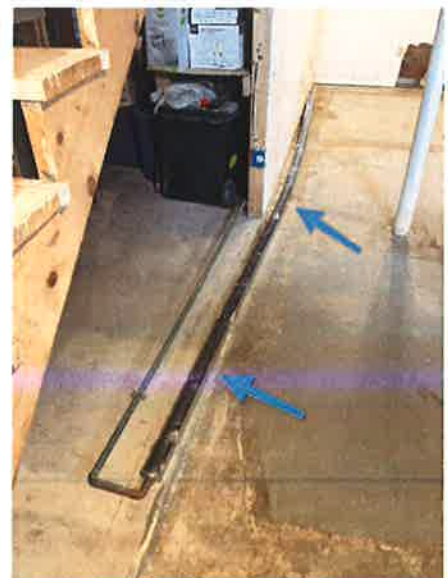
7.3.1 Distribution Systems

UNCOVERED FIN-TUBE

I recommend installing covers over this heat pipe.

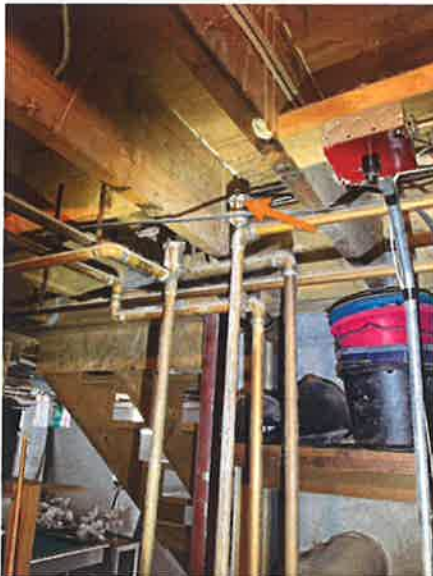
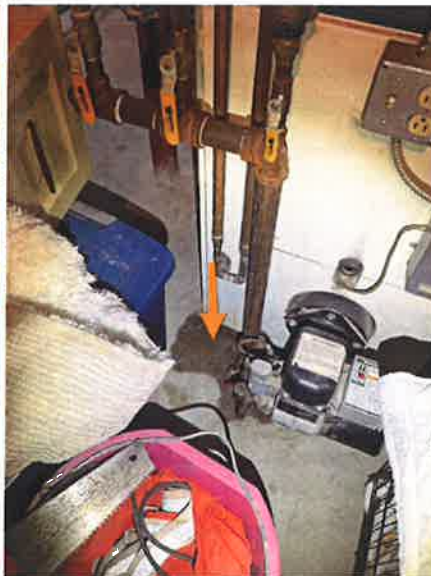
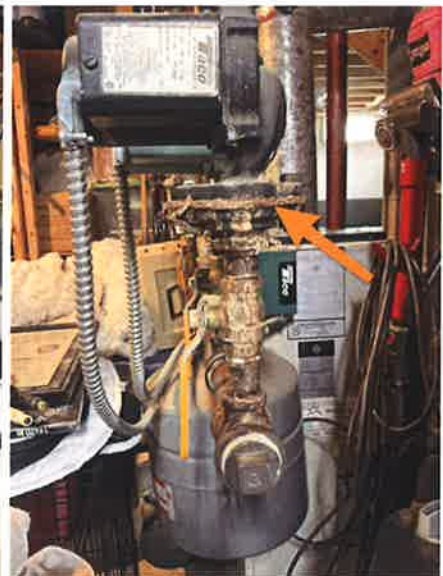
7.3.2 Distribution Systems

LEAKS

Contact a qualified professional.

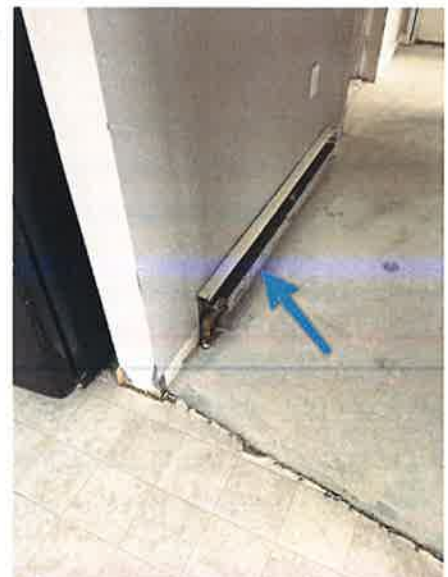
7.3.3 Distribution Systems

BASEBOARD COVERS

I recommend repairing/replacing any damaged sections.

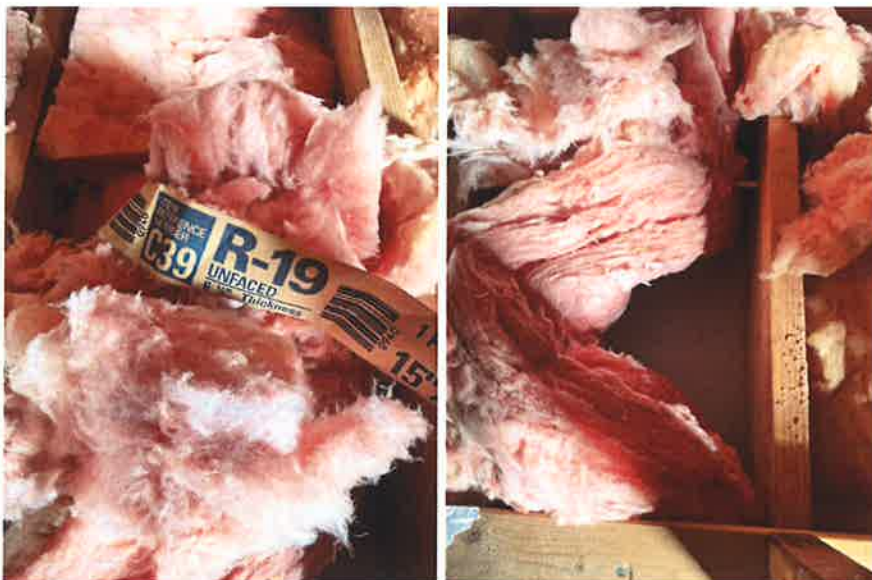
- significant voids/gaps were noted

Having cellulose installed over/in place of the existing fiberglass will help to fill voids while improving the overall insulation values.

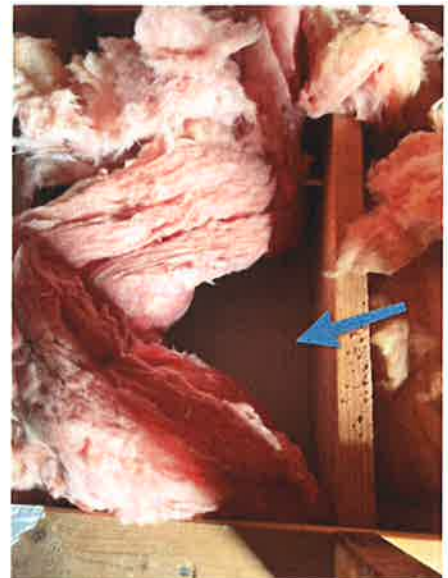
10.2.1 Vapor Retarders - Attic

MISSING OR INADEQUATE VAPOR BARRIER

Vapor barriers help minimize the transfer of moisture between living spaces and insulation.

As attic insulation is upgraded, a proper vapor barrier should be installed.

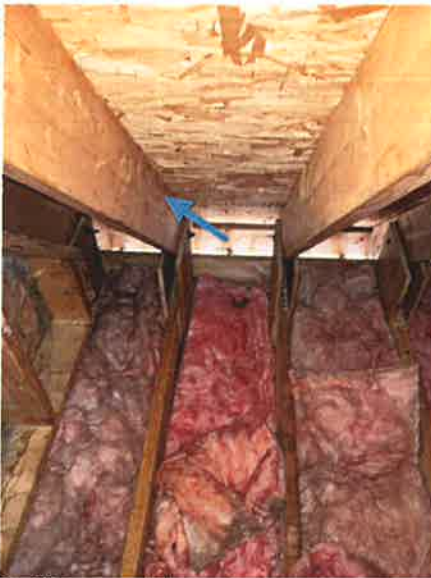
Soffit vent with no proper-vent channel

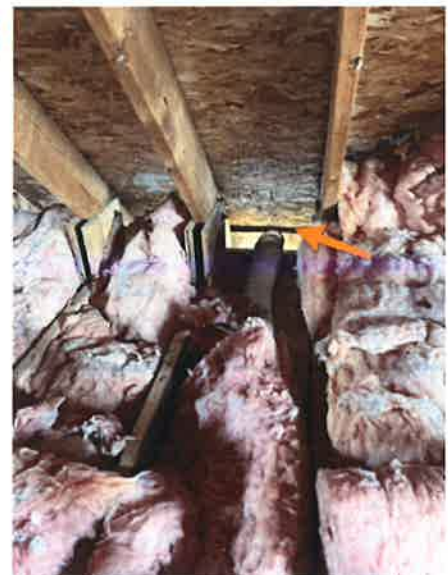
10.4.1 Exhaust Systems

NOTE: The vent is directed towards the soffit, and staining was noted in the area

I recommend having a qualified contractor extend the vent to the exterior of the home.

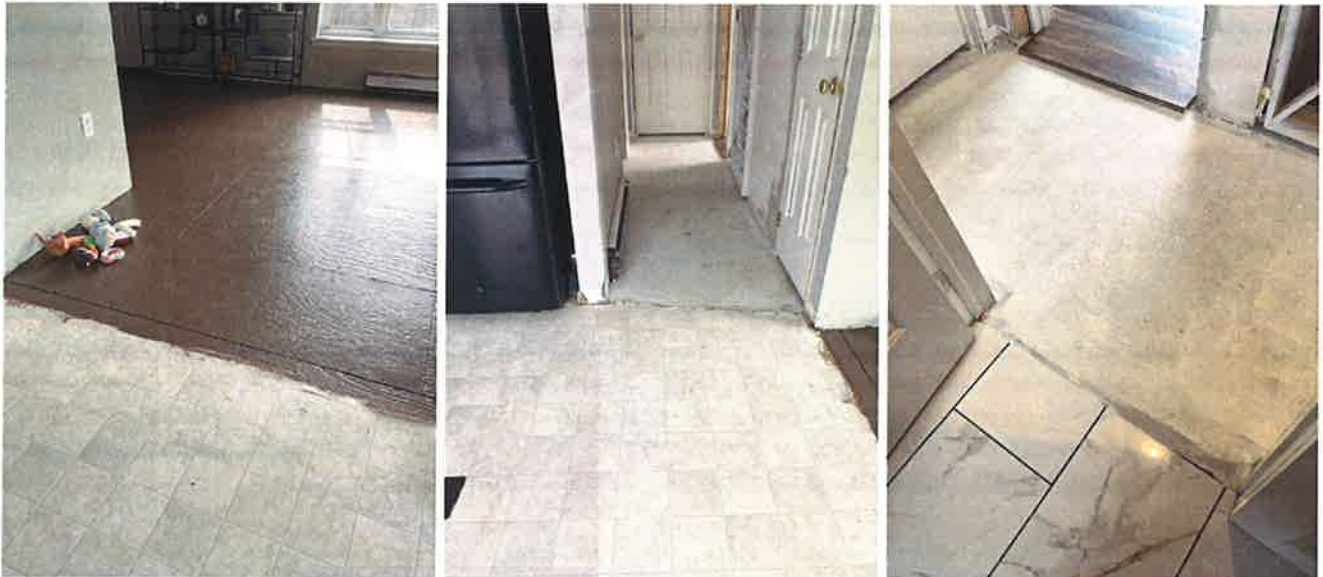
11.3.1 Floors

DAMAGE/UNFINISHED

- no finished floor is installed in the living room or hallway
- kitchen floor is damaged
- finished floor has been removed from finished space in the basement
- Thresholds are missing at floor transitions from the hallway

Flooring throughout the home will need repairs and/or installation

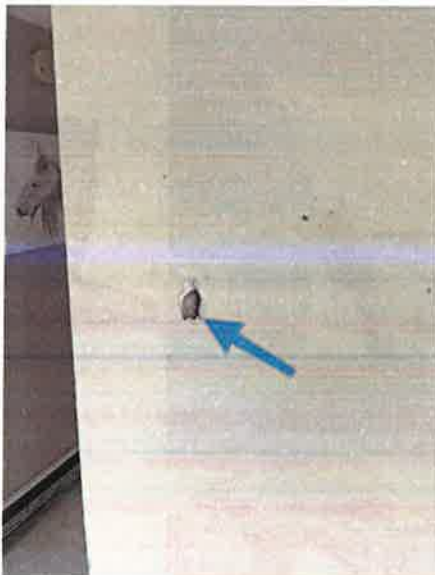
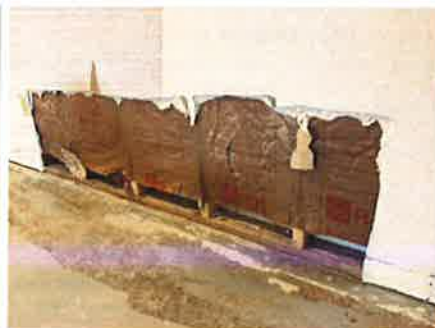
11.4.1 Walls

REPAIRS/MISSING

- Drywall damage consistent with normal wear and tear was noted around the home
- Drywall is removed/damaged in the back bedroom and basement

These areas can be easily repaired and repainted.

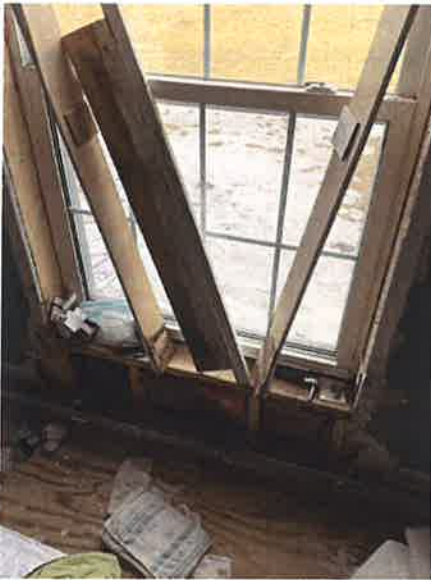
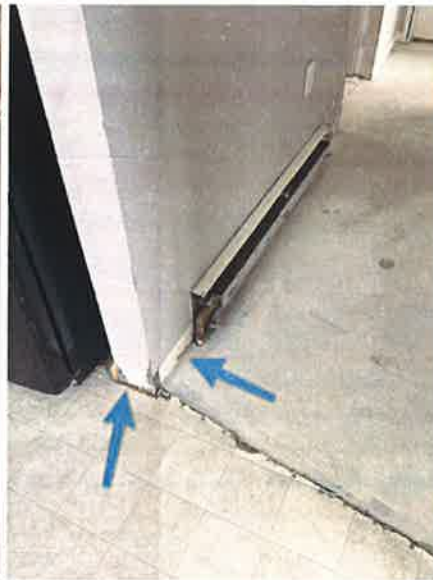
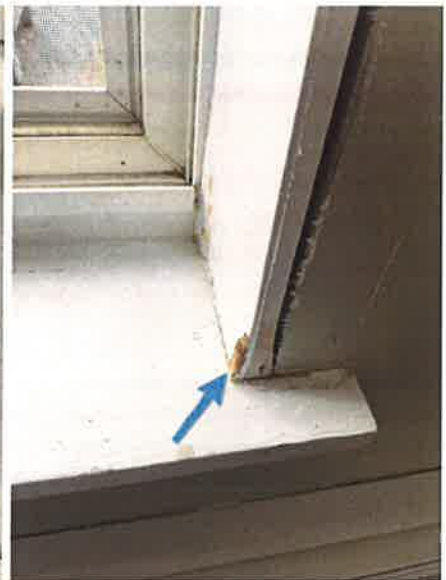
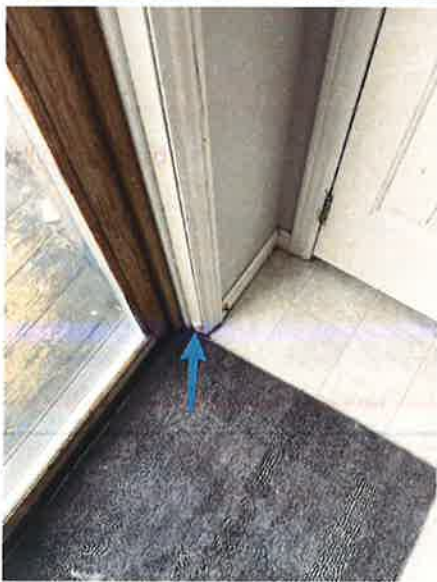
- Baseboard trim is missing in several areas
- window and door trim is missing in several areas
- Composite window and door trim shows damage/deterioration in several areas

Trim can be installed/repaired as needed.

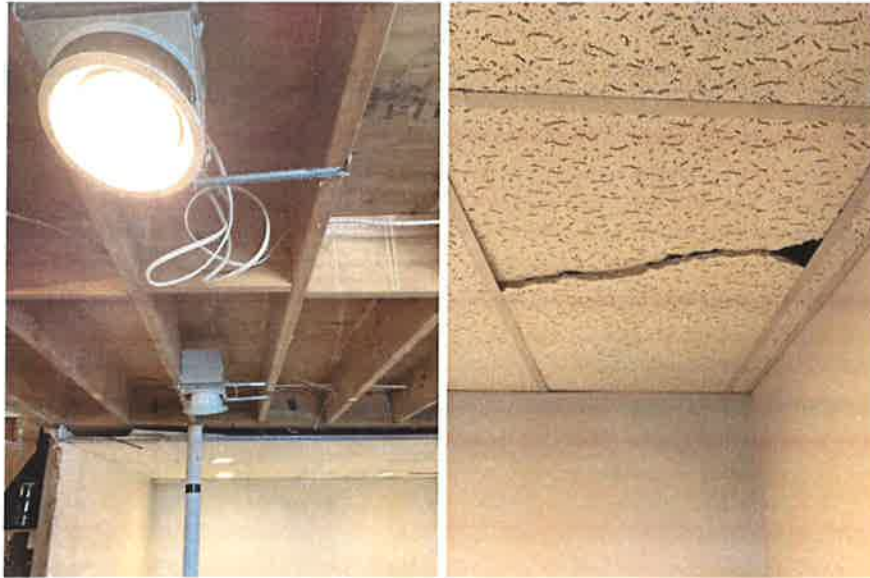
11.5.1 Ceilings

In the finished portion of the basement, ceiling tiles are missing/removed and some are damaged. Repair/replacement will be needed.
