CAPITAL FACILITIES PROJECT BINDER

Town of Norwich Police, Fire and Public Works Facilities

The following report was prepared for the Town of Norwich Vermont by a team of professionals assembled by Mink Brook Management, LLC with the intent to identify the code and functional deficiencies within the three Town buildings housing the Department of Public Works, the Town Police Department, and the Town Fire Department. We have included in this report budget figures showing estimated costs to bring these buildings up to code and meet the functional standards typical for each department if these buildings were new today. The standards were identified by the team of professionals who have designed and constructed complexes in each of the categories discussed. We understand that each of these buildings is in need of maintenance work at this time and there are line items in the budget showing some of the maintenance repairs identified during our inspections. It is not the intent of this report to try to sway the Town of Norwich to perform the remedial work as described as it may not be in the best interest of the Town to do so. It is the intent of the report to inform the Town of Norwich

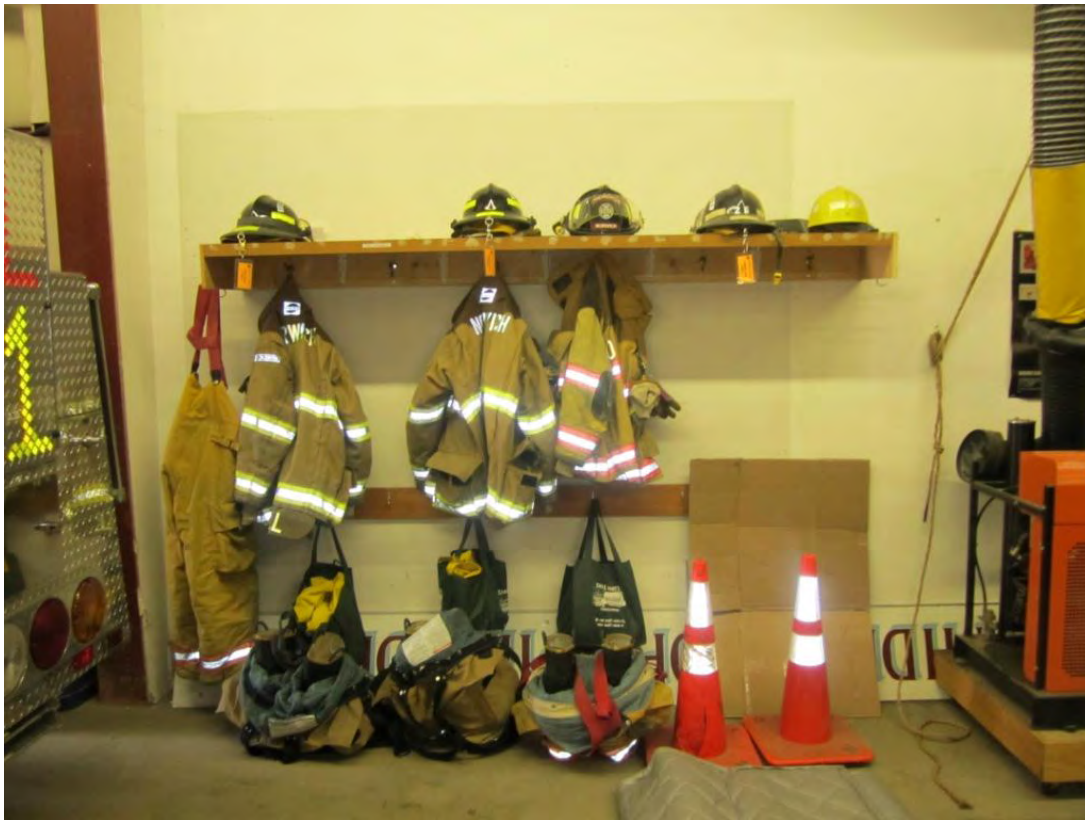
Photograph No. 2: Open storage for Personal Protective Equipment.

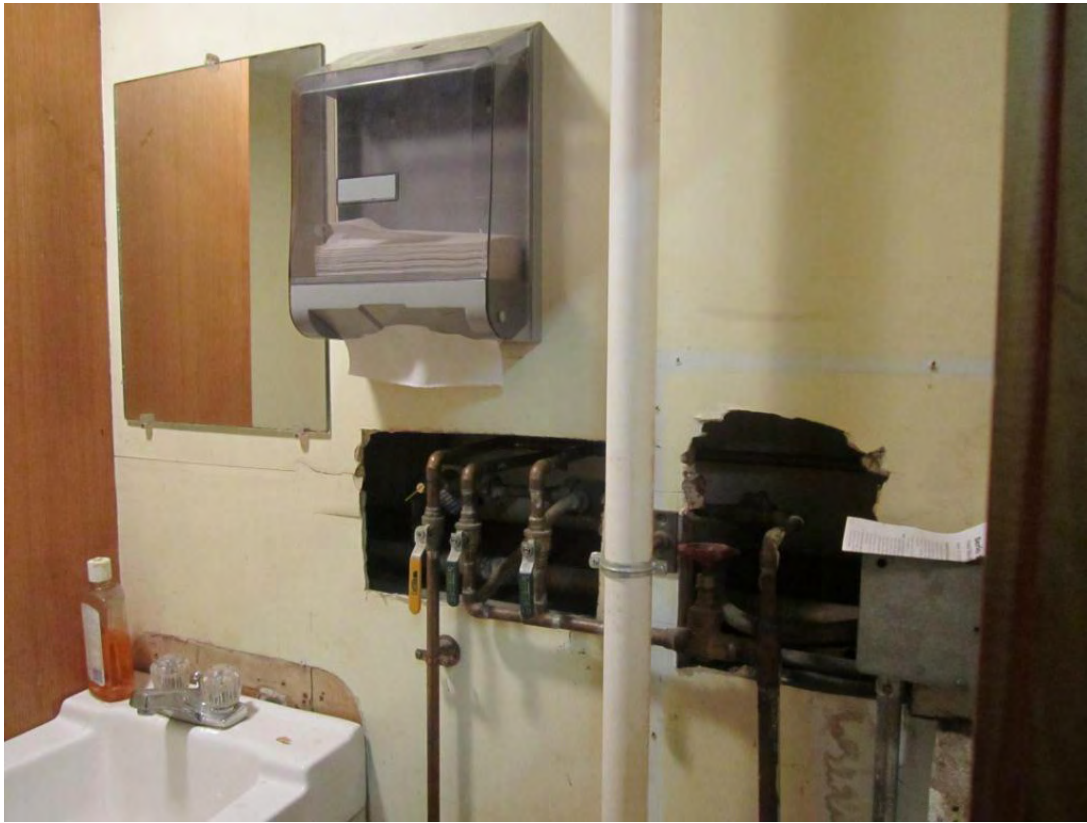
Photograph No. 4: Bathroom with holes through the wall into furnace room.

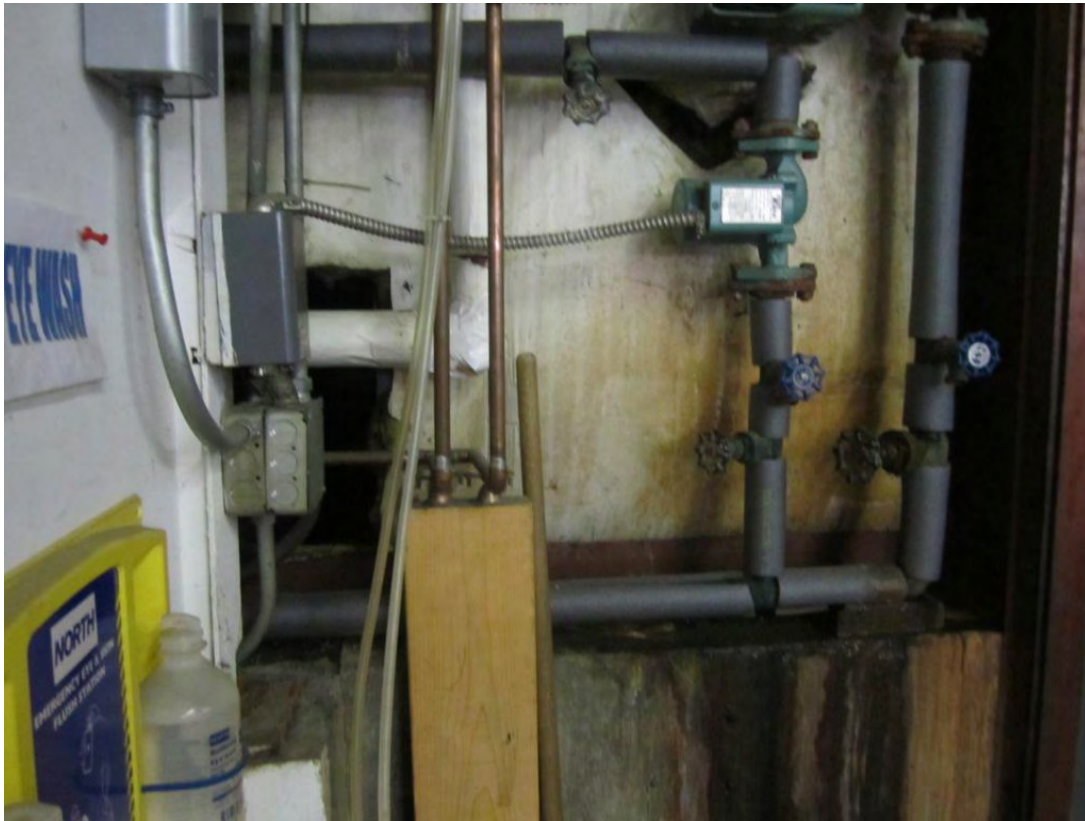
Photograph No. 6: Holes in the wall through to the furnace room from outside the bathroom and from the main Fire Station building.

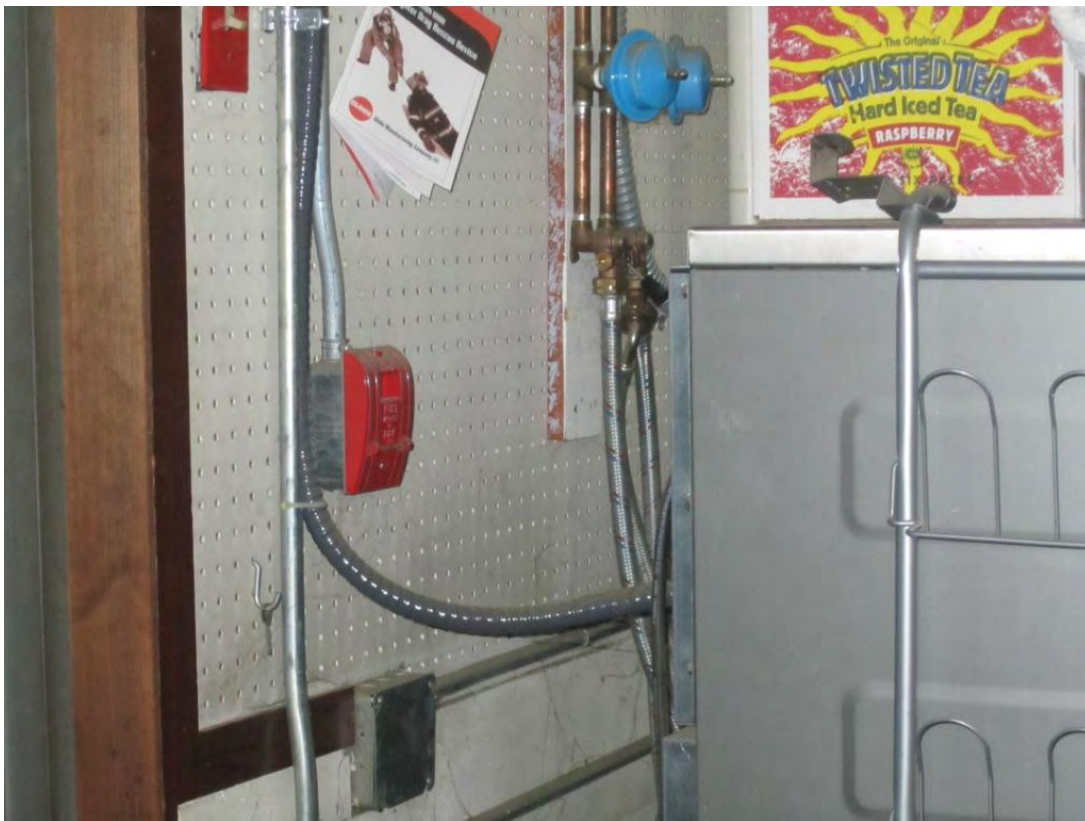
Photograph No. 7: Washing machine with partially hidden pull station.

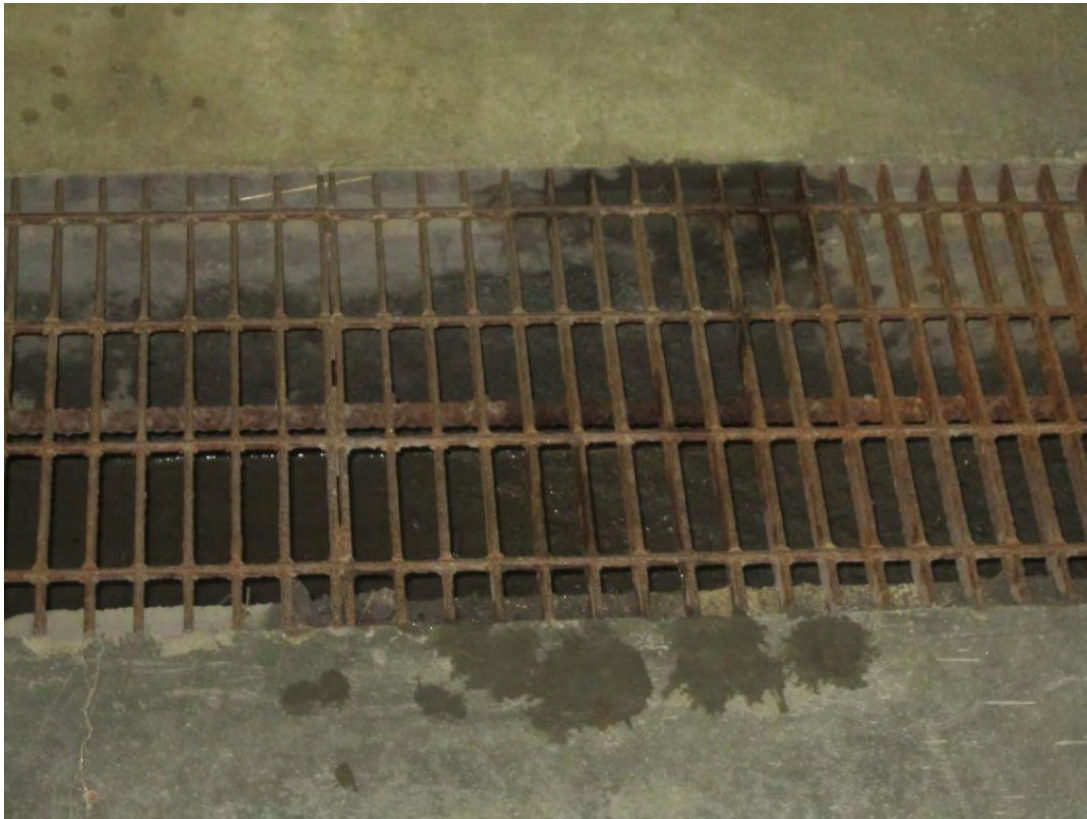
Photograph No. 11: Open floor grate that runs full length of the building.

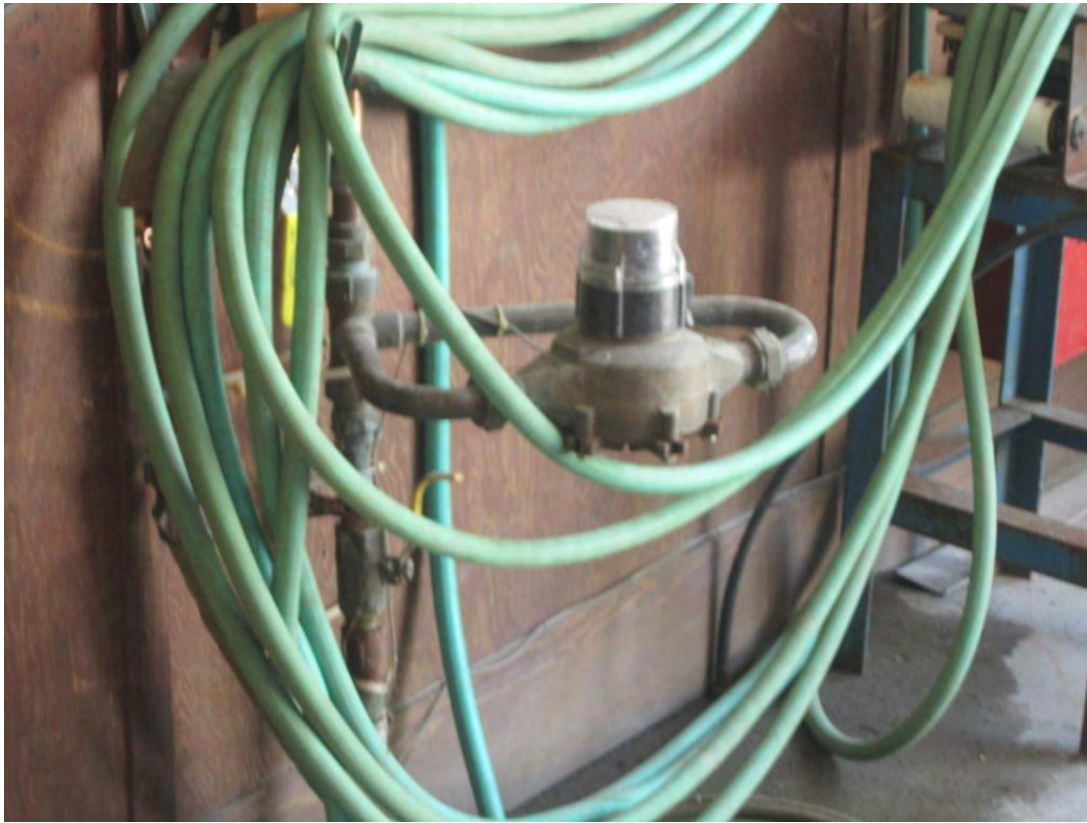
Photograph No. 14: Town water meter without backflow prevention.

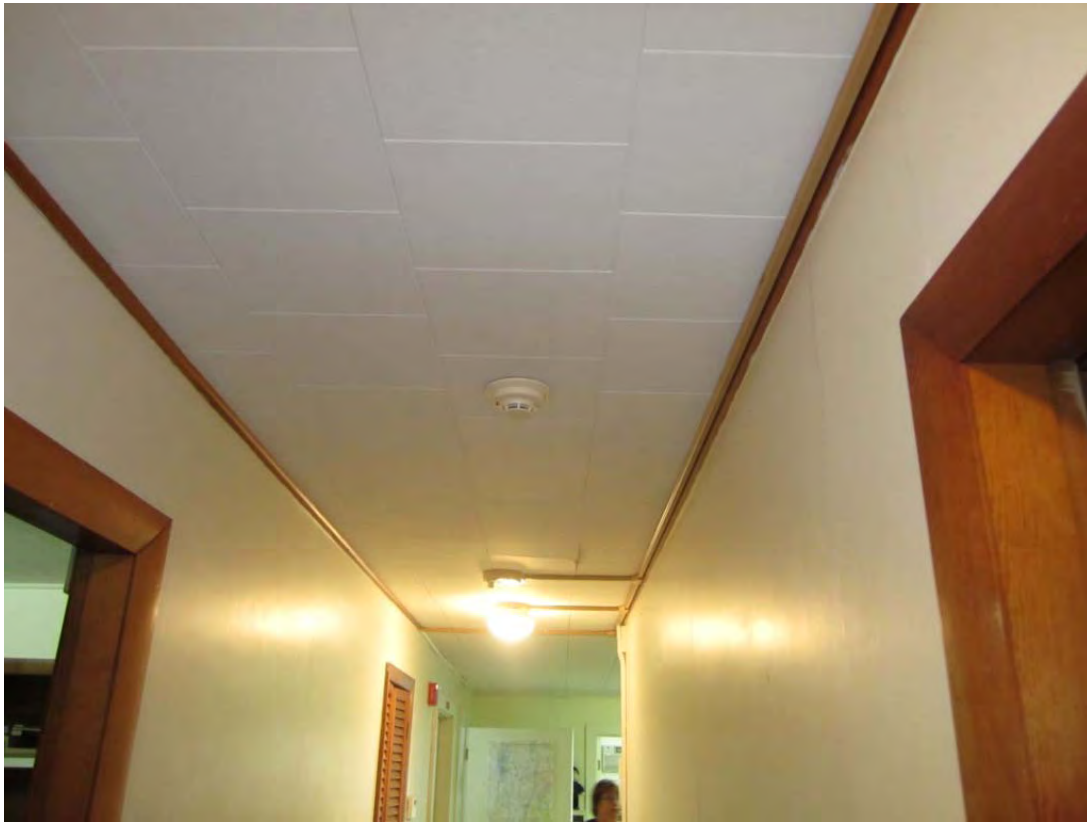
Photograph No. 7: Flammable ceiling tile typical throughout the building.

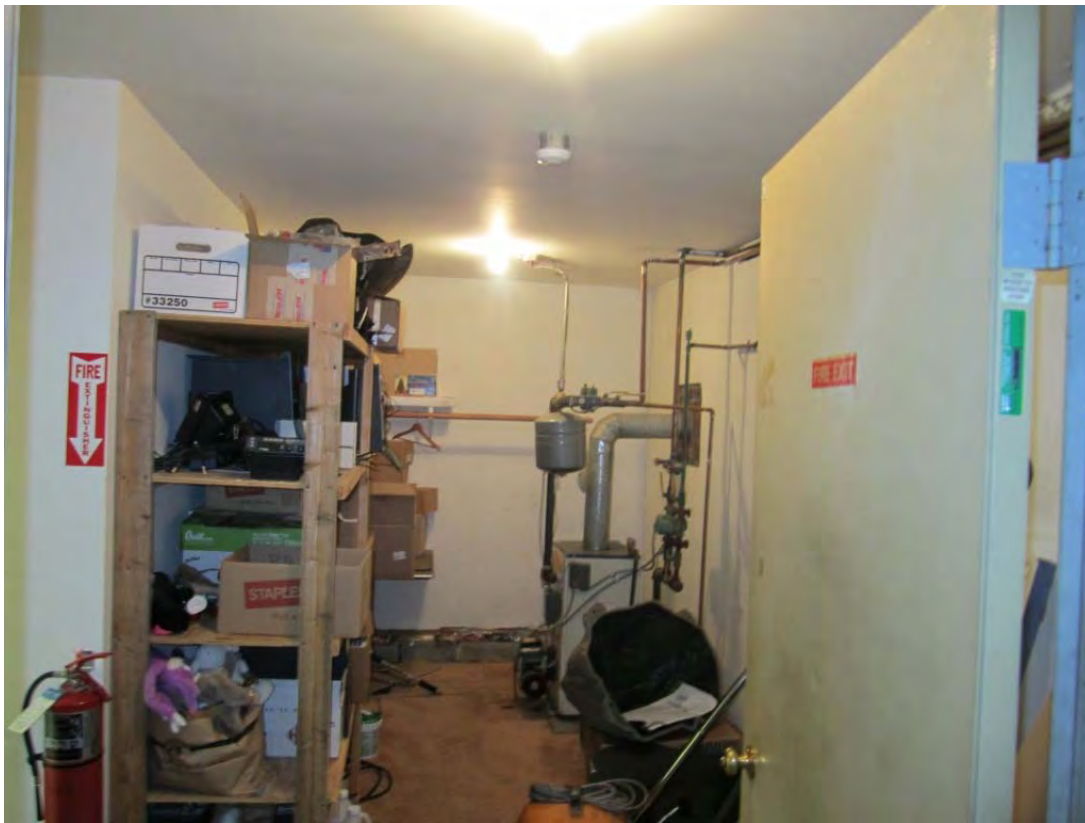
Photograph No. 11: Furnace room with open storage.

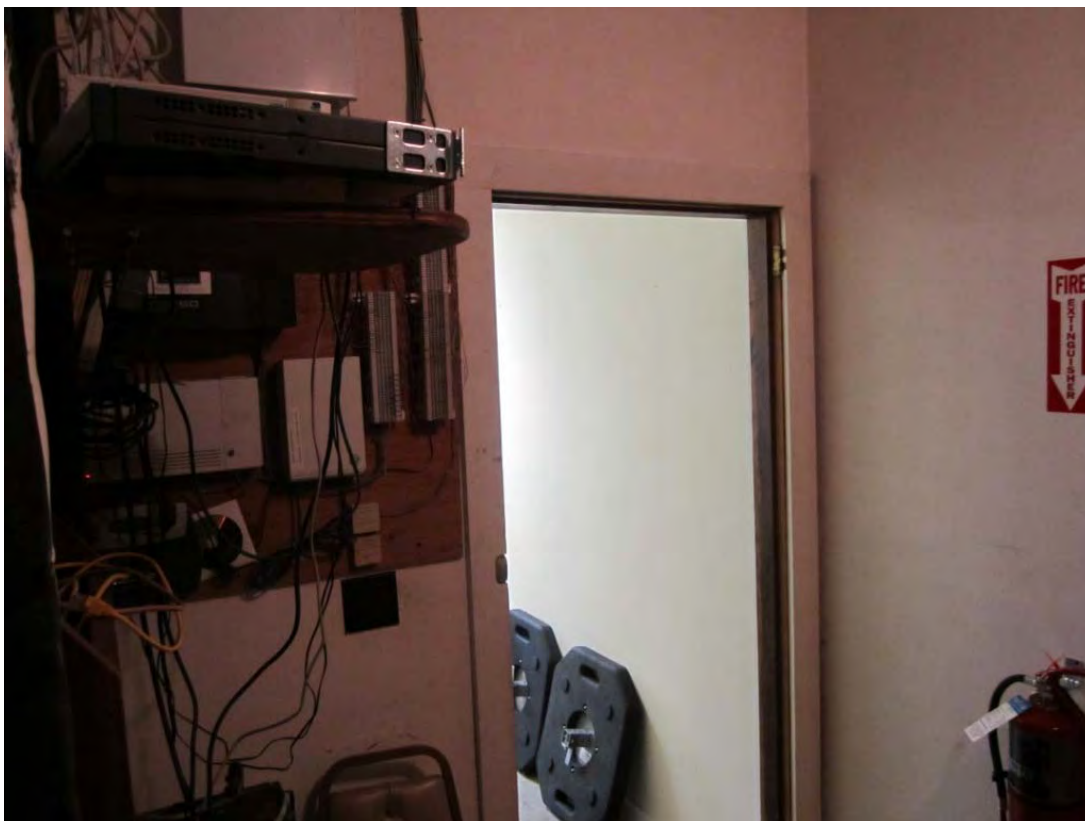
Photograph No. 12: Open telephone punch board.

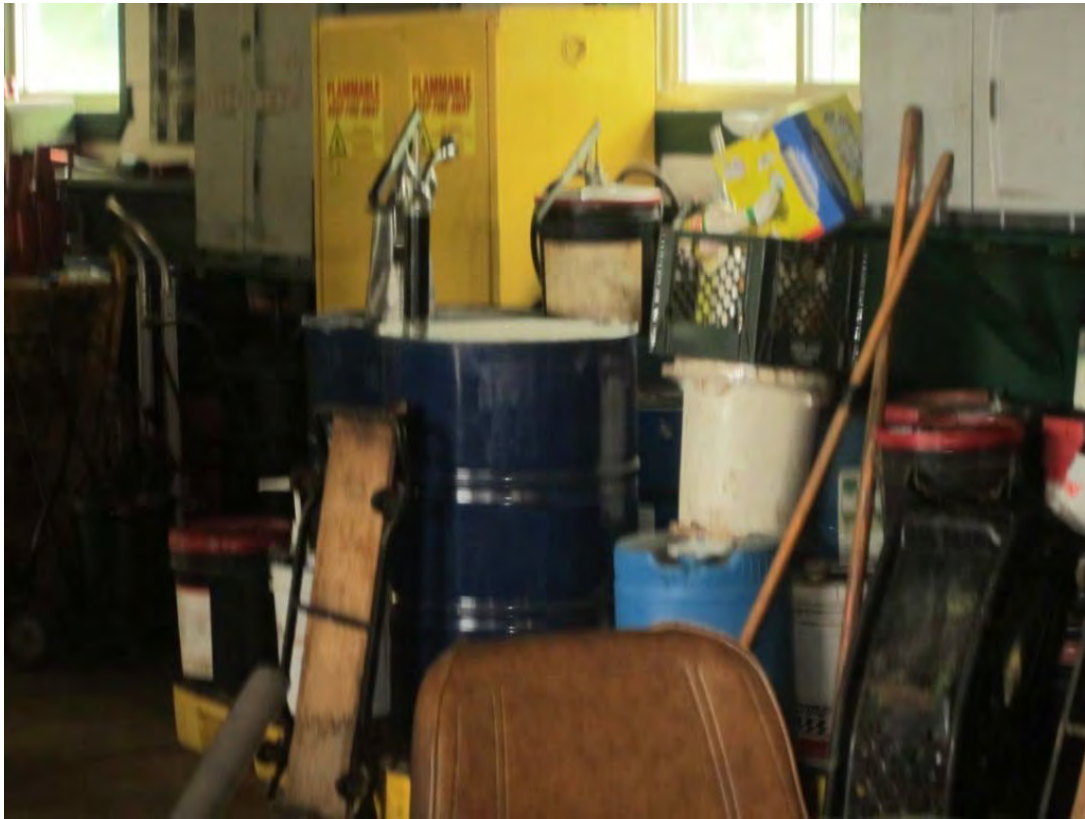
Photograph No. 3: More flammable fuel oil storage in bulk in the main DPW maintenance shop.

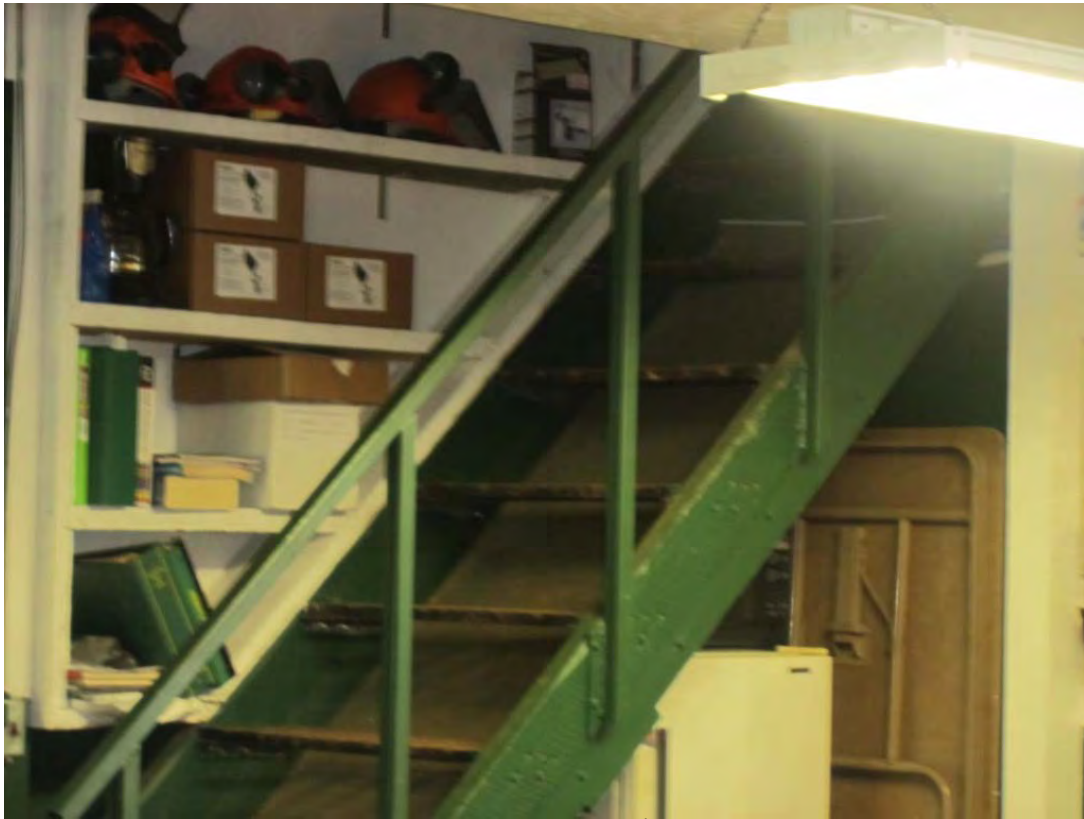
Photograph No. 5: More of the stairway to the 2nd level that needs mid-rail.

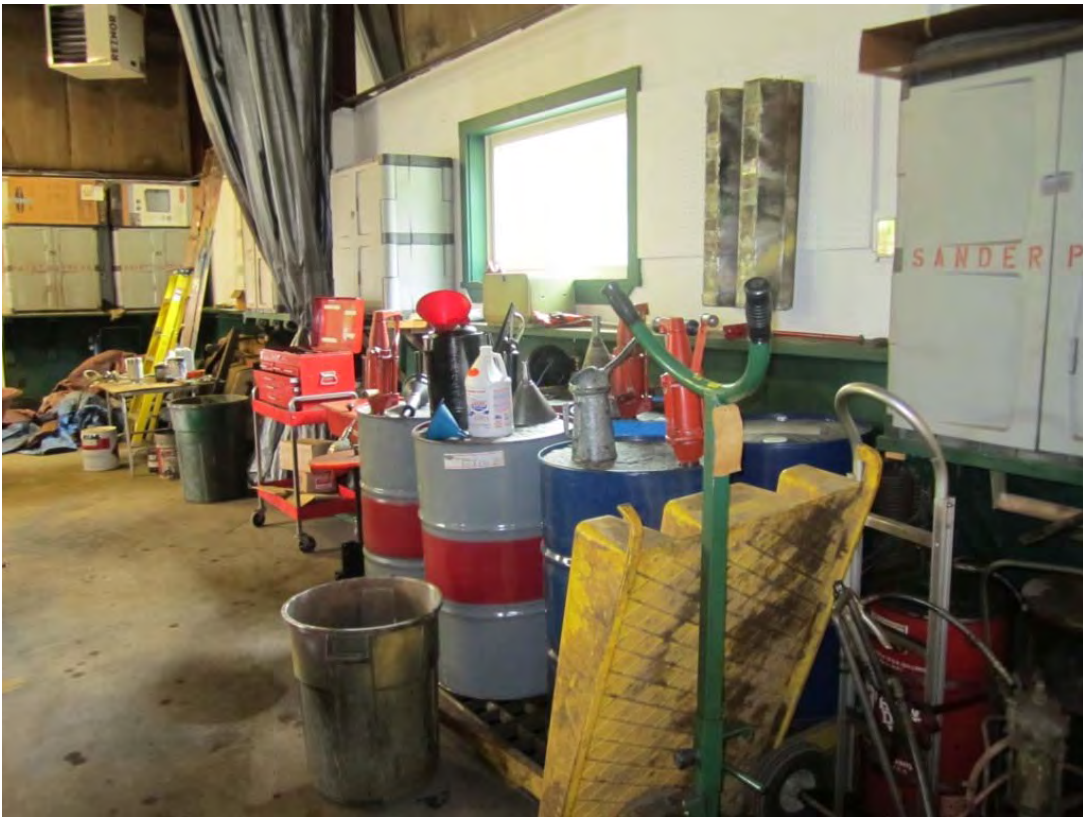
Photograph No. 8: Flammable liquid containers stored in maintenance garage.

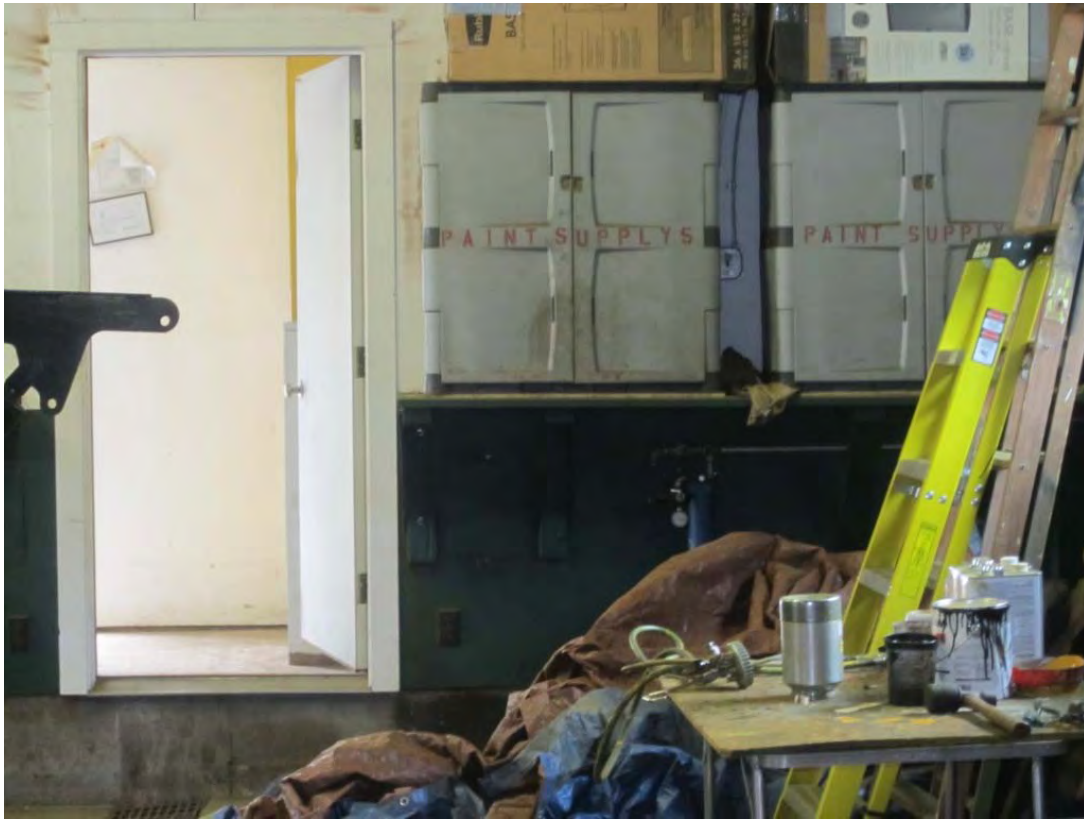
Photograph No. 9: More Flammable cabinets and oversized step up into generator room.

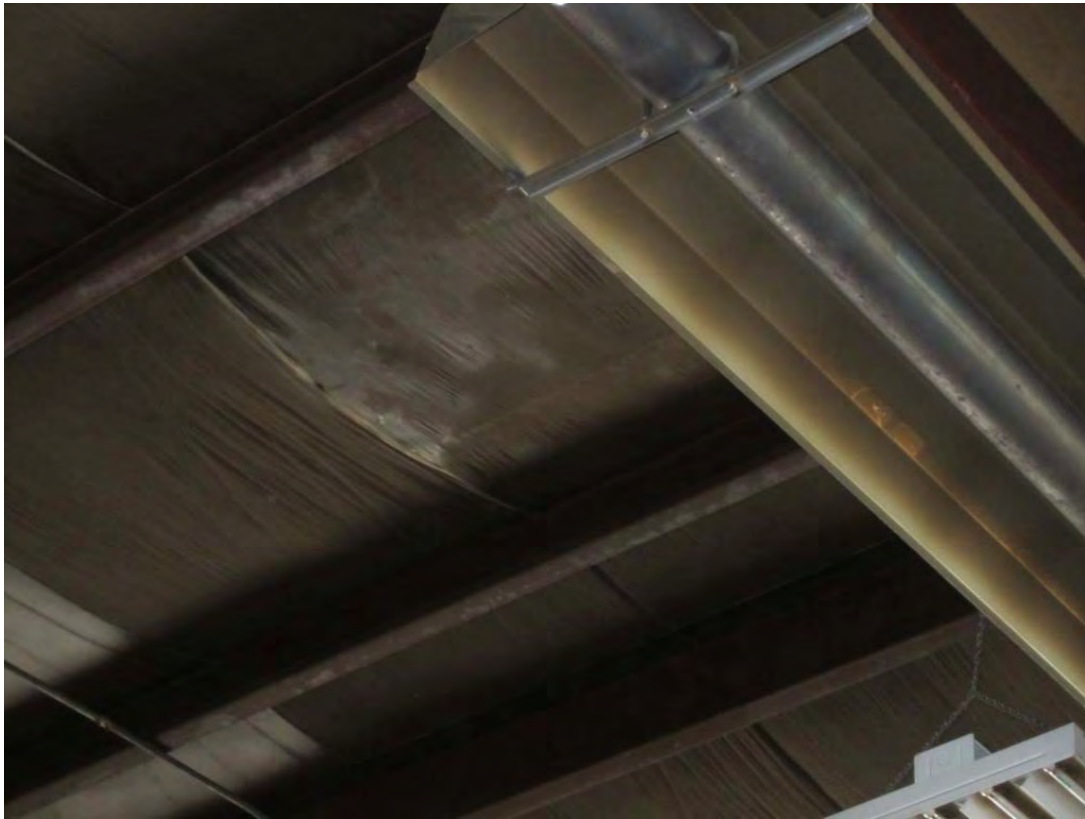
Photograph No. 11: Standard metal building insulation soaked by leaking roof.

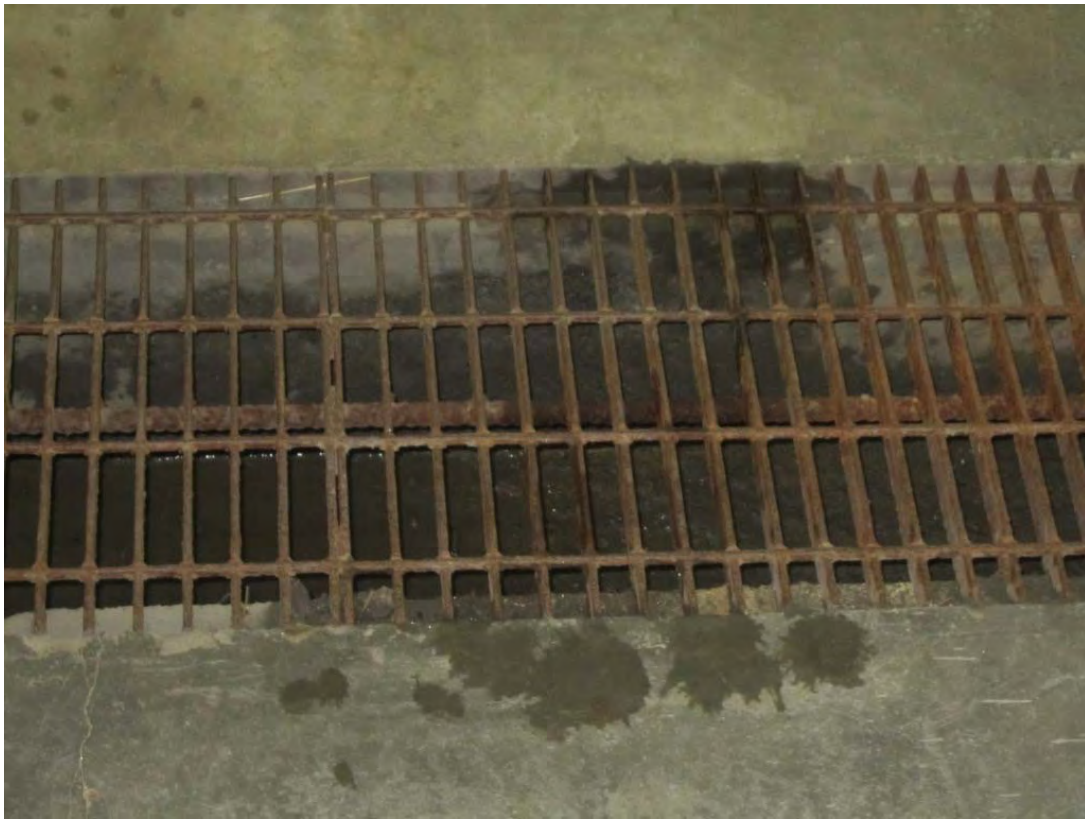
Photograph No. 20: Continuous floor drain grate to nowhere.
