RE: Town of Norwich Pool Dam Reconstruction, Stream Alteration Permit
Application

VERMONT AGENCY OF NATURAL RESOURCES
STREAM ALTERATION INDIVIDUAL PERMIT APPLICATION

NORWICH POOL DAM
 TOWN OF NORWICH VERMONT
 WINDSOR COUNTY

NORWICH POOL DAM REHABILITATION PROJECT

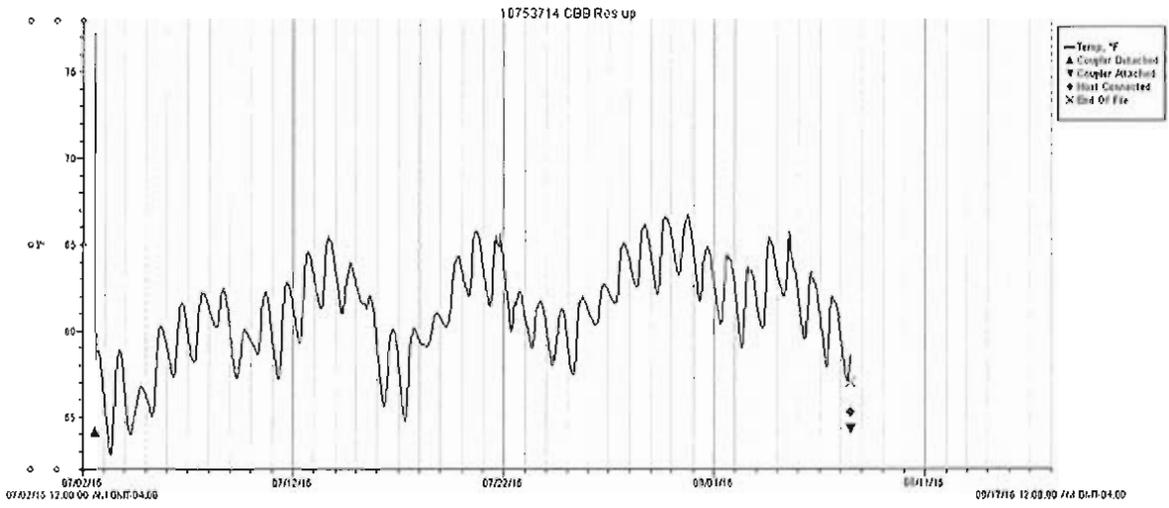
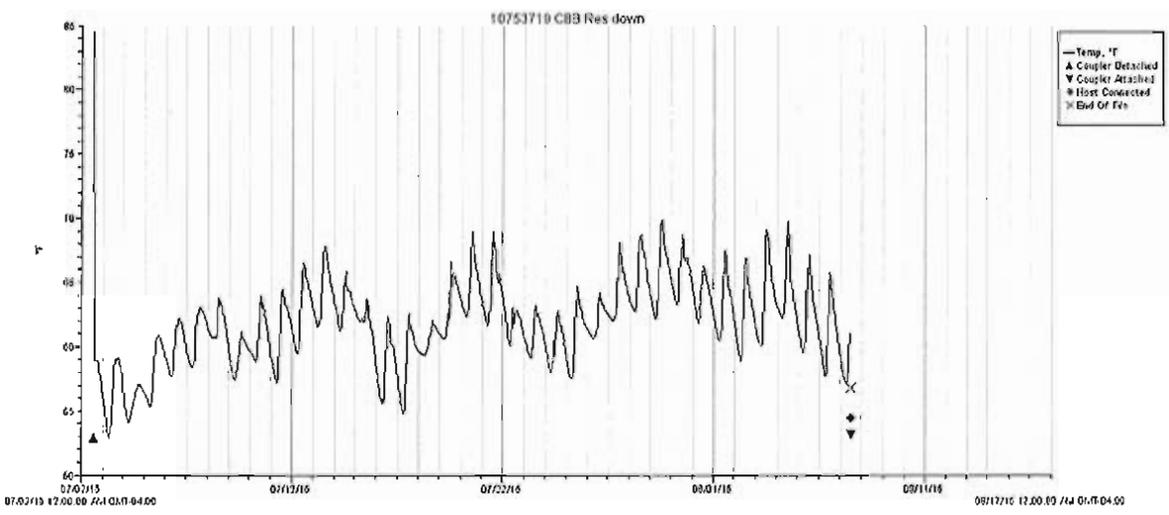
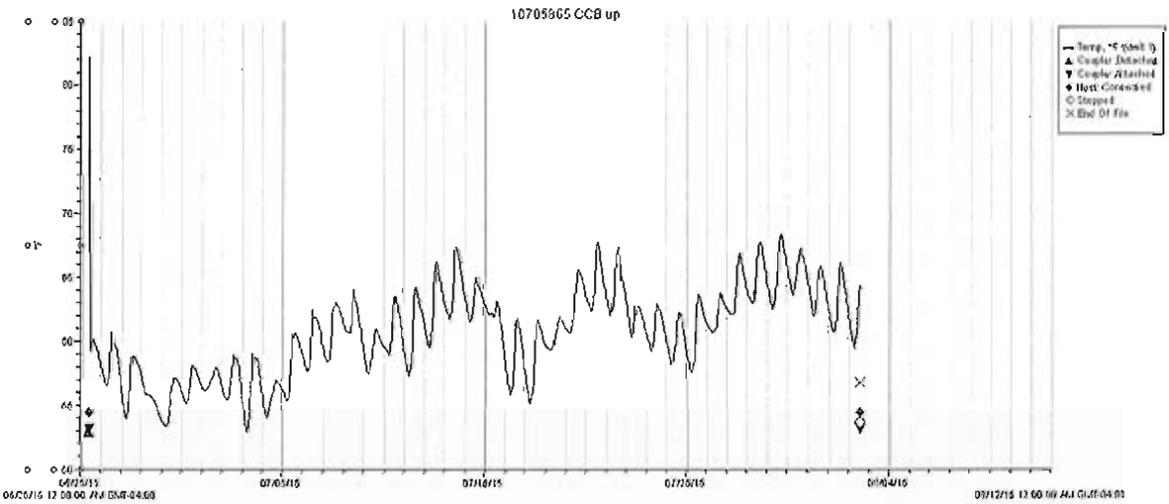
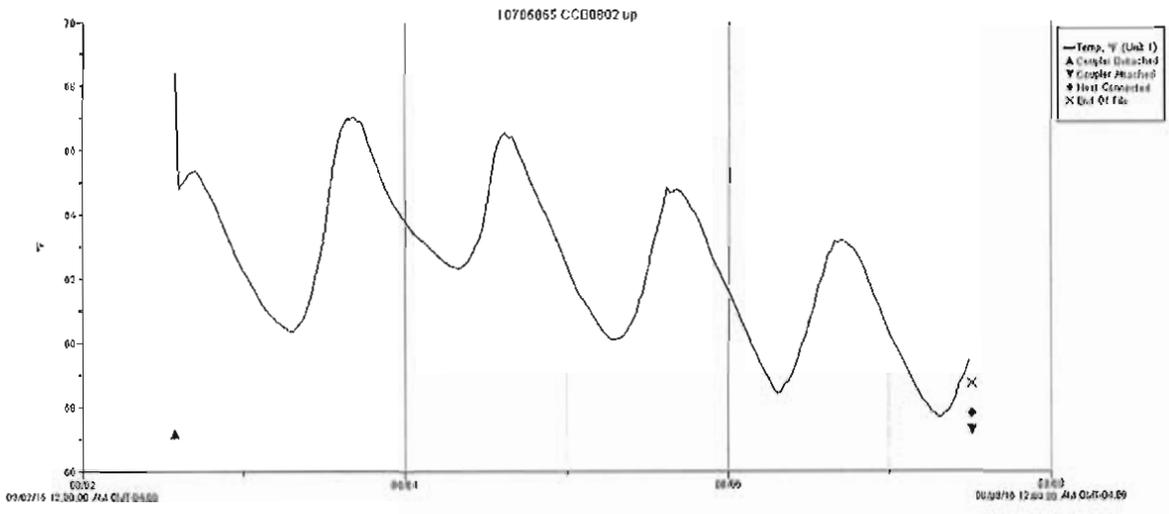
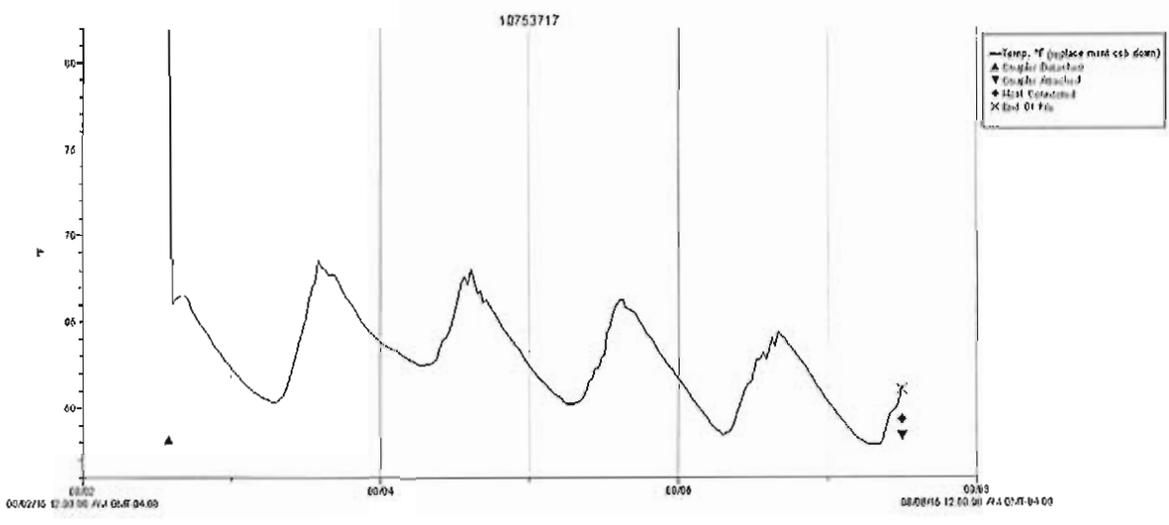
EXHIBIT 2
DAILY TEMPERATURE FLUCTUATIONS
IN CHARLES BROWN BROOK

Currently, an ongoing temperature study has indicated that (1) the temperature of Charles Brown Brook fluctuates diurnally and (2) water temperatures increase as waters travel downstream in 'natural' (no Pool operations) conditions. The diurnal fluctuation monitoring suggests that warming of the waters does occur throughout the Charles Brown Brook during the daytime of sunny days in all stations monitored. However, waters at each of the stations cool off substantially during the evening/night time resulting in temperatures nearly equal to the previous day's temperatures during the late night/early daylight hours. For example, comparison of temperatures at the stations both above and below the proposed Norwich pool site varied by nearly 7 F from 8:30am to 4:30pm (8/3/15; Upstream 60.4 F to 67.0 F; Downstream 60.8 F to 67.7 F, respectively). (See Table in Exhibit 2 appended hereto).

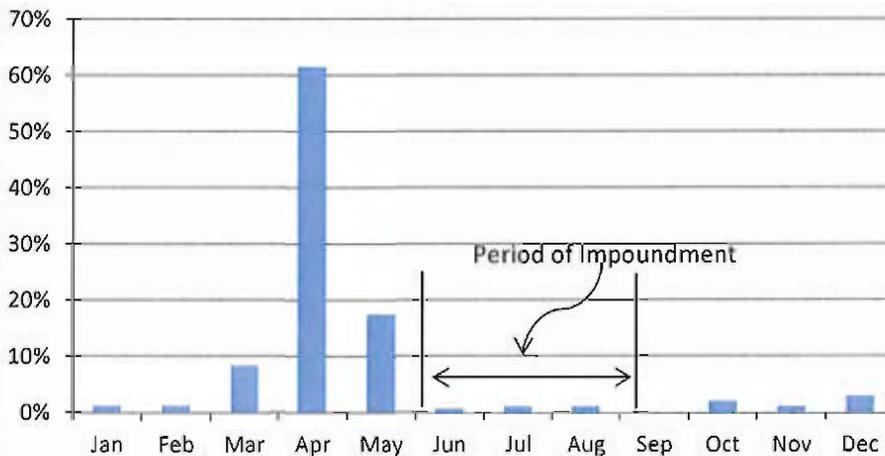
Frequency of Flows ≥ 94 cfs by Month

Total Recorded Observations:	20,826	
Total Observations ≥ 94 cfs:	229	
Total Observations ≥ 94 cfs Falling in June - August:	8	← 3.5% of flows ≥ 94 cfs occurred June-Aug

8/28/2011	267	cfs
6/30/1973	242	cfs
6/27/1998	130	cfs
7/1/1973	120	cfs
8/7/1990	114	cfs
8/10/1976	112	cfs
7/2/1973	106	cfs
7/3/1973	98	cfs

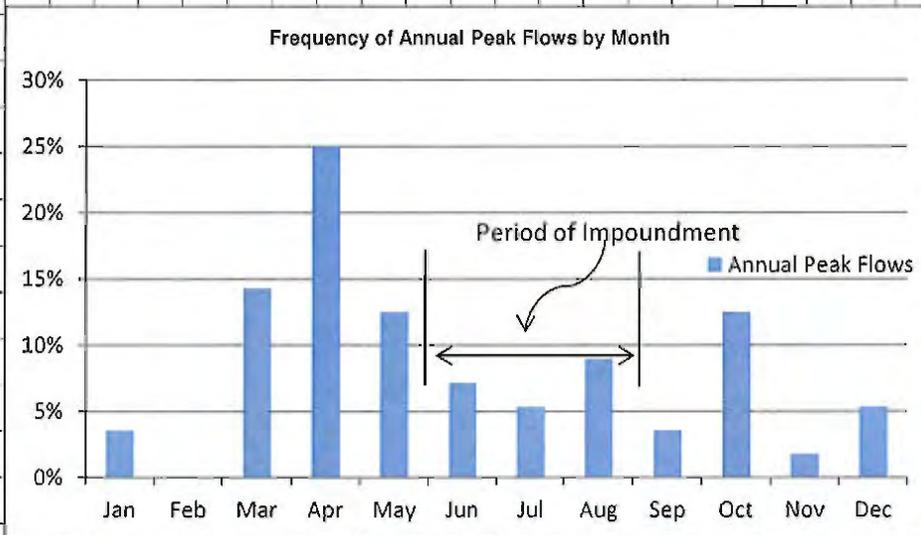
The Monthly occurrence of annual peak flows at the East Orange gage are also investigated

Total Recorded Peak Annual Observations:	56		
Total Peak Observations Falling in Sept - April:	44	←	78.6% Occurred Sept - April
Total Peak Observations Falling in June - August:	12	←	21.4% Occurred June - Aug

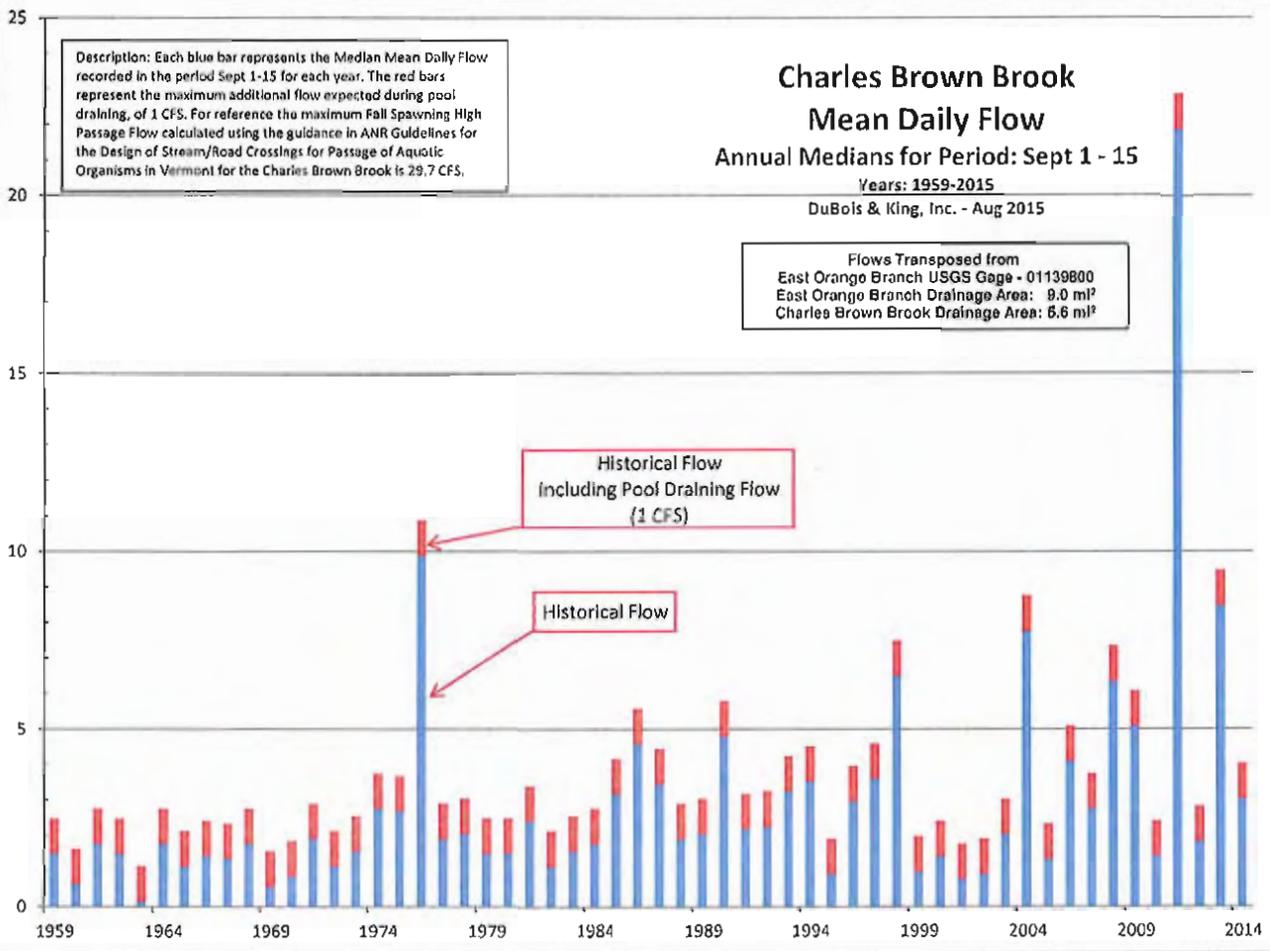
Charles Brown Brook Mean Daily Flow Annual Medians for Period: Sept 1 - 15

Description: Each blue bar represents the Median Mean Daily Flow recorded in the period Sept 1-15 for each year. The red bars represent the maximum additional flow expected during pool draining, of 1 CFS. For reference the maximum Fall Spawning High Passage Flow calculated using the guidance in ANR Guidelines for the Design of Stream/Road Crossings for Passage of Aquatic Organisms in Vermont for the Charles Brown Brook is 29.7 CFS.

Flows Transposed from
East Orange Branch USGS Gage - 01139800
East Orange Branch Drainage Area: 9.0 mi²
Charles Brown Brook Drainage Area: 5.6 mi²

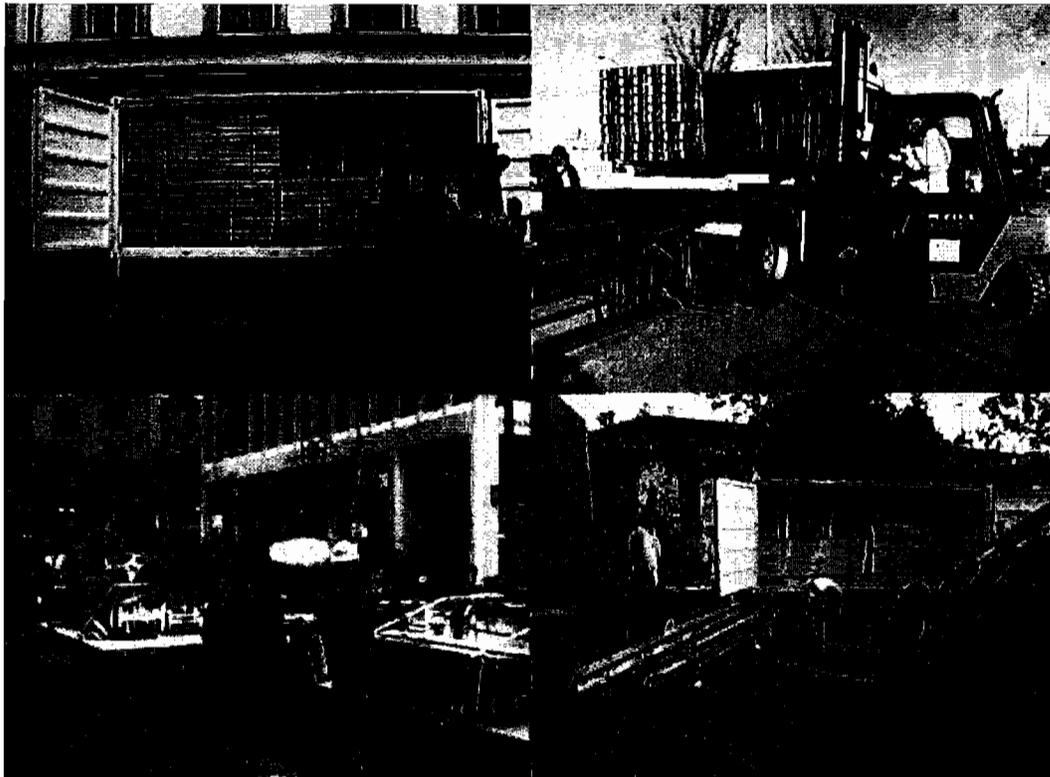
Transporting The Posts and Beams:

Transport the posts to the alignment on a forklift. Take the posts first. Doing so will let you have two or three workers immediately begin erecting the posts. Then transport the beams and the rest of the crew can place the beams and secure the hold downs.

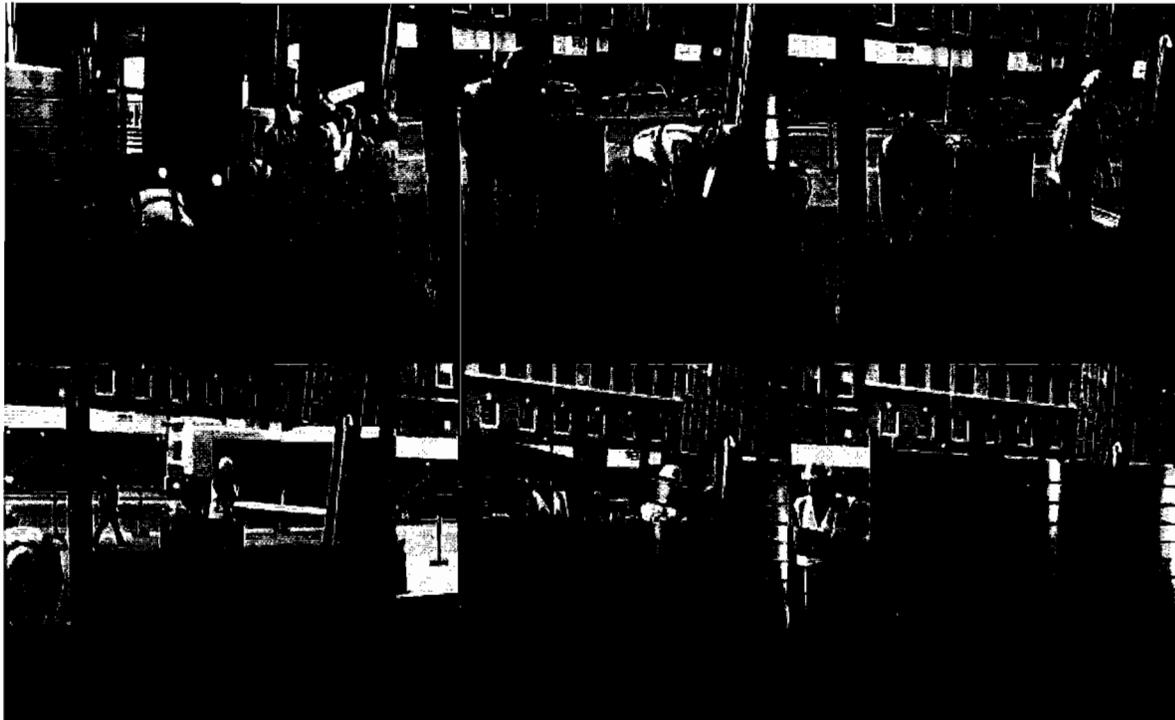
The first log to go in is the bottom log and must have the thick foam rubber bottom seal in place, inserted between the rubber seals on the log. Then, position the next logs, rubber edge seal down in between the post openings and side channels until you have them up to the required height.

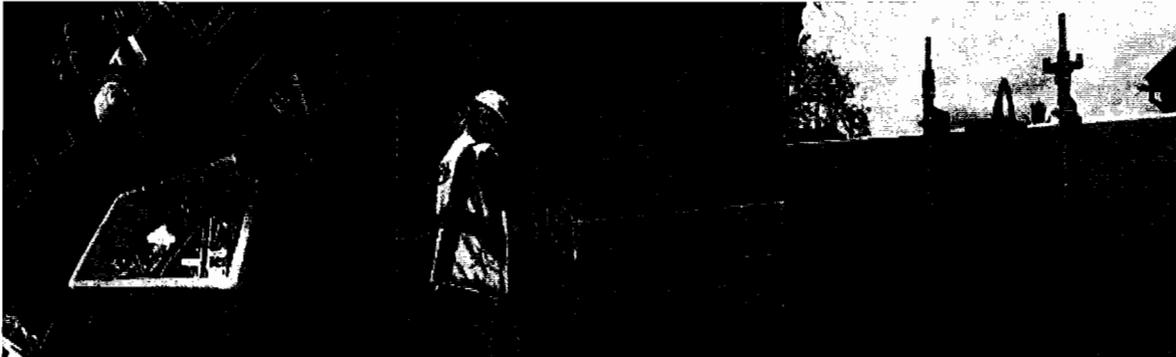
Securing The Hold-Down Clamps:

When all the beams in a section have been properly placed, the hold down clamp can be attached to the post on the pins located in the top of the side channel. Spin the nut down and turn to tighten. A few turns of the hold-down clamp wing nut will provide adequate down pressure to firmly hold the beams in place and provide a watertight seal. This step should be repeated as you go down the length of the wall, section by section. And this is the last step in erecting the EKO Removable Barrier Flood Wall.
