CAPITAL FACILITIES PROJECT BINDER

Town of Norwich Police, Fire and Public Works Facilities

The following report was prepared for the Town of Norwich Vermont by a team of professionals assembled by Mink Brook Management, LLC with the intent to identify the code and functional deficiencies within the three Town buildings housing the Department of Public Works, the Town Police Department, and the Town Fire Department. We have included in this report budget figures showing estimated costs to bring these buildings up to code and meet the functional standards typical for each department if these buildings were new today. The standards were identified by the team of professionals who have designed and constructed complexes in each of the categories discussed. We understand that each of these buildings is in need of maintenance work at this time and there are line items in the budget showing some of the maintenance repairs identified during our inspections. It is not the intent of this report to try to sway the Town of Norwich to perform the remedial work as described as it may not be in the best interest of the Town to do so. It is the intent of the report to inform the Town of Norwich

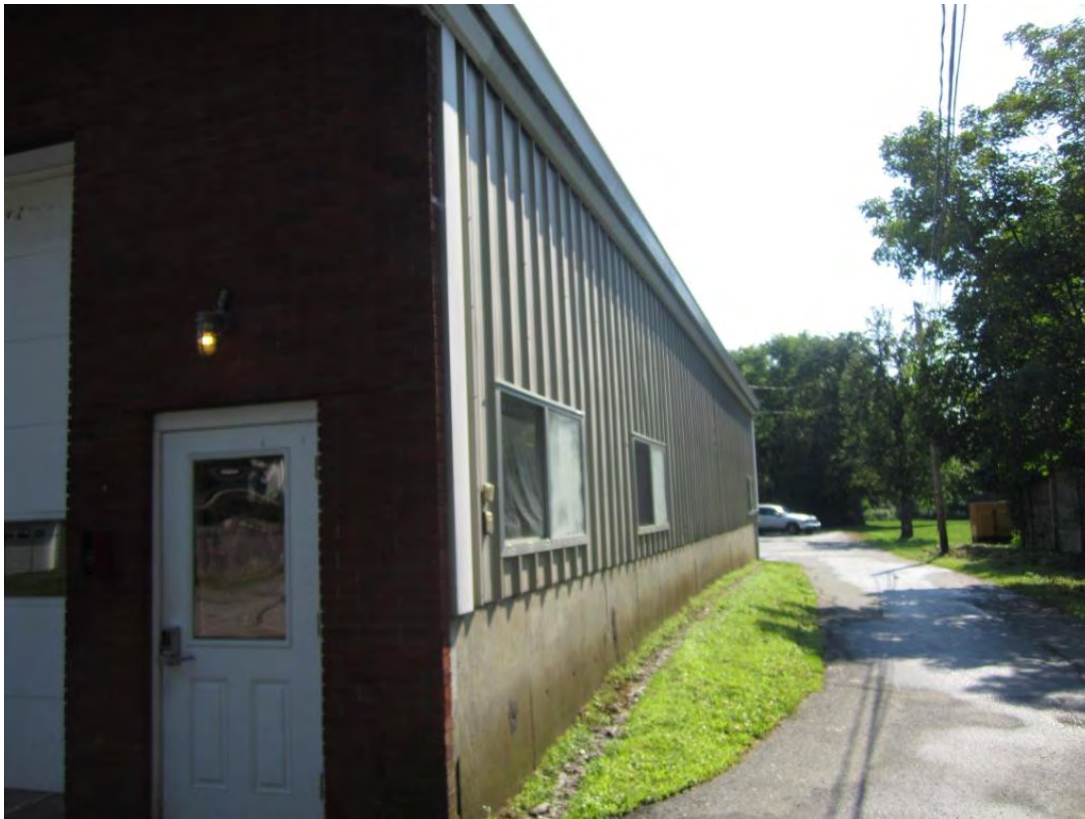
Photograph No. 1: Exterior side of the building looking toward Police station.

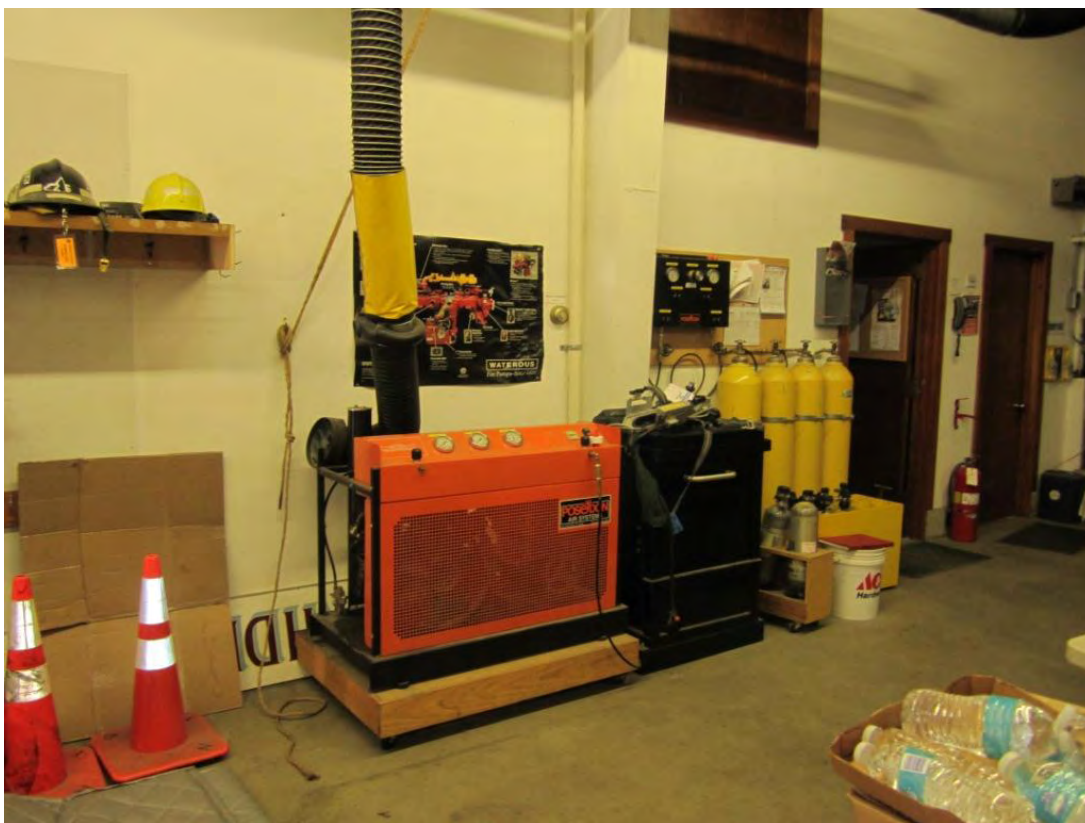
Photograph No. 3: More open storage and equipment.

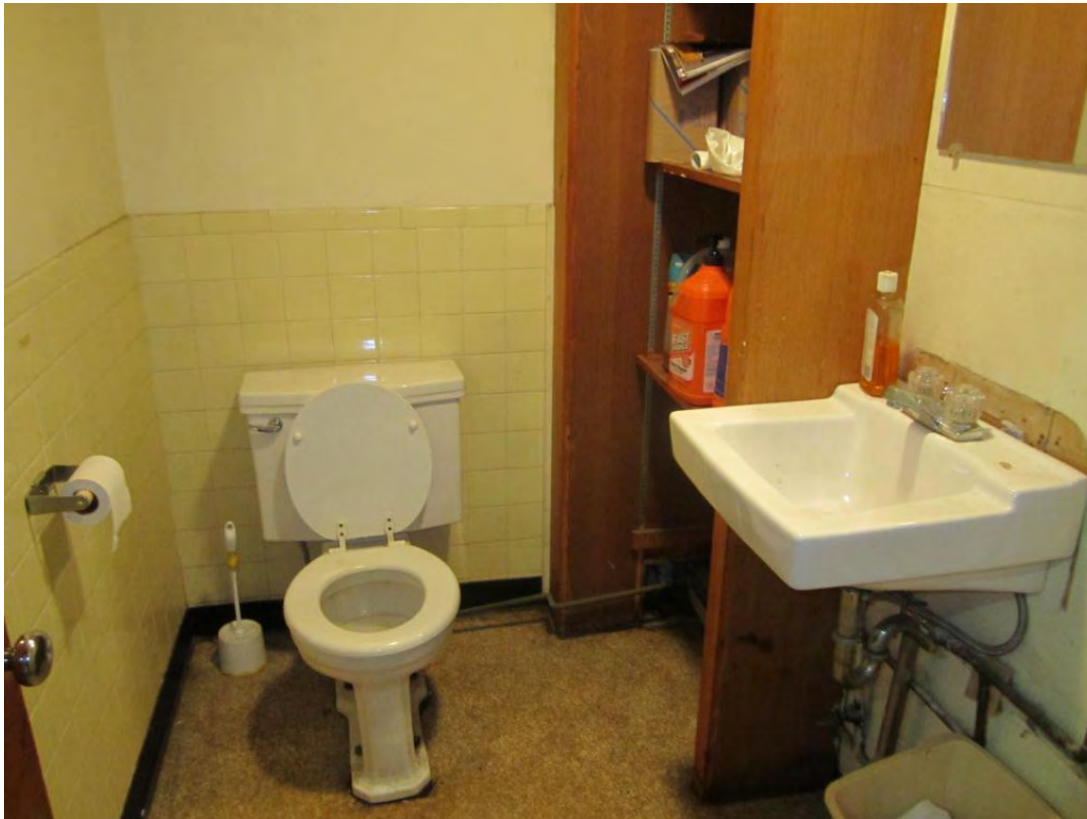
Photograph No. 5: More bathroom.

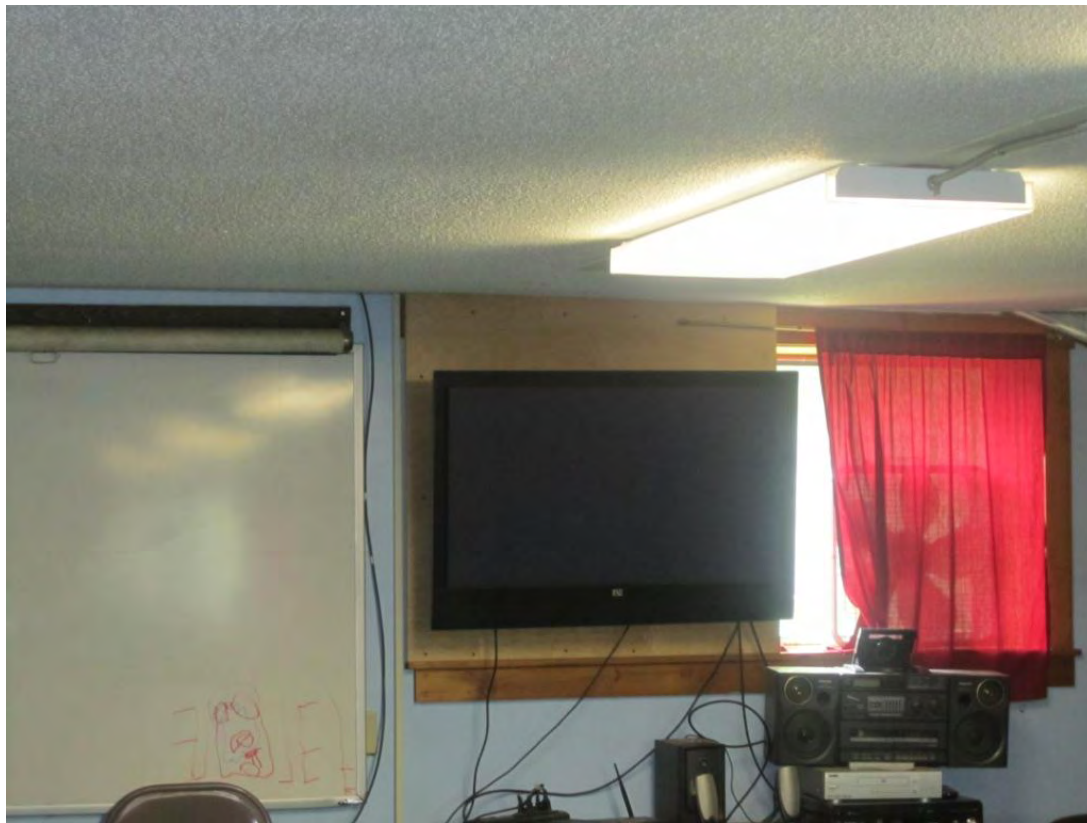
Photograph No. 8: Training room exterior wall with window.

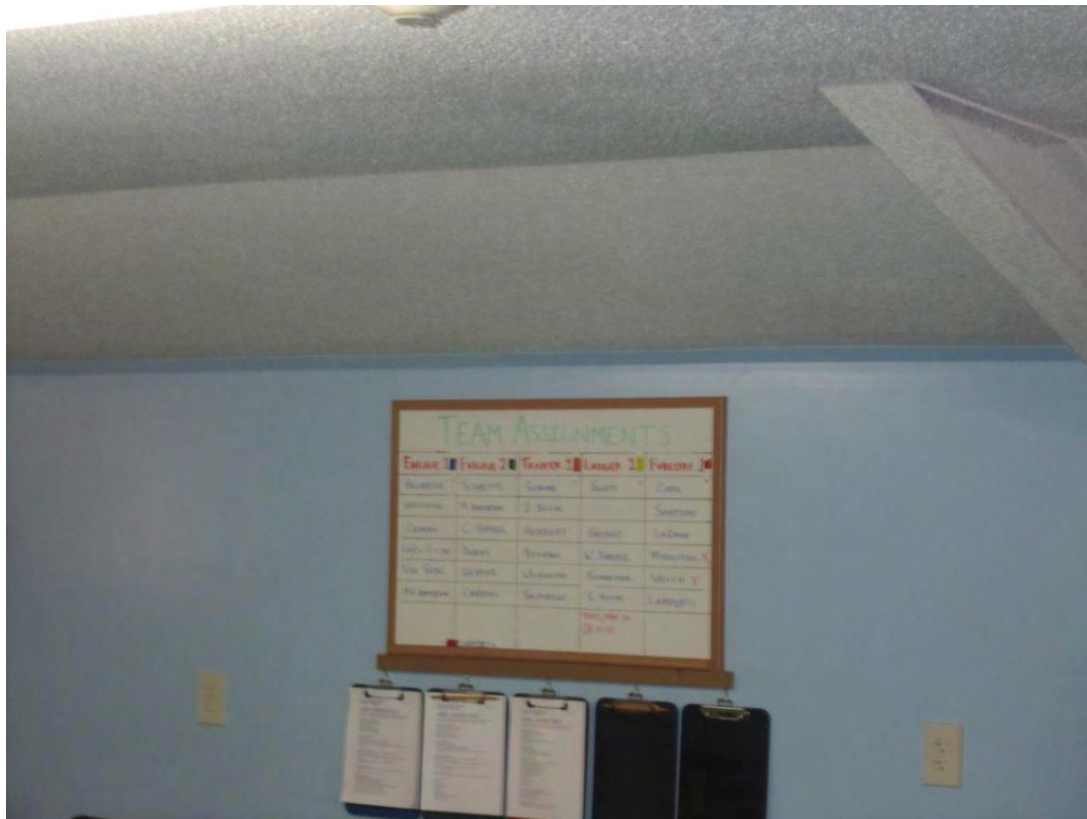
Photograph No. 9: Training room continued.

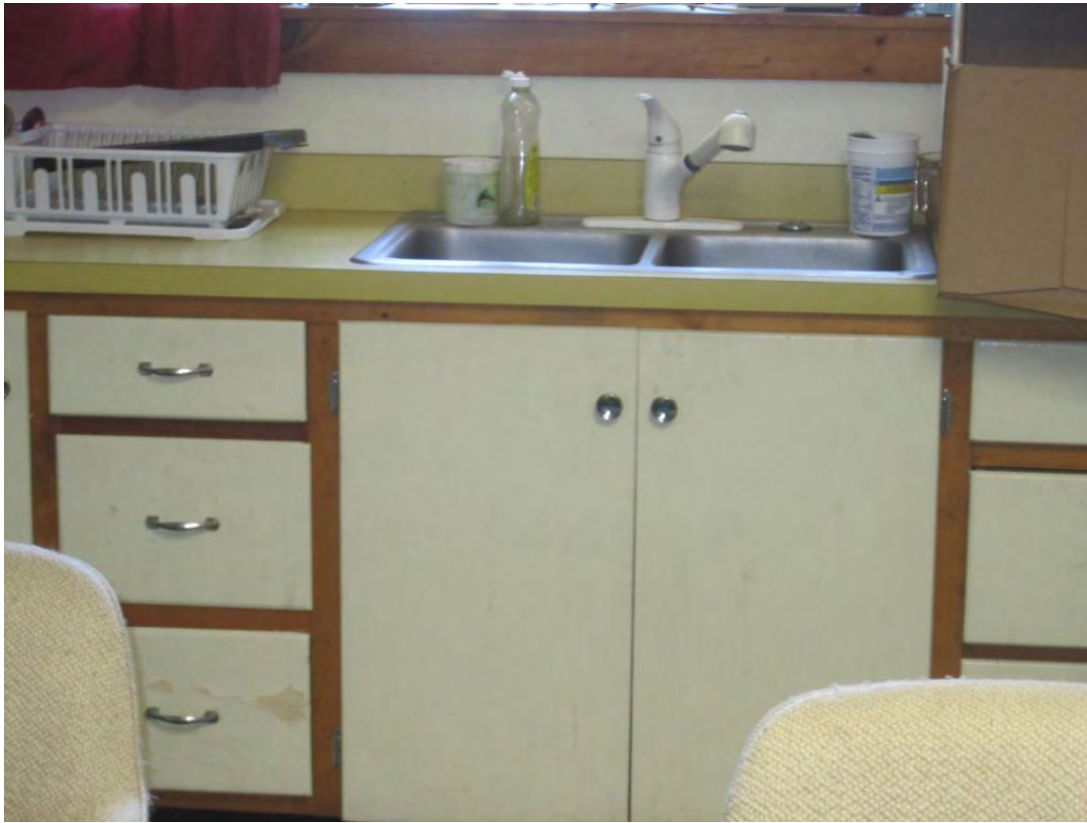
Photograph No. 10: Kitchen.

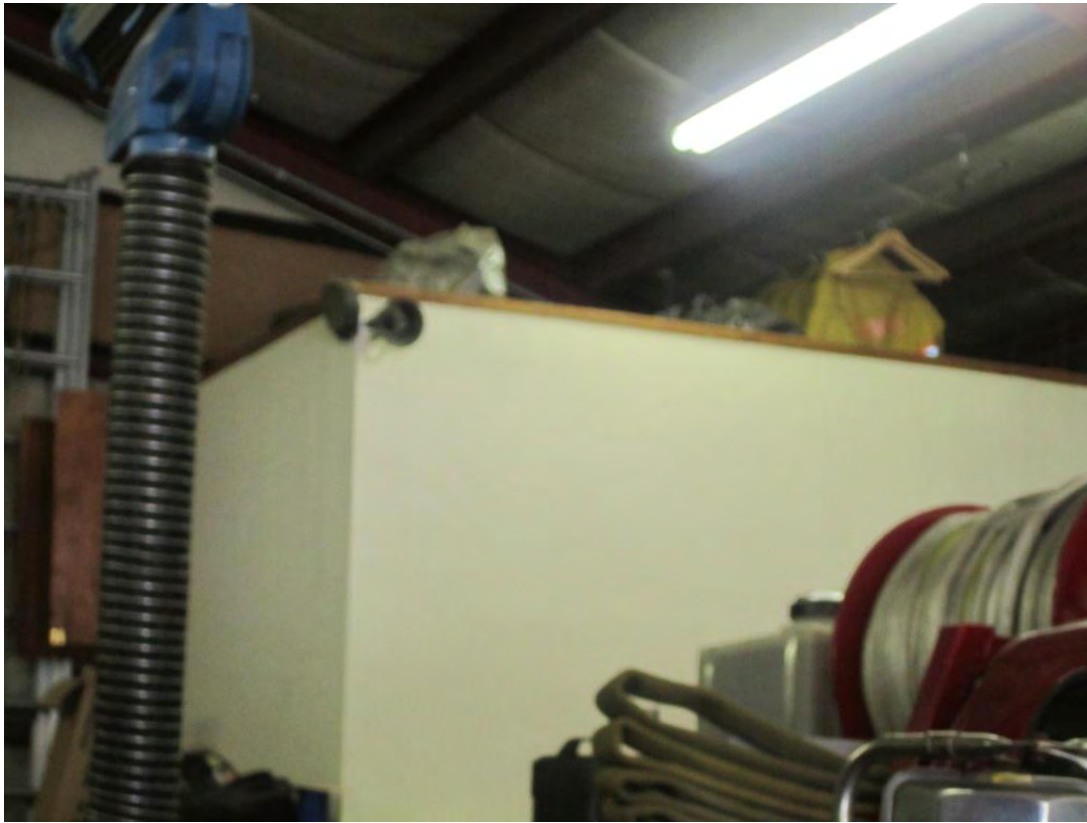
Photograph No. 12: Exhaust extraction hose system and open storage beyond.

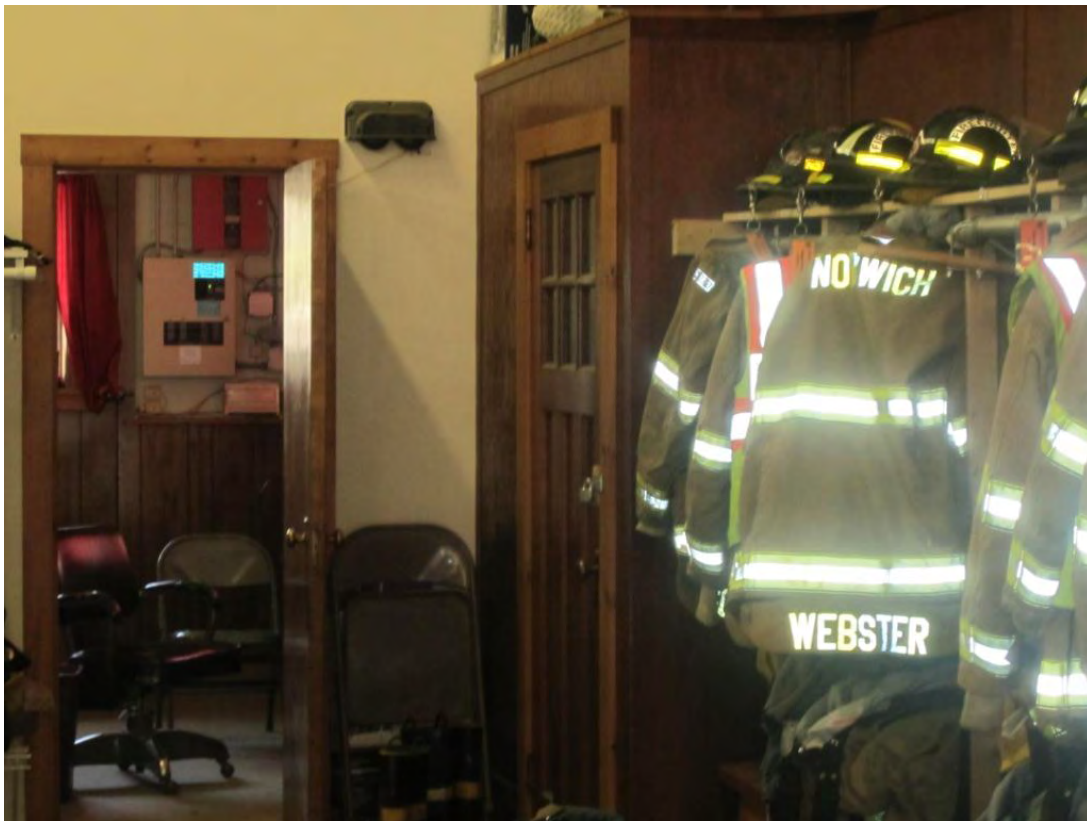
Photograph No. 13: Open storage and electrical, telephone office.

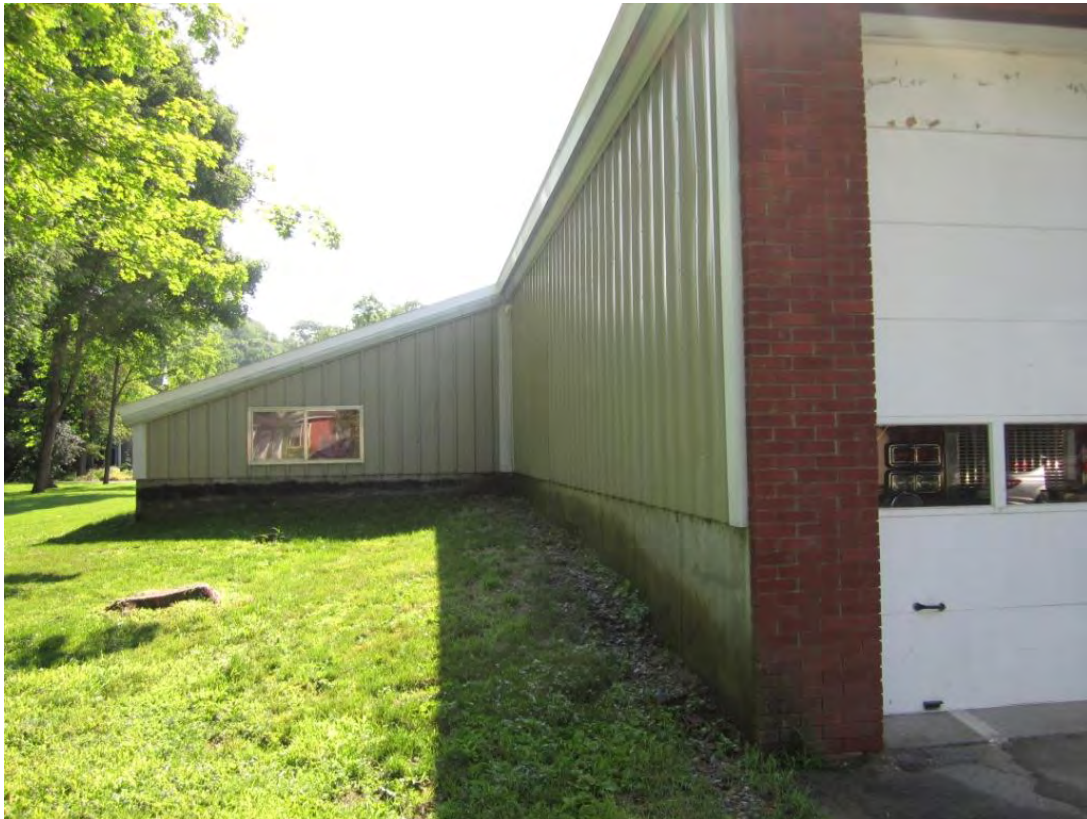
Photograph No. 15: Exterior of the building looking toward the police station on the other side.

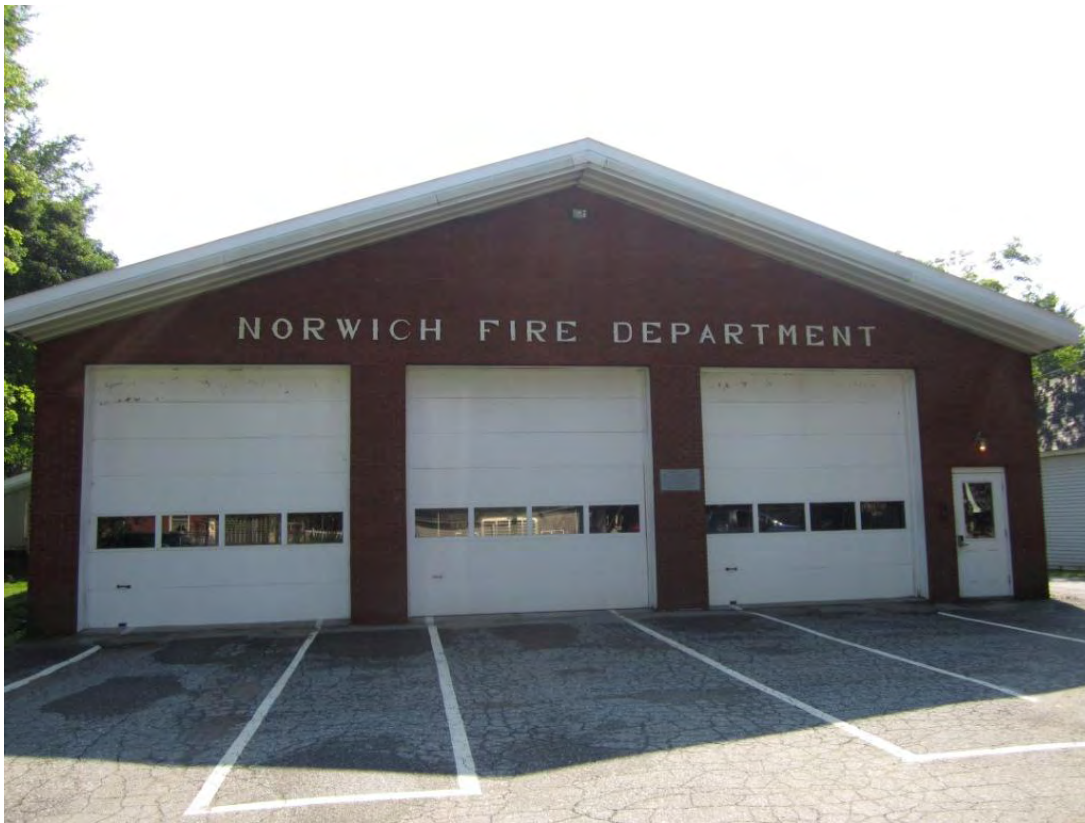
Photograph No. 16: Front of the building showing OH Doors for equipment and front entrance door.

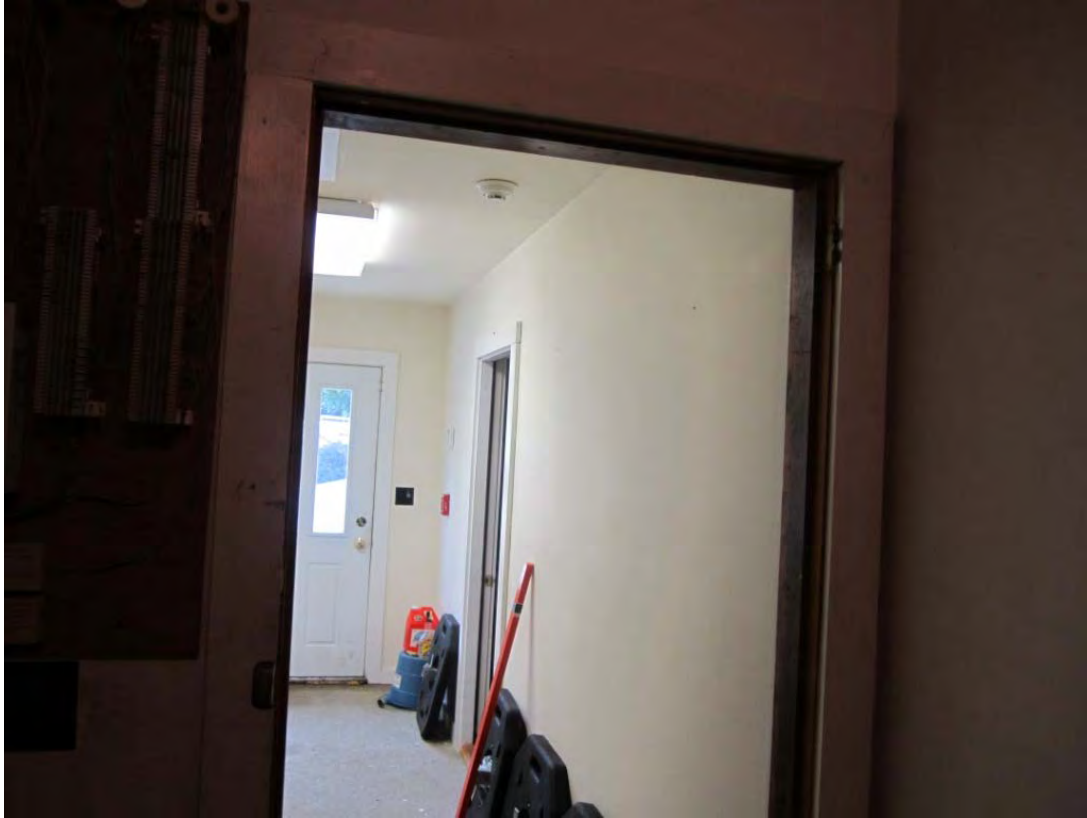
Photograph No. 1: Exit hallway to garage entrance.

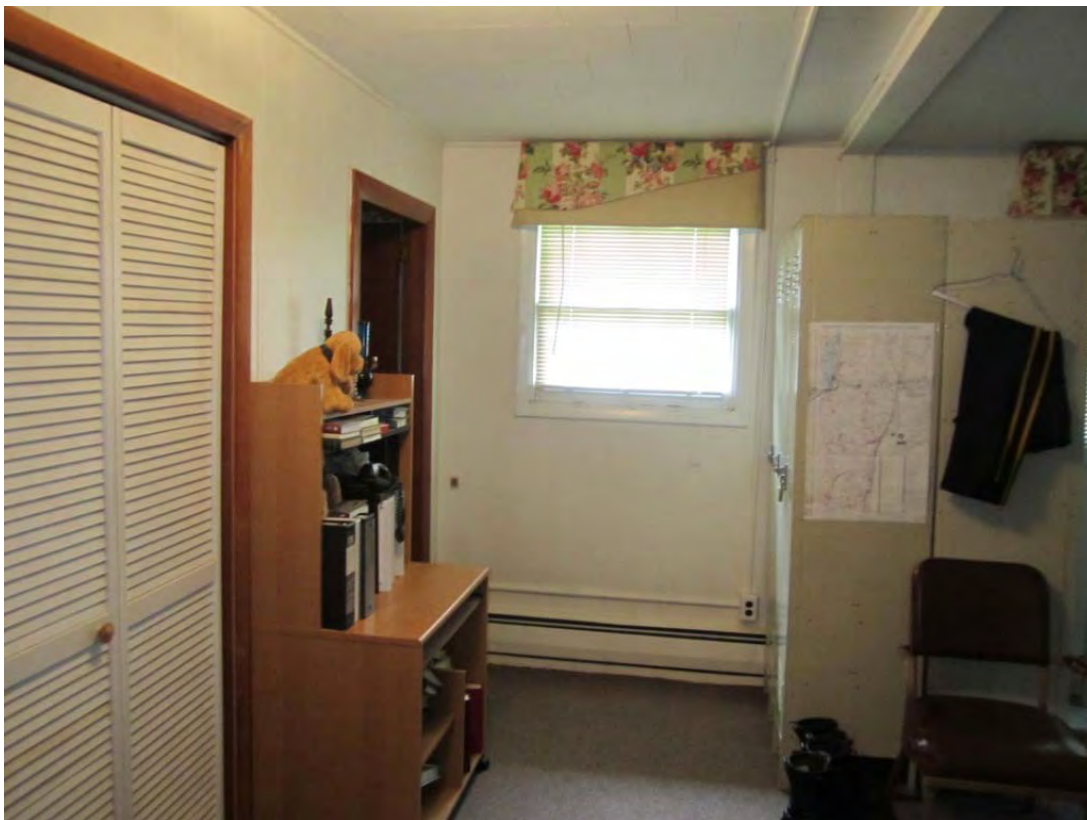
Photograph No. 2: Partial locker room.

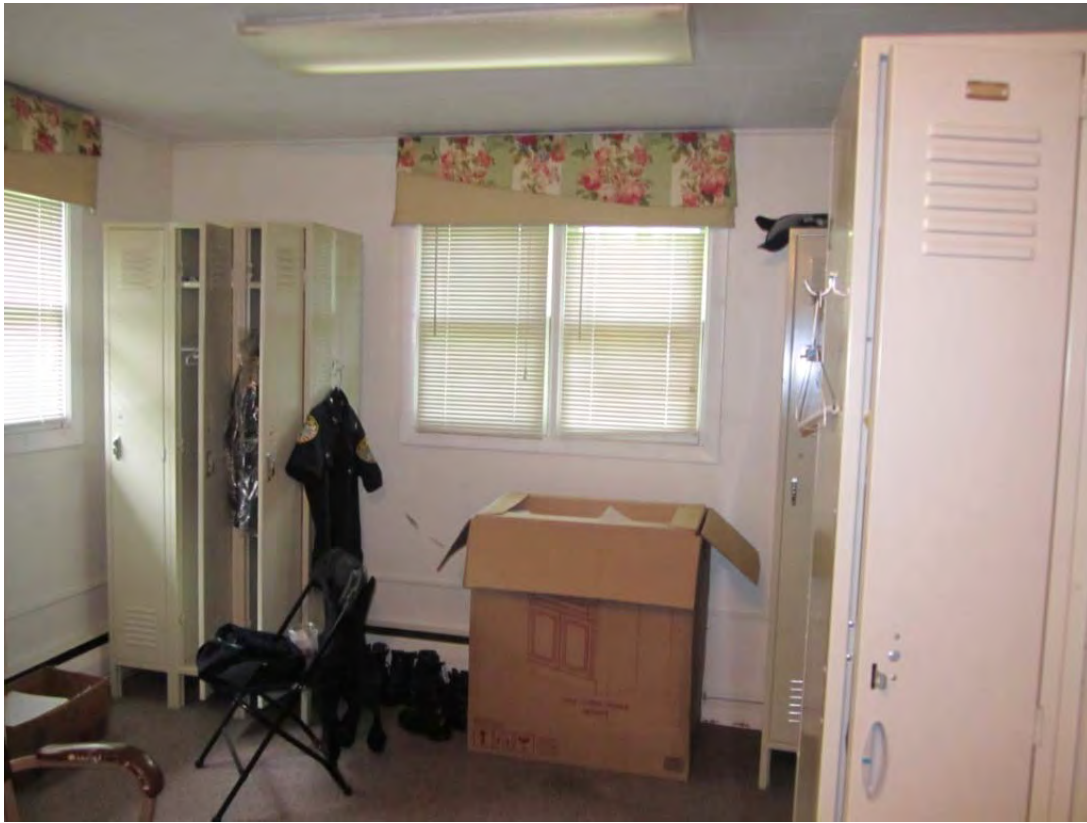
Photograph No. 3: Partial locker room.

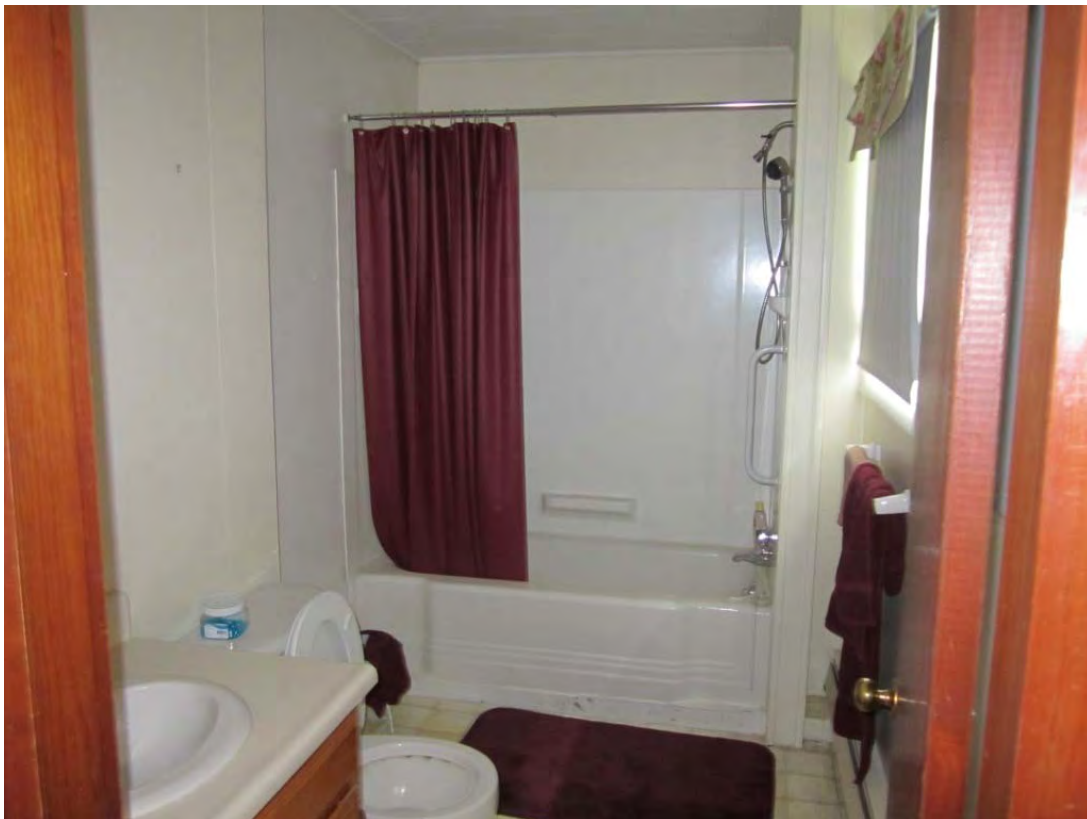
Photograph No. 4: Bathroom and shower off locker room.

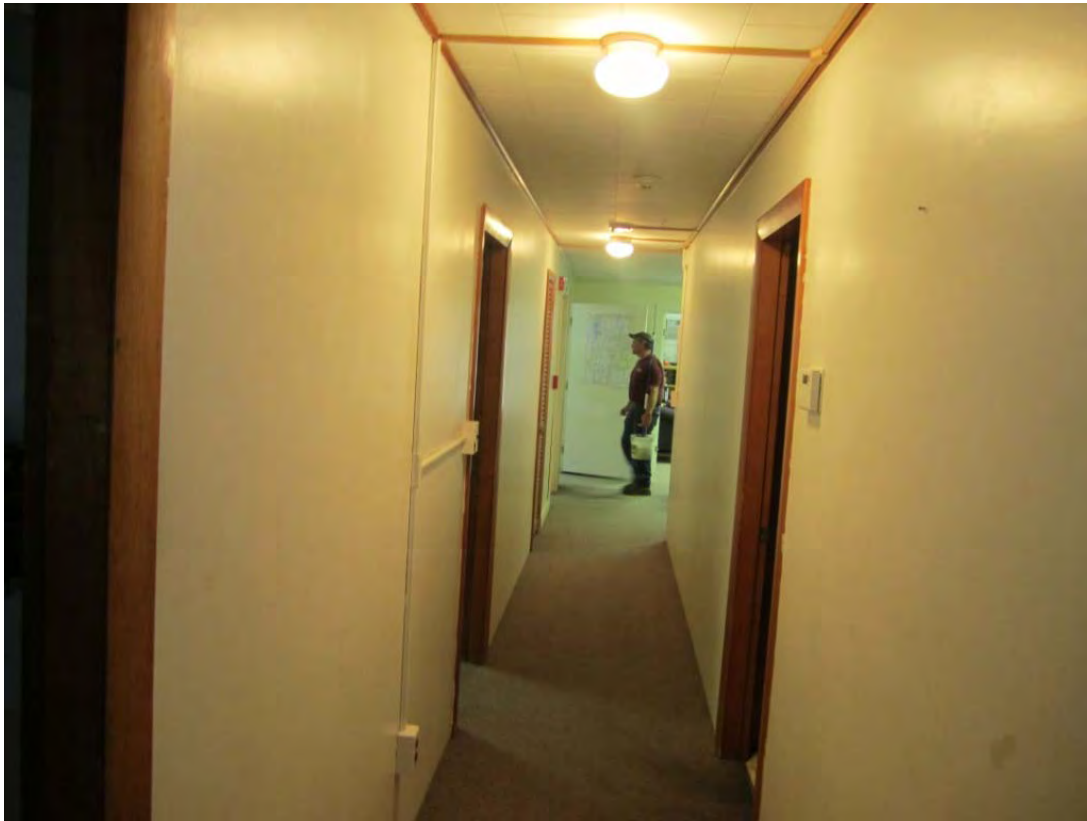
Photograph No. 5: Narrow corridor from Fire Chief office looking toward conference room and front entrance.

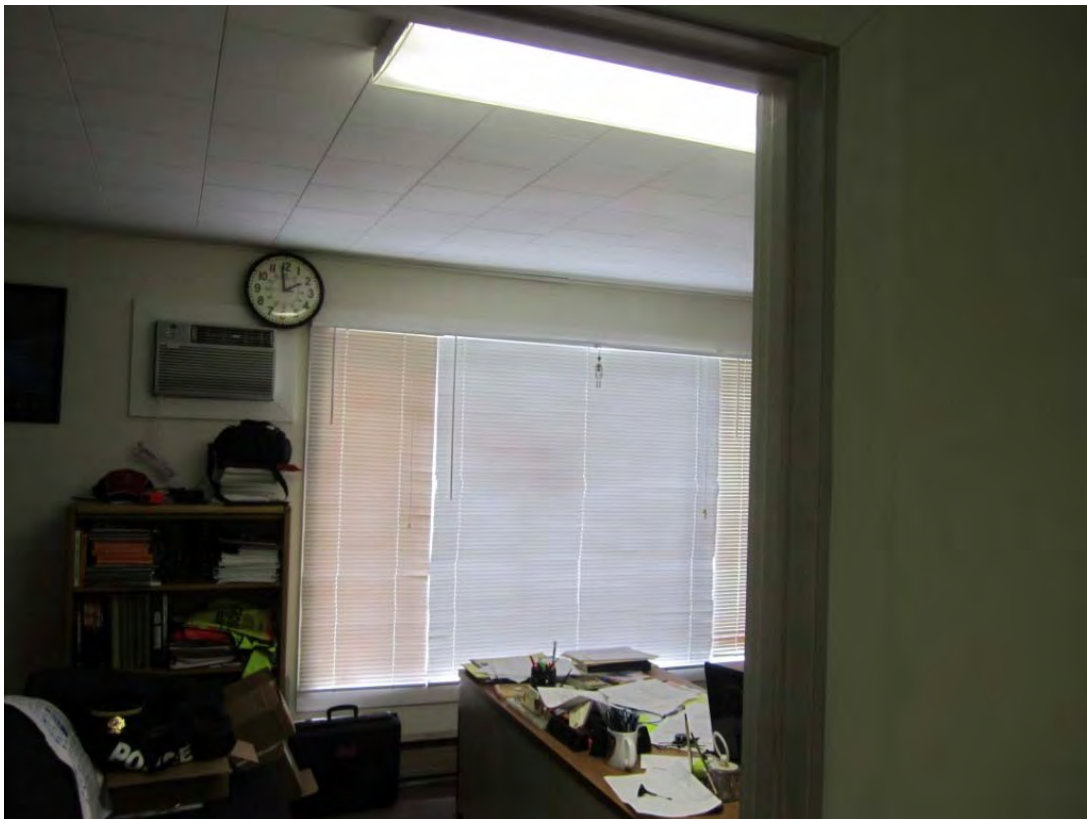
Photograph No. 8: Police Chief office.

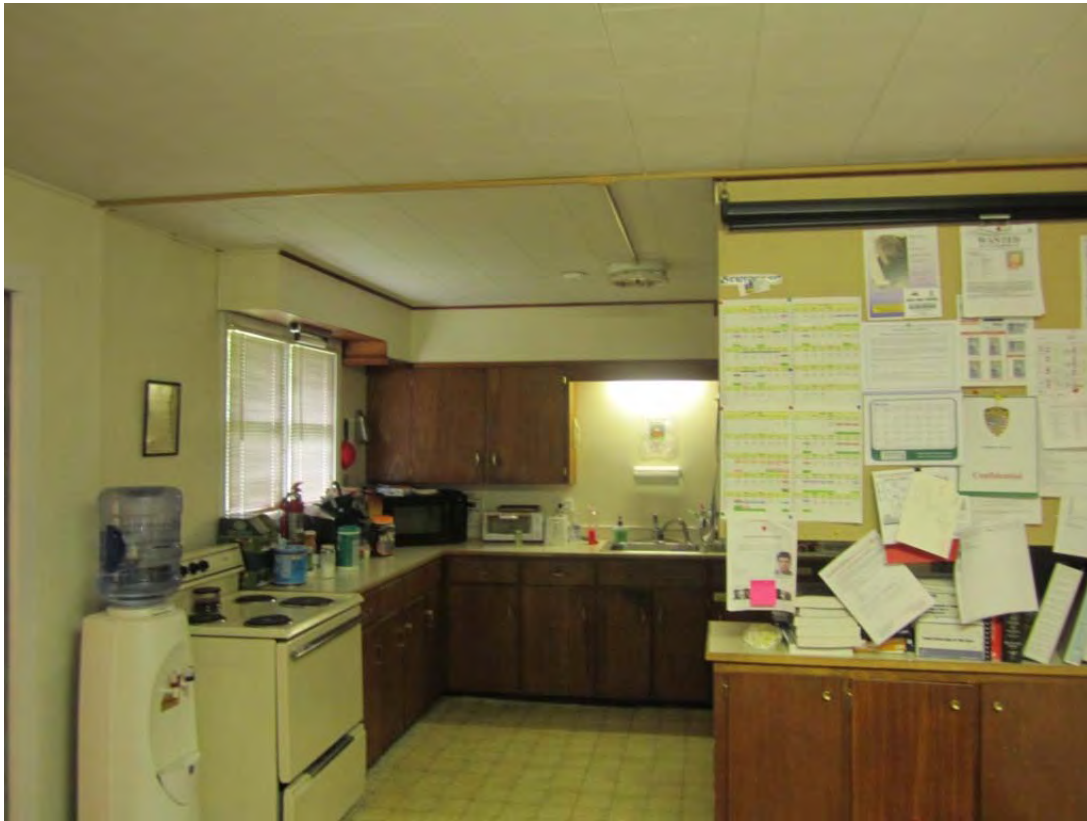
Photograph No. 9: Existing kitchen.

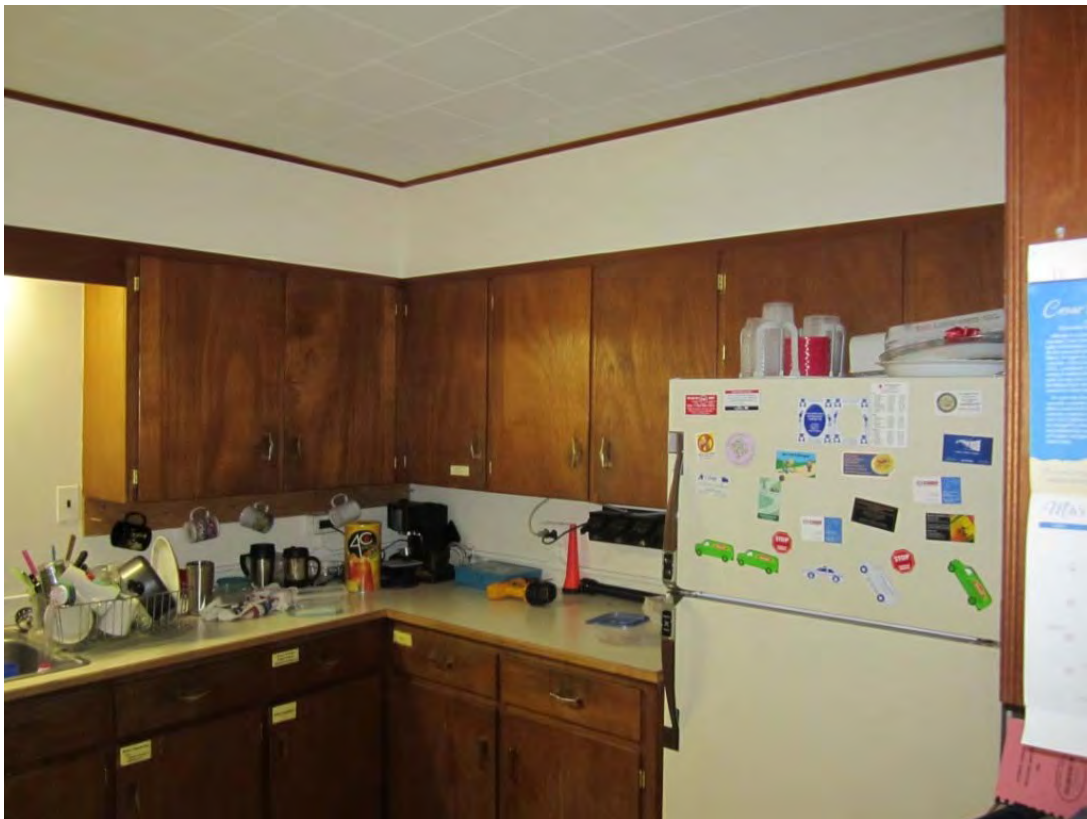
Photograph No. 10: Existing kitchen.

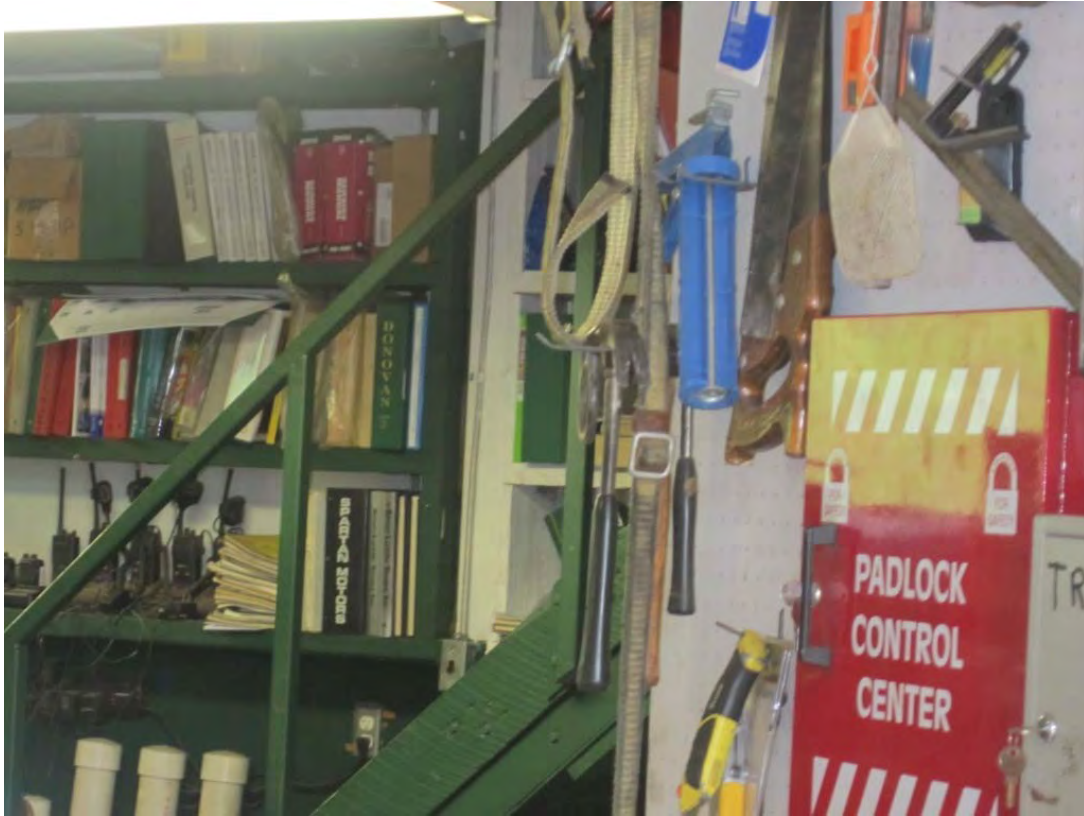
Photograph No. 1: Stairway going to 2nd level of DPW that needs mid-rail at the least.

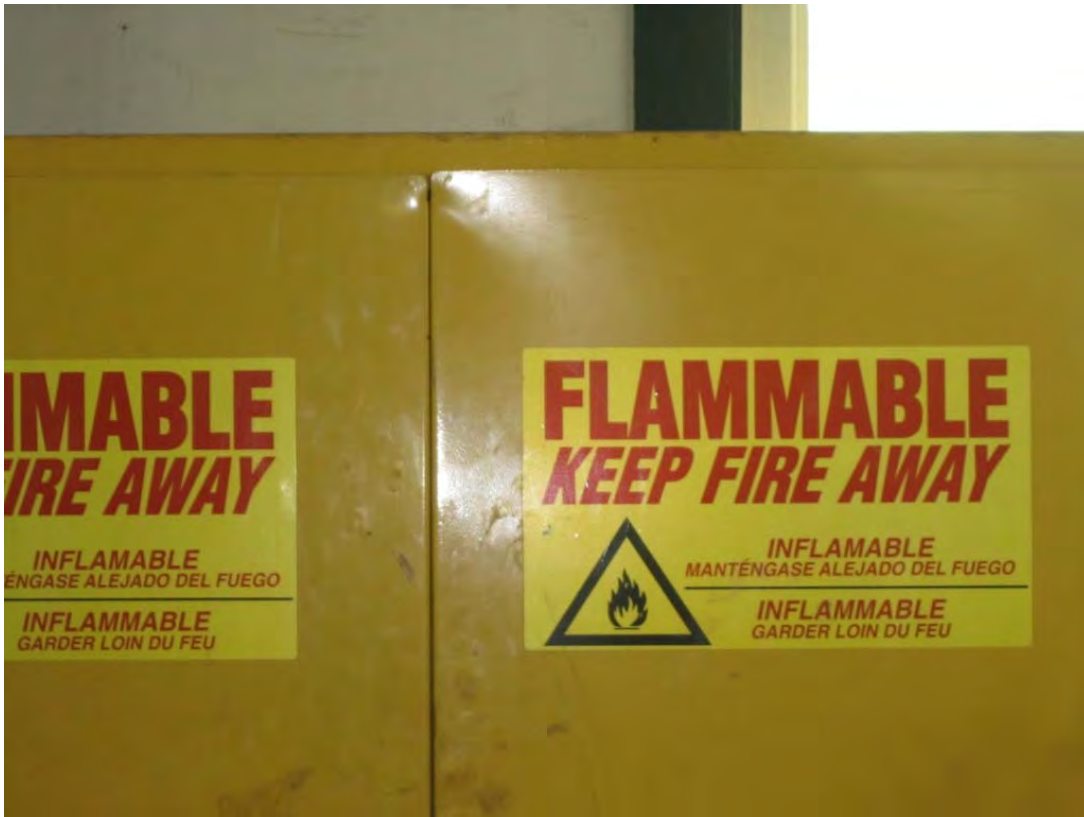
Photograph No. 6: Flammable cabinets, several throughout the shop.

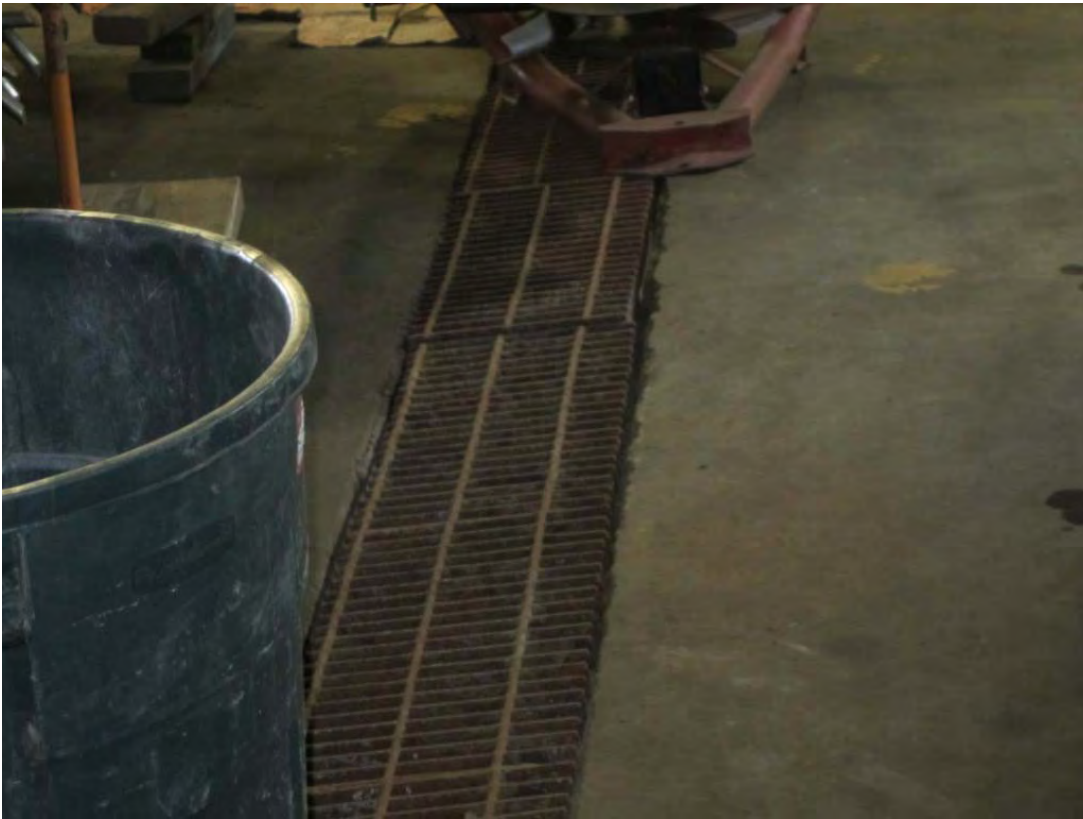
Photograph No. 7: Continuous floor grate for floor drain.

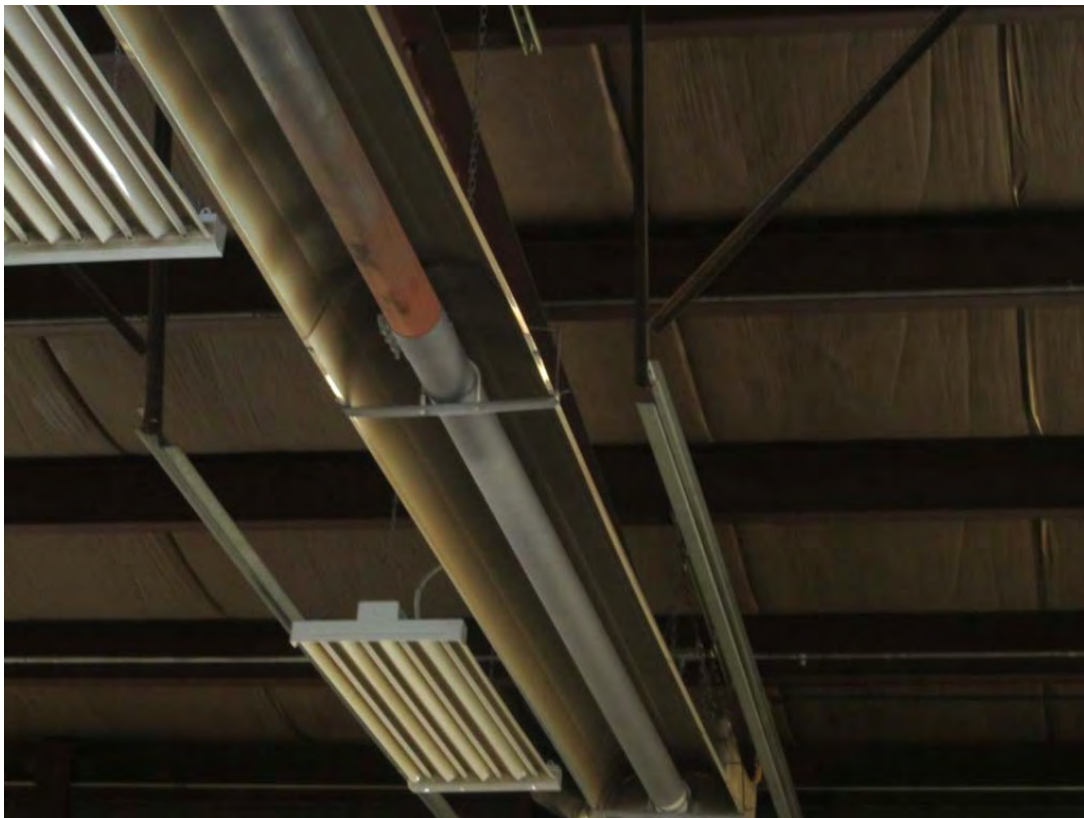
Photograph No. 10: Heat piping for convection style heat system.

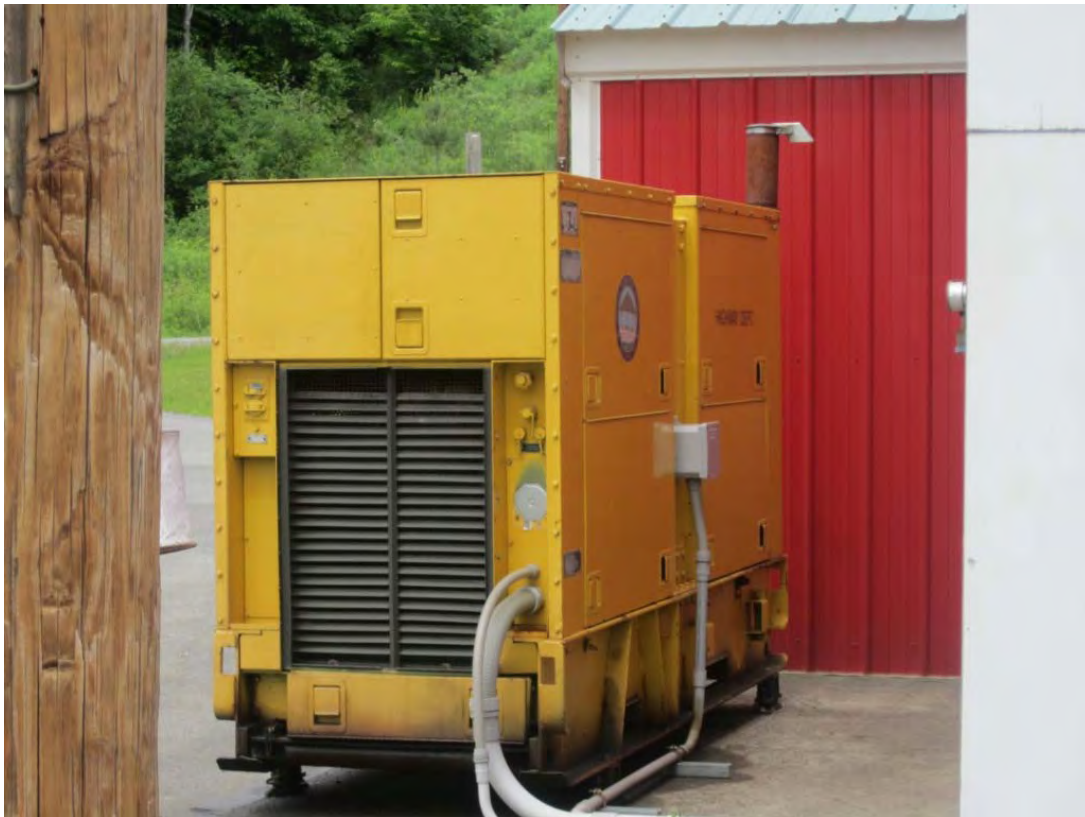
Photograph No. 12: Generator

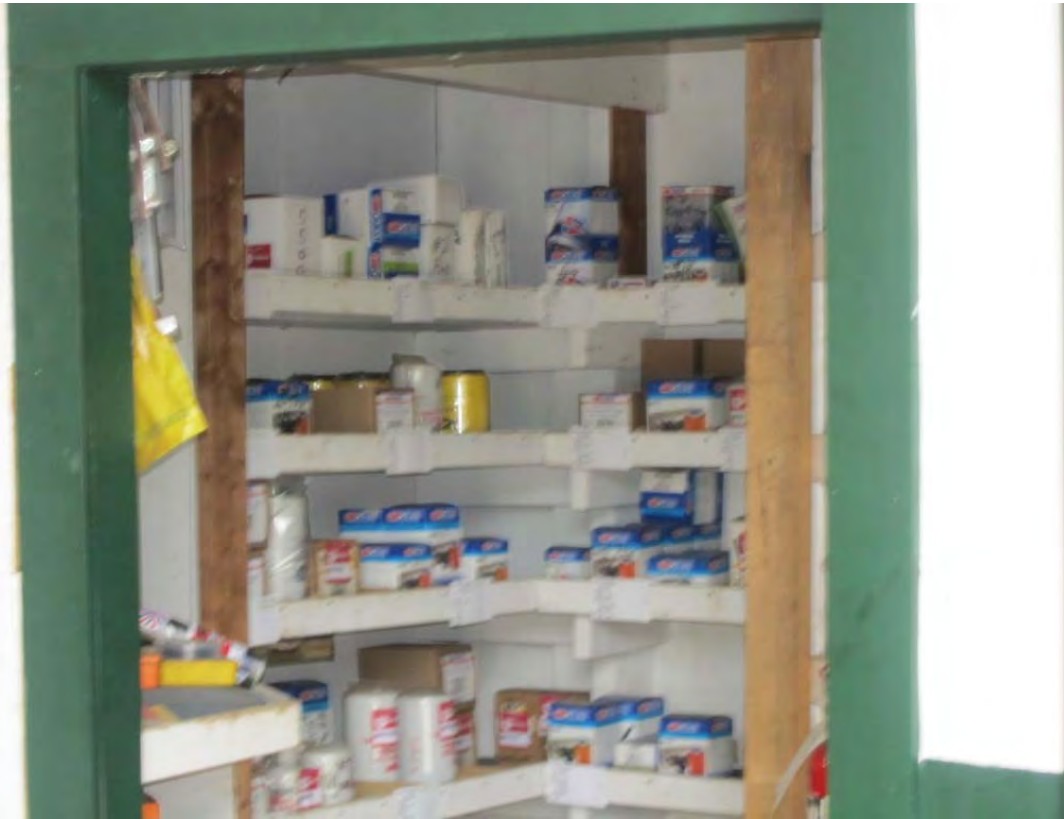
Photograph No. 13: Small open storage room.

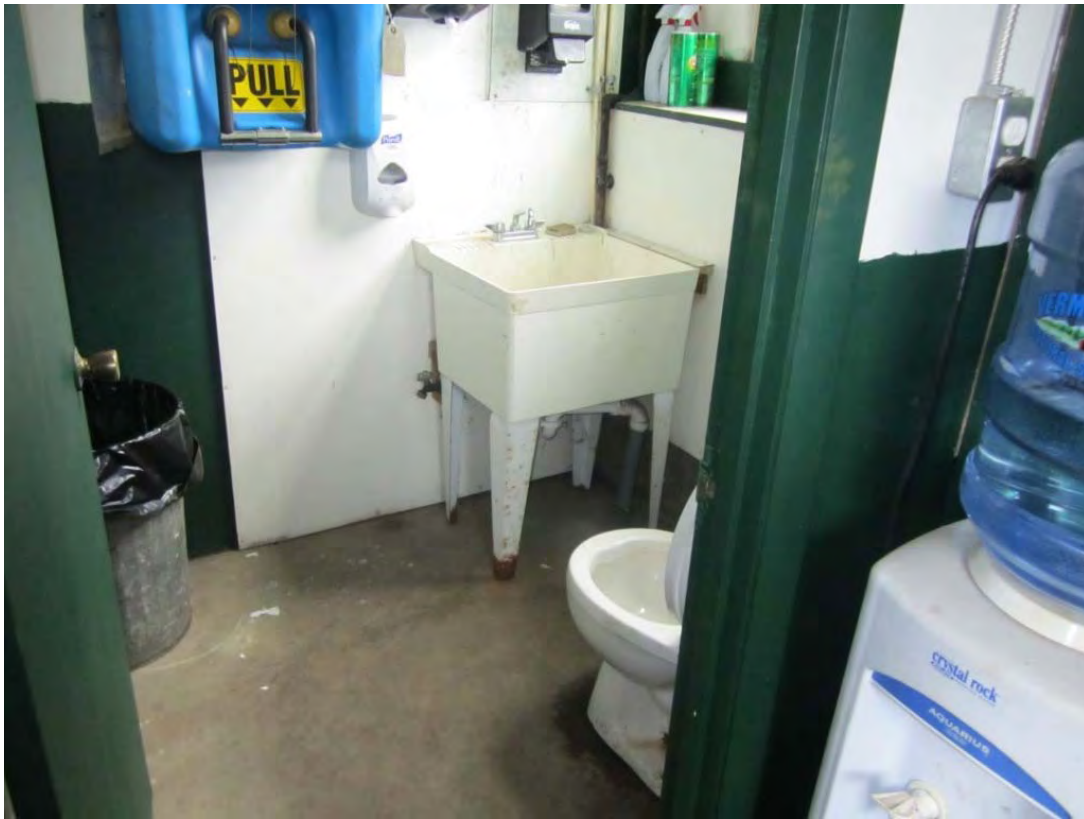
Photograph No. 14: Existing bathroom and eyewash station.
