CAPITAL FACILITIES PROJECT BINDER

Town of Norwich Police, Fire and Public Works Facilities

The following report was prepared for the Town of Norwich Vermont by a team of professionals assembled by Mink Brook Management, LLC with the intent to identify the code and functional deficiencies within the three Town buildings housing the Department of Public Works, the Town Police Department, and the Town Fire Department. We have included in this report budget figures showing estimated costs to bring these buildings up to code and meet the functional standards typical for each department if these buildings were new today. The standards were identified by the team of professionals who have designed and constructed complexes in each of the categories discussed. We understand that each of these buildings is in need of maintenance work at this time and there are line items in the budget showing some of the maintenance repairs identified during our inspections. It is not the intent of this report to try to sway the Town of Norwich to perform the remedial work as described as it may not be in the best interest of the Town to do so. It is the intent of the report to inform the Town of Norwich

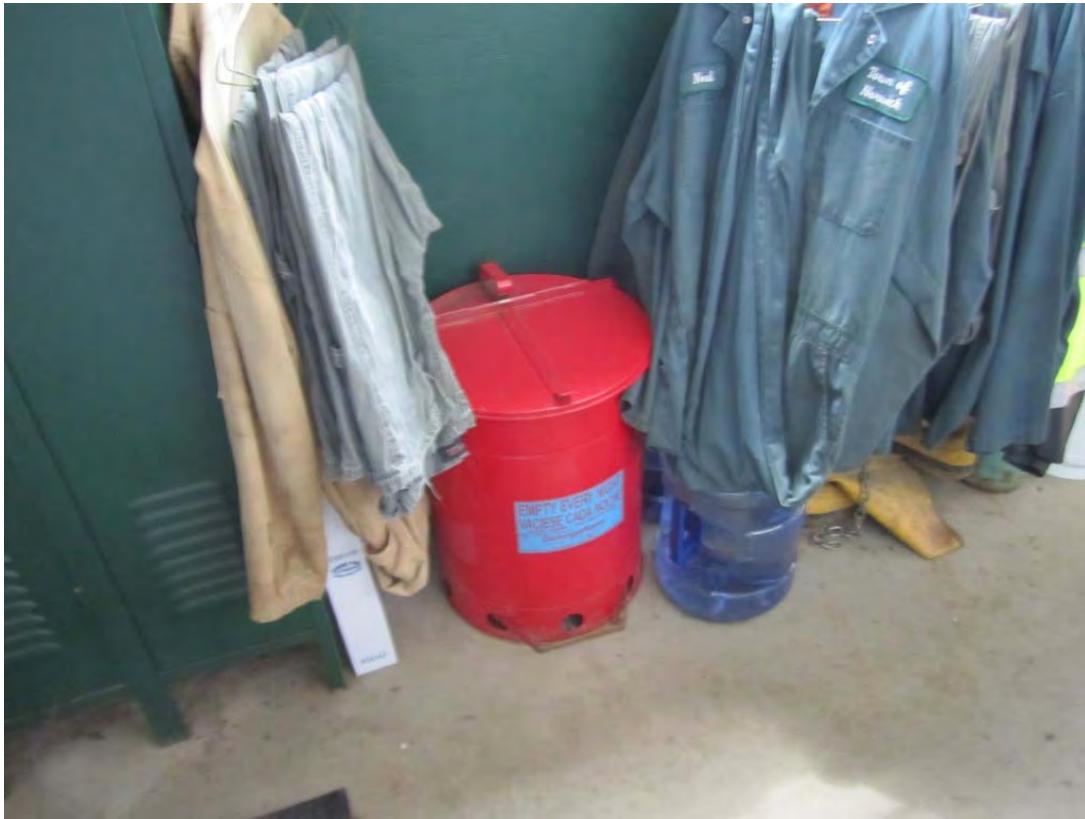
Photograph No. 15: Oily rag container.

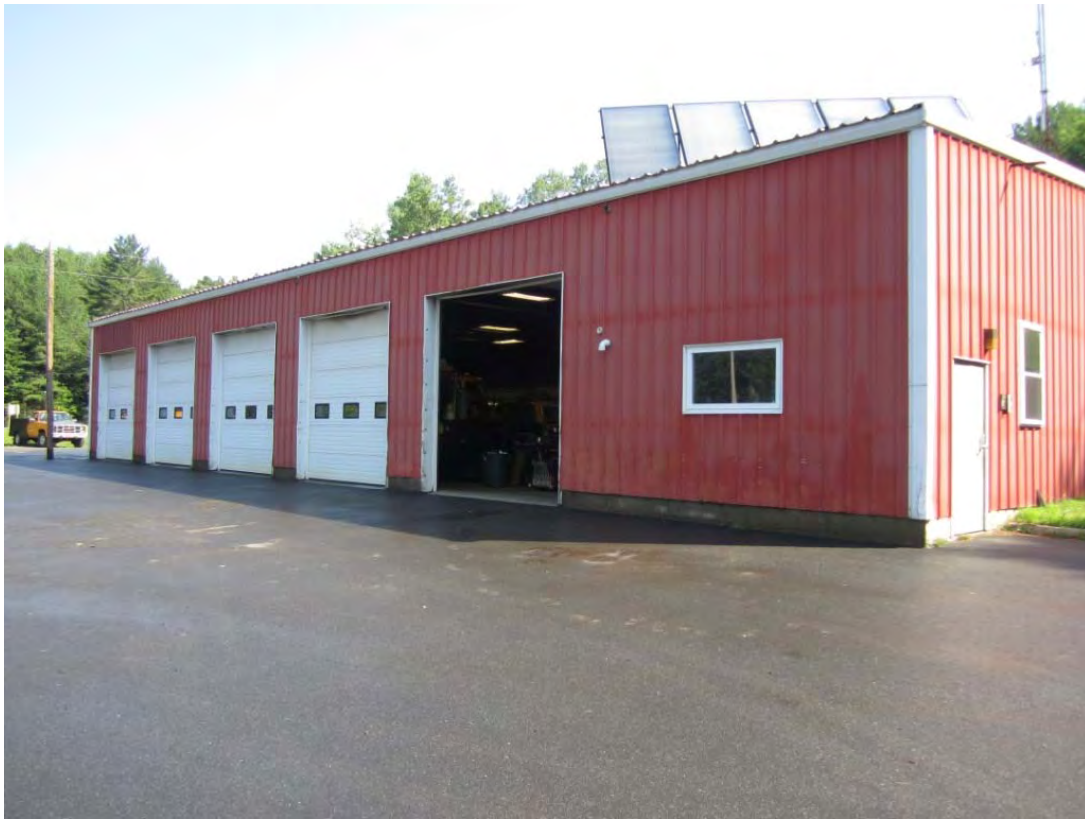
Photograph No. 16: Exterior of the existing building with solar panels.

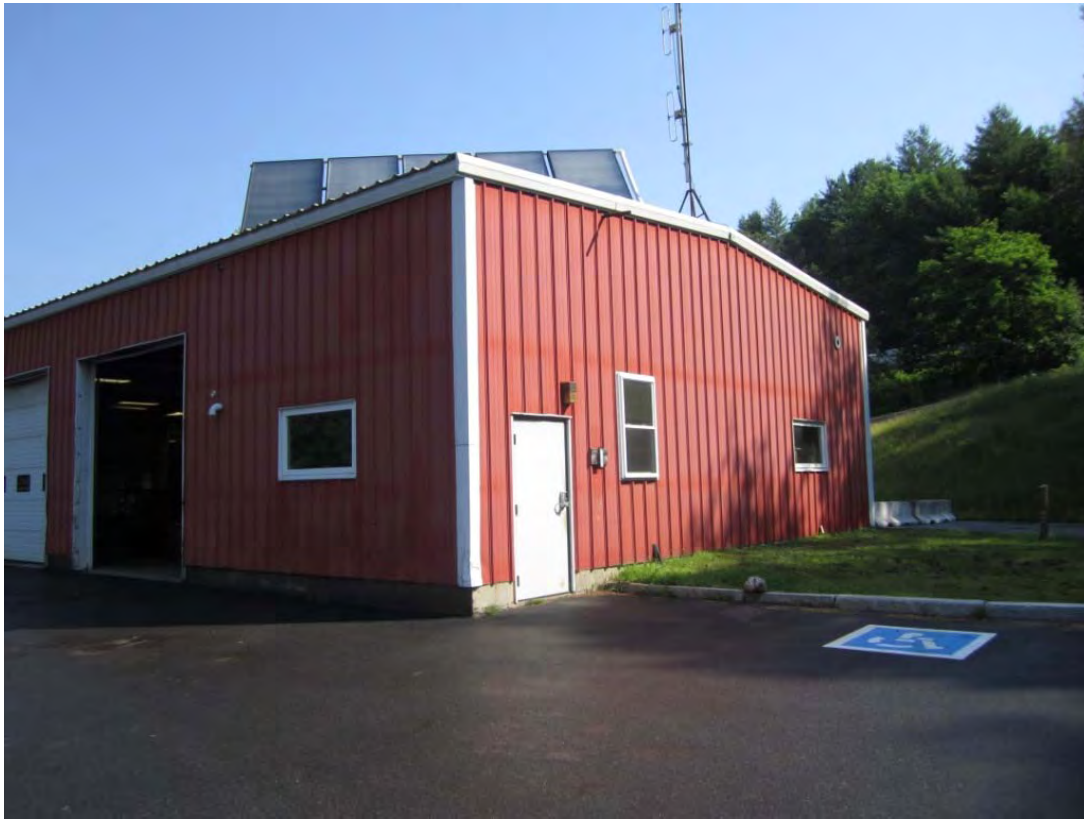
Photograph No. 17: Exterior of the existing building with solar panels.

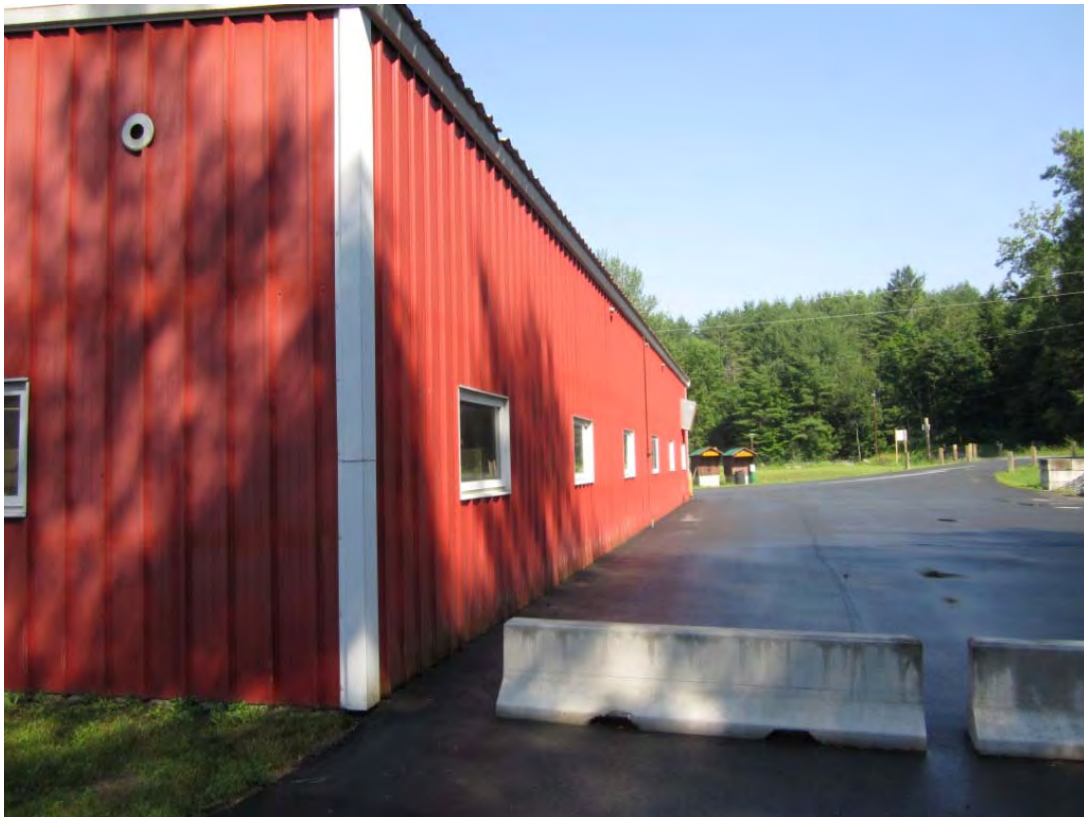
Photograph No. 18: Exterior of the existing building with solar panels.
