Town of Norwich Board of Civil Authority
Tax Assessment Appeals

Appellant Evidence Packet

RESIDENTIAL REPORT

153 Delta Dr
WHITE RIVER JUNCTION, VT 05001

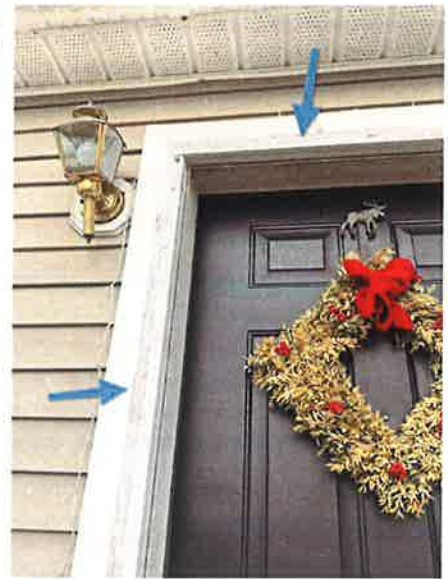
3.1.6 Siding, Flashing & Trim

WINDOW INSTALL/LEAKS

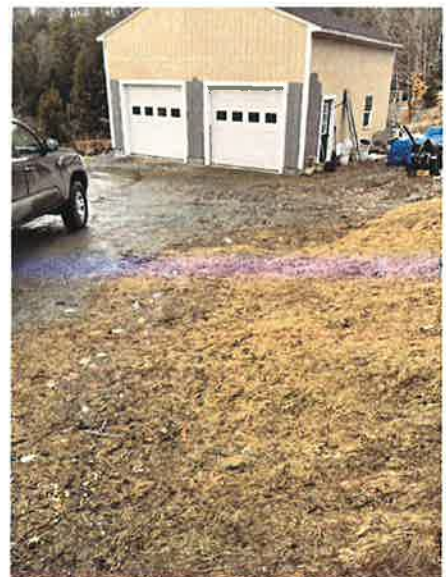
Excessive mud and ponding was noted

This can help to improve overall site drainage.

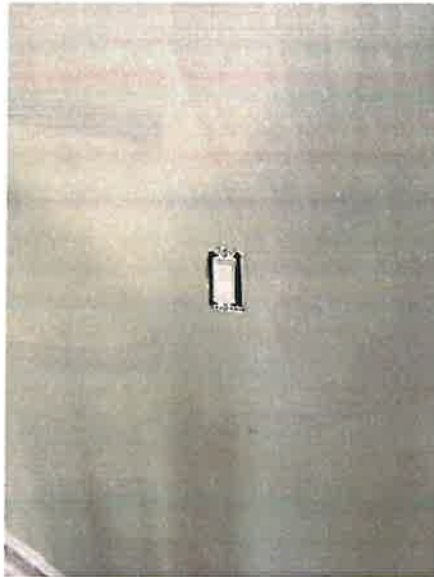
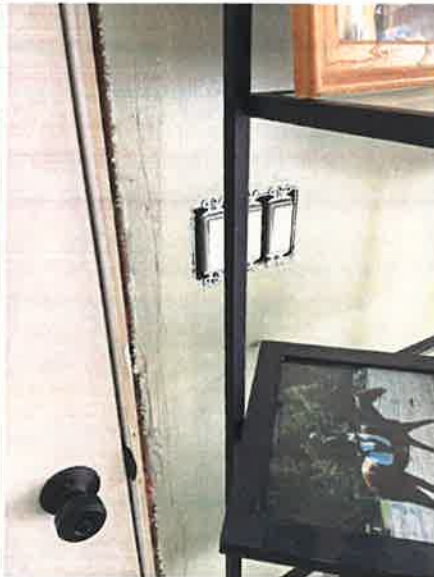
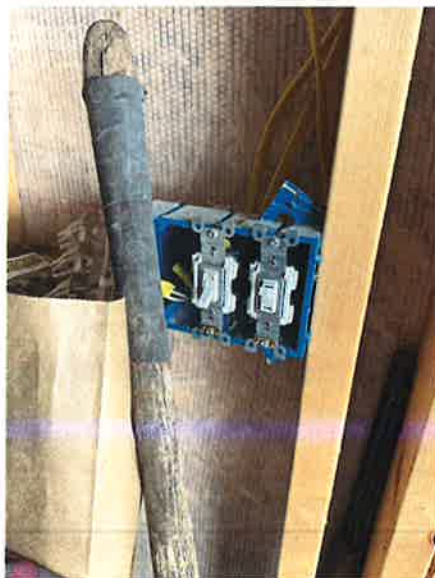
5.4.1 Lighting Fixtures, Switches & Receptacles

COVER PLATES MISSING

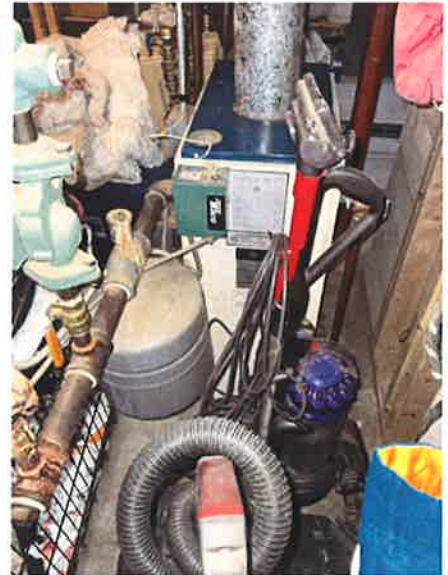
7.3.1 Distribution Systems

UNCOVERED FIN-TUBE

The fins on this heat pipe are very fragile, and can be easily damaged.

I recommend installing covers over this heat pipe.

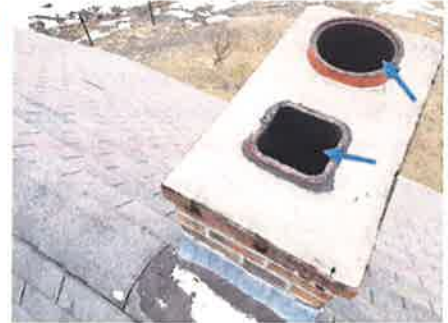
9.1.2 Vents, Flues & Chimneys

CLEANING

Any chimney/flue that serves a wood-burning (or pellet) burning appliance should be cleaned annually.

I recommend having any/all applicable flues thoroughly cleaned prior to use.

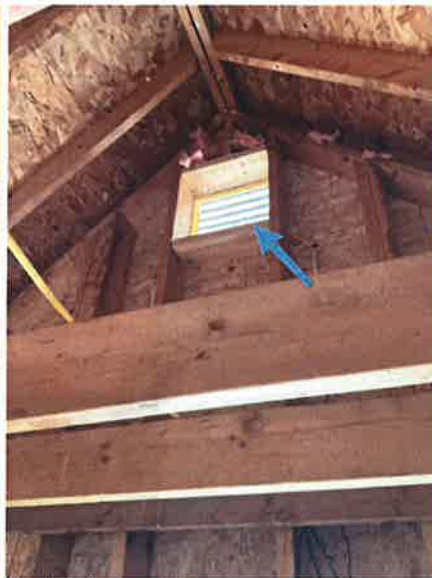
Undersized gable vents

As improvements to insulation are made, I recommend having proper ventilation installed.

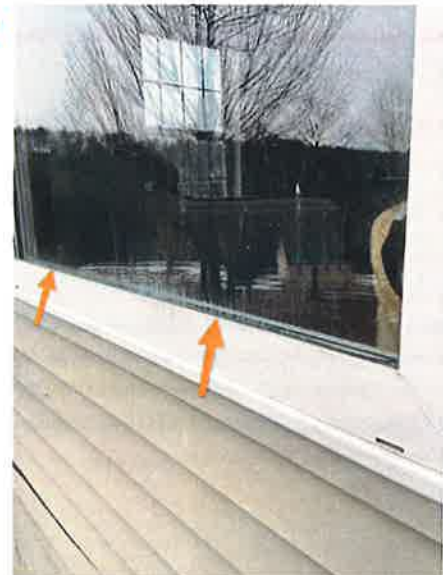
11.2.2 Windows

FAILED BALANCE

Several windows around the home have failed balances or springs in their tracks.

The window tracks on most units will need repair/replacement.

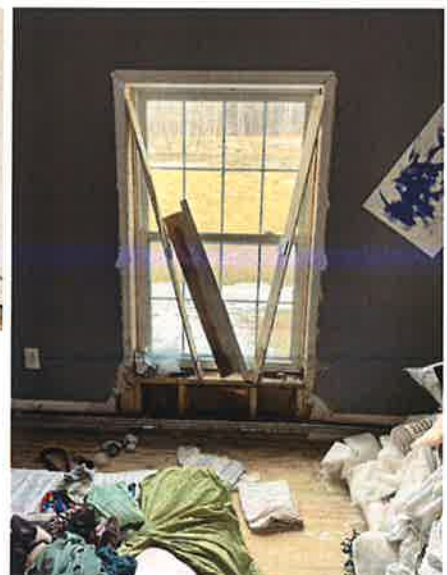
11.4.2 Walls

TRIM

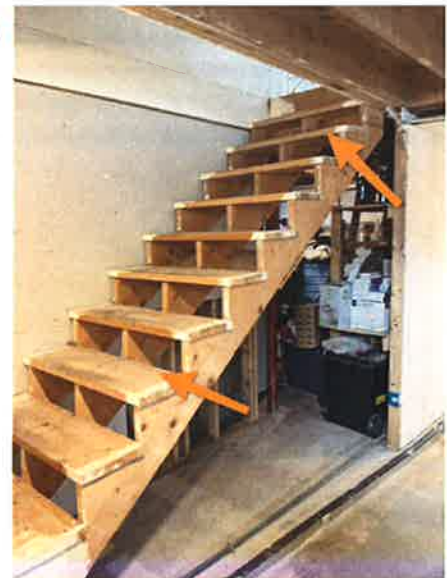
11.6.2 Steps, Stairways & Railings

BASEMENT STAIRS

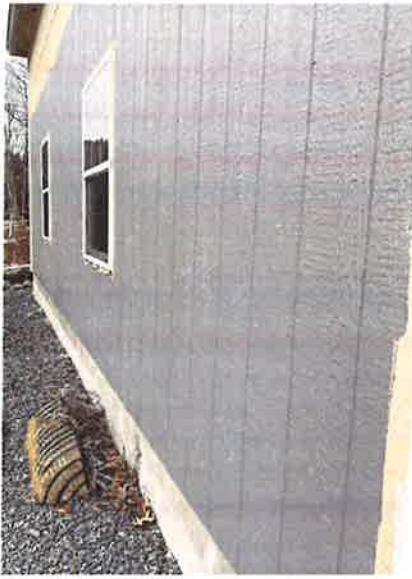
Exterior: T-111 Notes

T-111 plywood siding is prone to decay, if it is not well-maintained.
Keep the siding (especially edges) well-sealed.

Improving ground clearance would also be beneficial.
